304
IMPROVEMENT OF INSPECTION PERFORMANCE

A MASTER'S THESIS

Department of Industrial Engineering

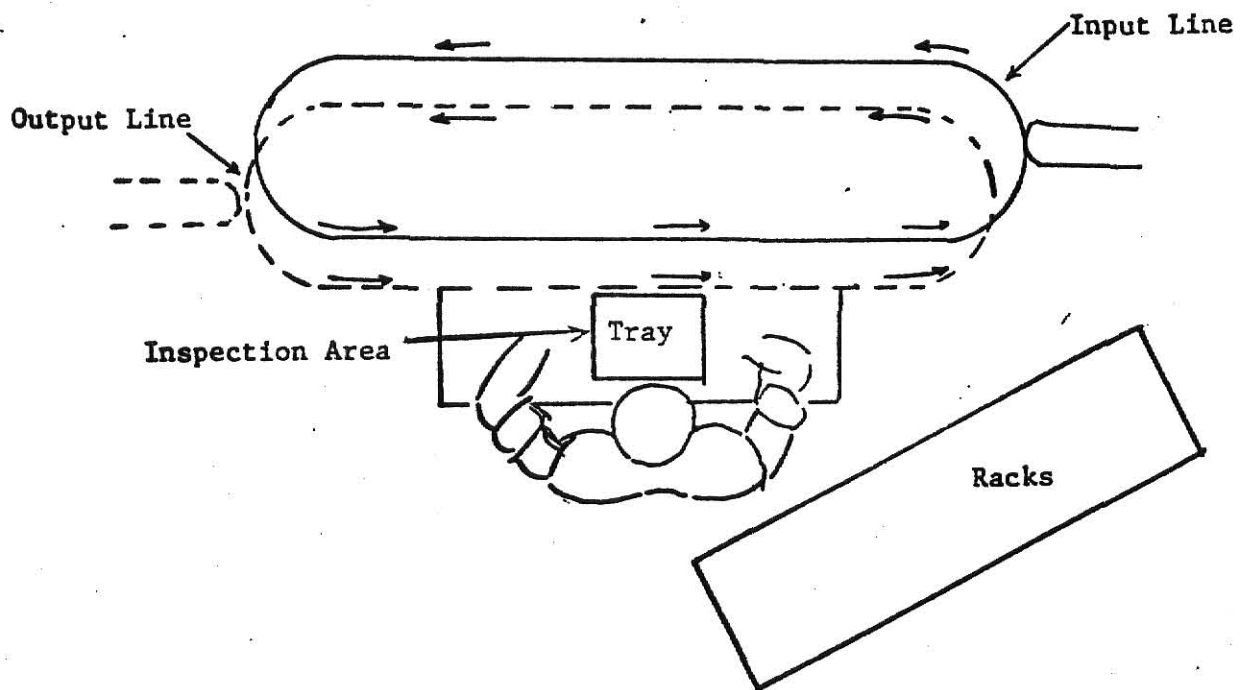
FIG. 1: THE PRESENT MOUNT INSPECTION STATION ARRANGEMENT.

The 40-watt inspectors receive the mounts at an erratic rate and must transfer approximately 85% to the demand conveyor which runs at a constant rate. The extra 15% also are stored in trays. Thus the 40-watt operator acts as both a "shock absorber" and an inspector who presently must transfer and inspect the lamp bulb ends at a rate of 1.4 seconds/part. These inspectors remove the mounts from one conveyor which is moving left to right and transfer it to another conveyor which also is moving left to right at a different (slower) speed (see Figure 1). The extra mounts are placed into trays for storage to be used during the time when the machine which

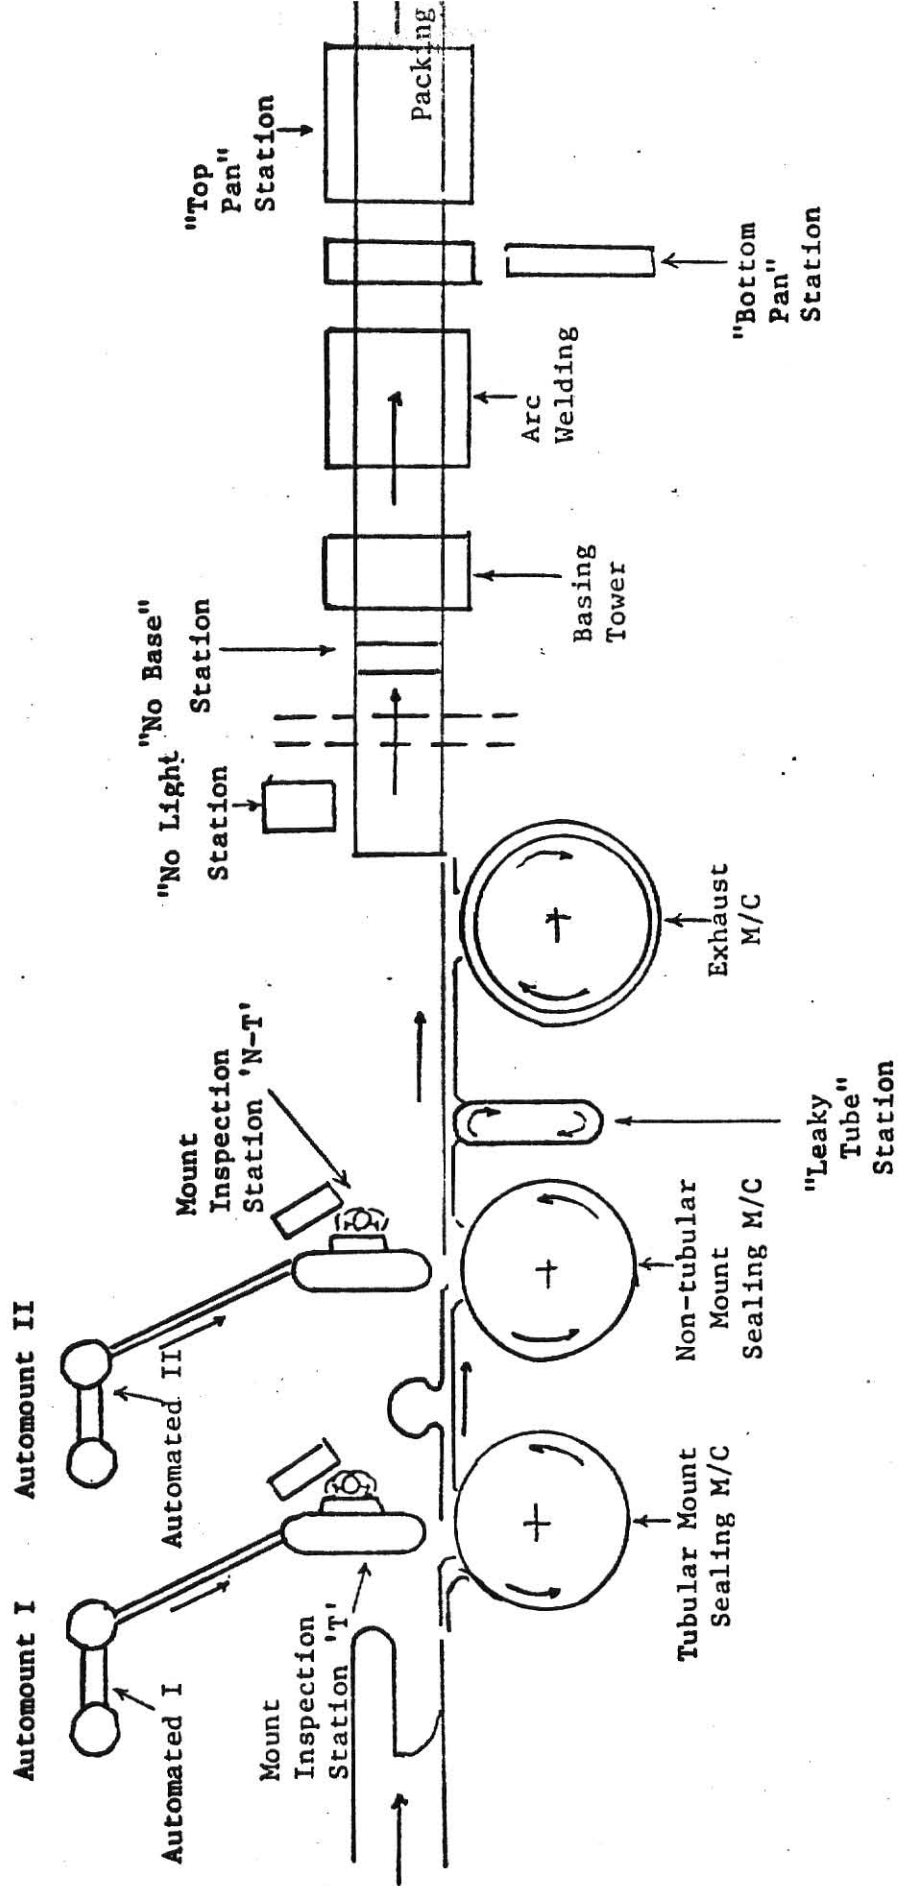
FIG. 2: 40-WATT BULB MANUFACTURING LINE (HAP I).

Presently there are six automated inspection stations and two manual inspection stations per line, totaling eight inspection stations a lamp must pass before being packed (see Fig. 2). These are described as follows:

(see Figure 2). There are 62 positions for holding the rejected tubes at this station. Here the tube is inspected automatically for the following defects:

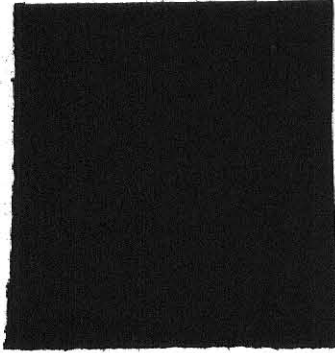
RED

WHITE

YELLOW

OFF-WHITE

FIG. 3: COLOR SAMPLES FOR TEST 3 (BACKGROUND)

On the tubular mount machine, colored backgrounds (red, white, yellow and a cream or off-white color)(see Fig. 3) were experimented with for a short periods of time. Figure 4 shows a sketch of the background location. Various comments were made on each by the inspectors. They felt that the white would be best except that it caused too much glare. Therefore, the off-white was selected and installed. Both the yellow and red seemed to be too "bold" or "different" as described by the inspectors (see Fig. 3).

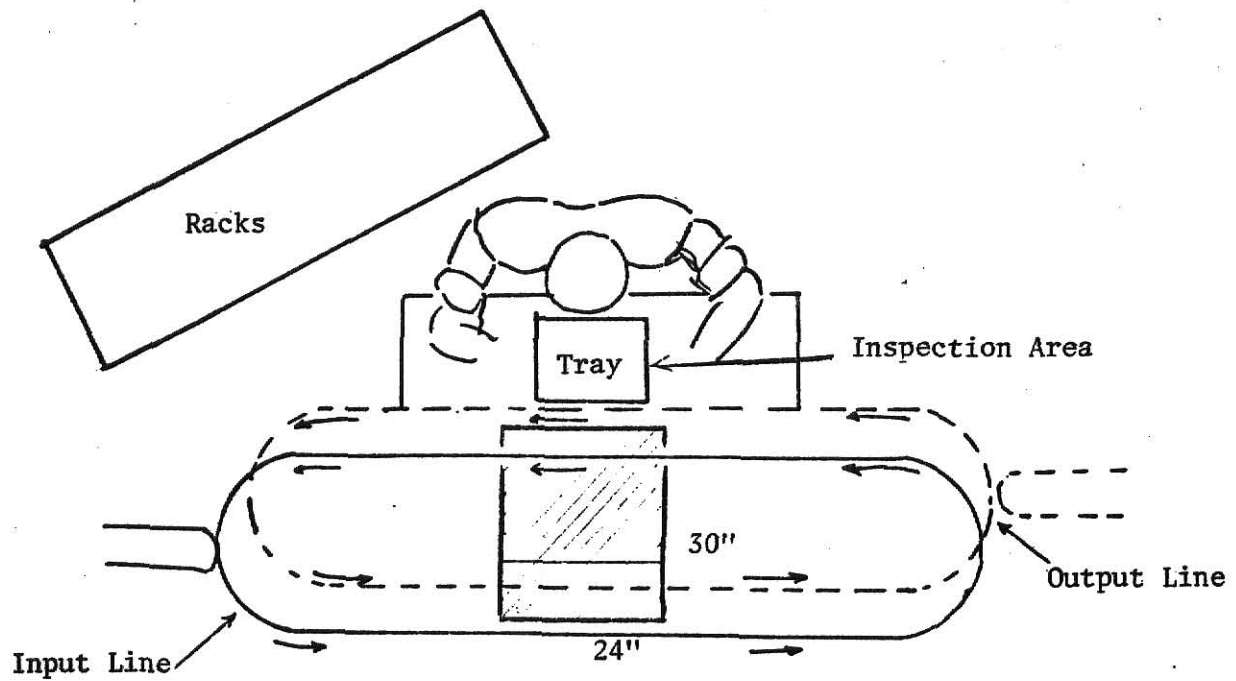
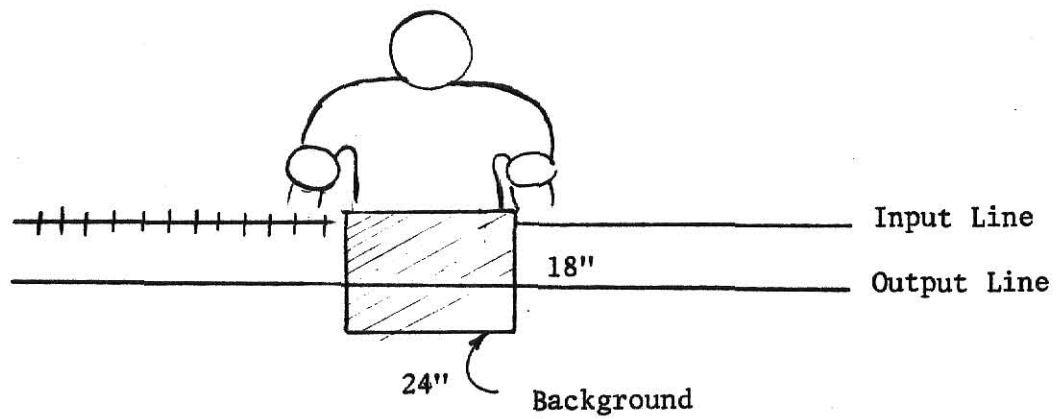
TOP VIEW

FRONT VIEW

FIG. 4: BACKGROUND LOCATION

- (3) Install an off-white opaque background at each work station, as shown in Figure 4. The test involving the opaque background indicates an overall improvement in performance due to the addition of the background (80% to 84%). Although there is a significant
