IMPROVING INSPECTION PERFORMANCE

A MASTER'S THESIS

Department of Industrial Engineering

KANSAS STATE UNIVERSITY  
Manhattan, Kansas

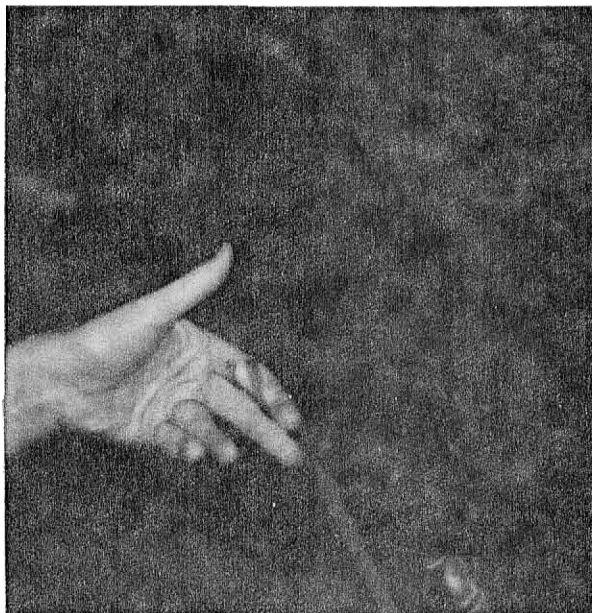
1. Pickup first two mounts with your left hand. Between 1<sup>st</sup> two fingers.

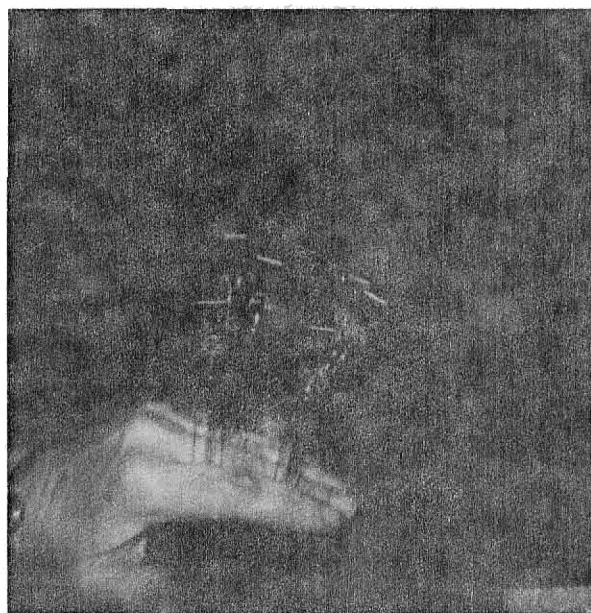
4. Turn your hand

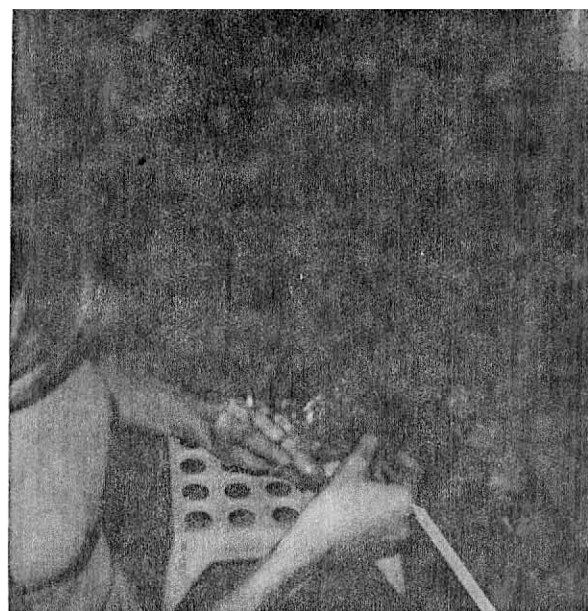
6. Grasp the first mount.  
Inspect for defects.  
Move to sealing conveyor.

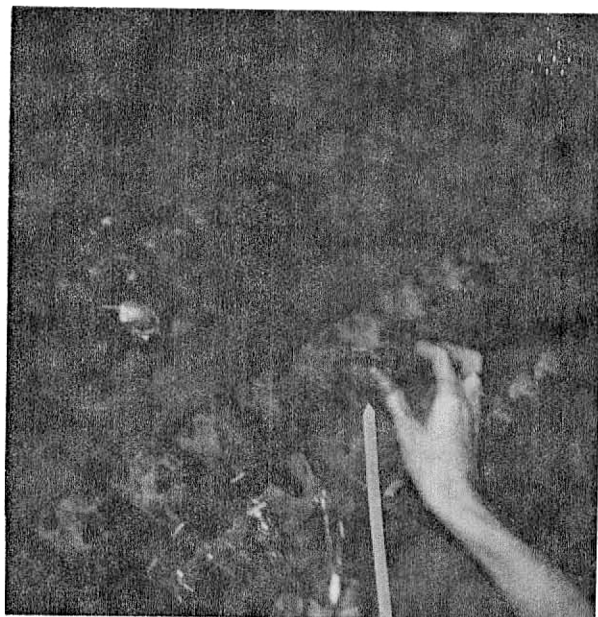
7. Load good mounts.

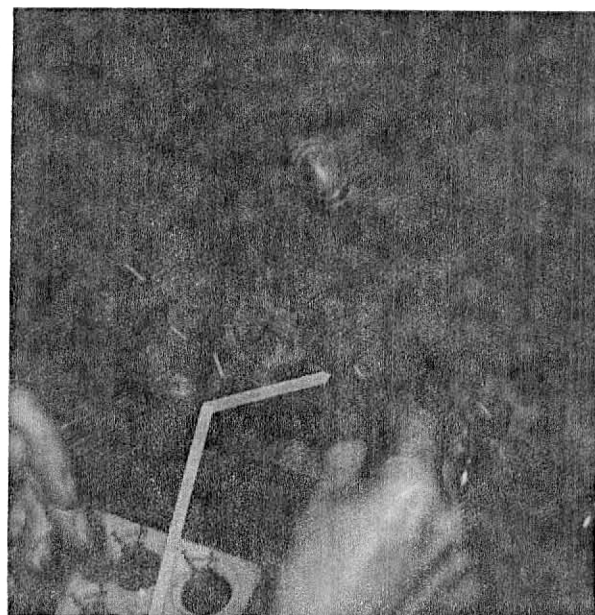
8. Orient while loading.

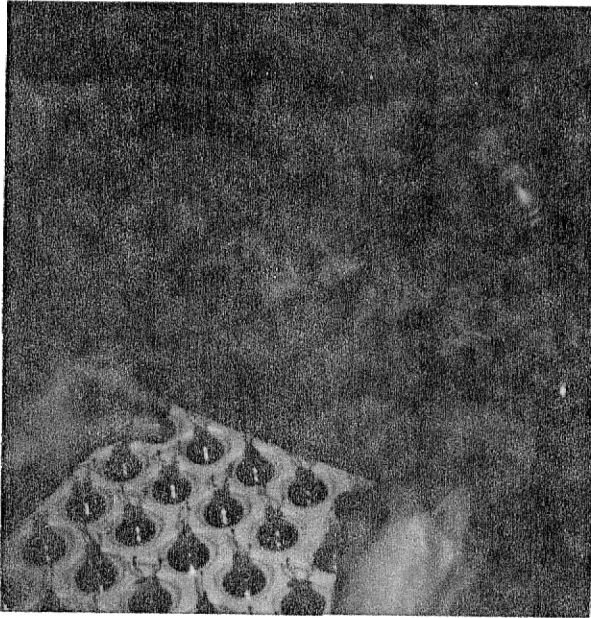
1a. Pickup two mounts simultaneously. Use both hands. Start on outside columns.

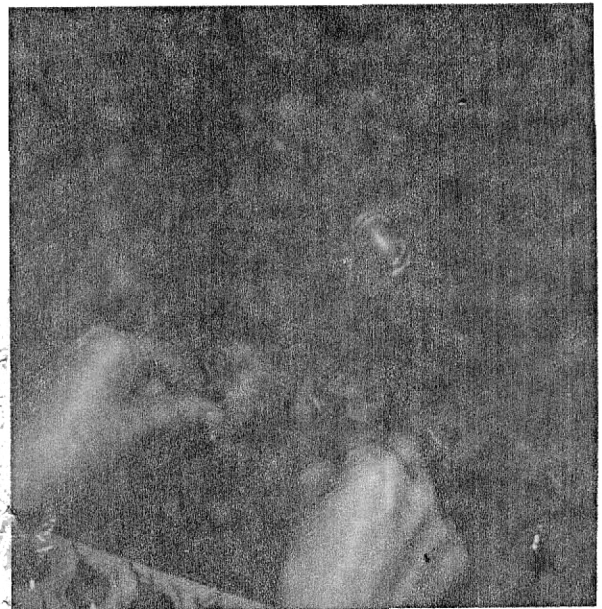
2. Load the two mounts on adjacent fixtures. Orient coils.

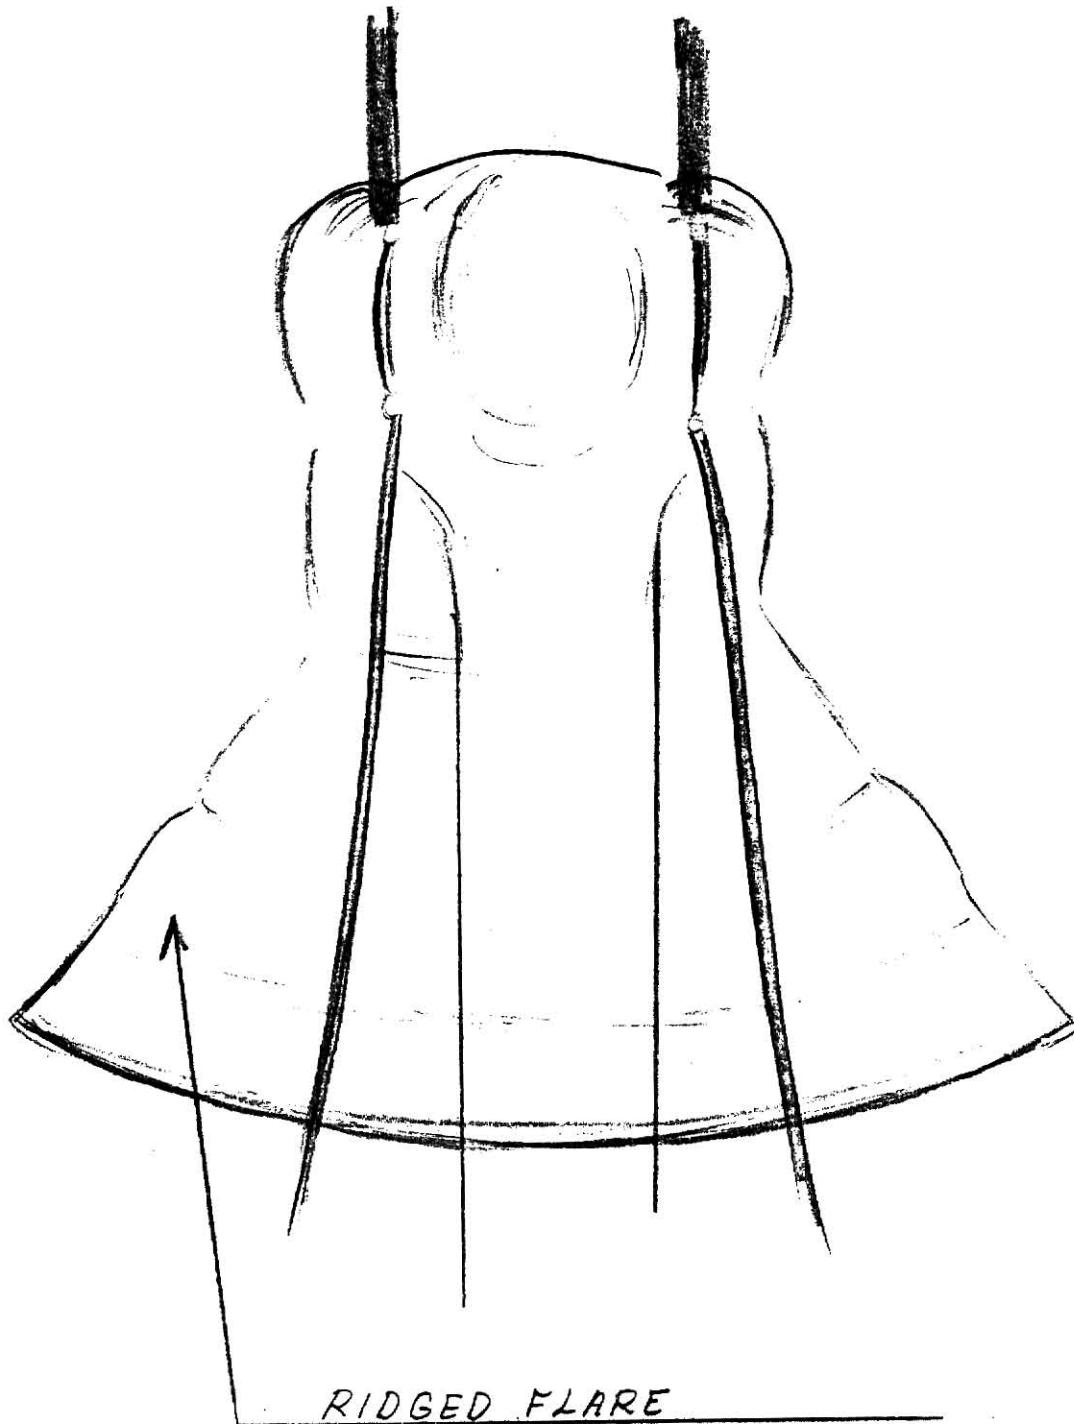
The ridged glass flare

MAJOR DEFECT

Consequence: Prevent sealing

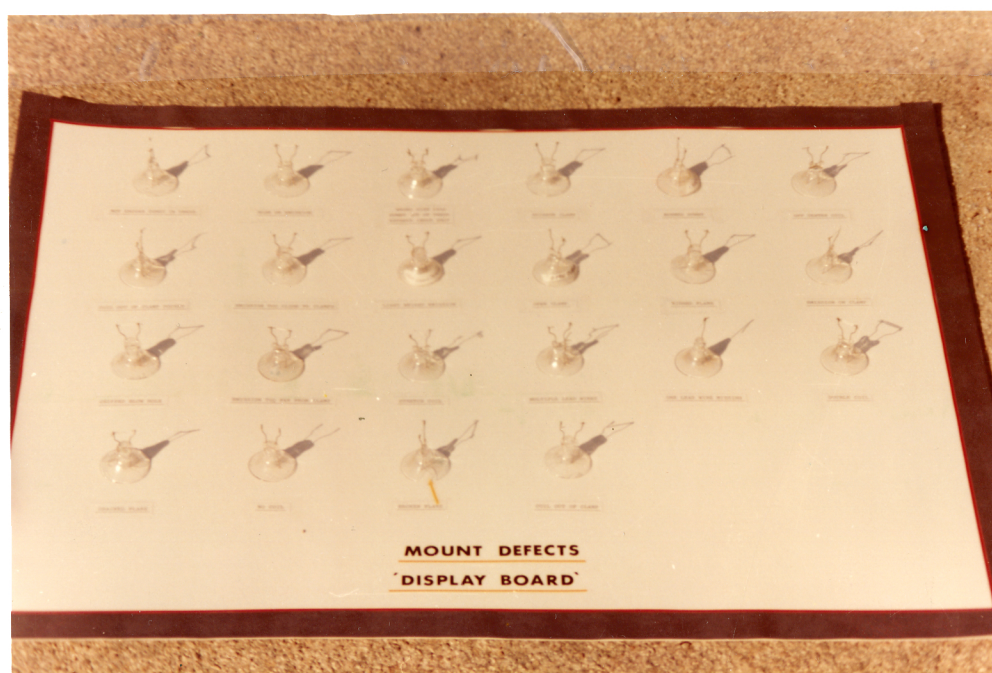
## APPENDIX L

## MOUNT DEFECTS DISPLAY BOARD

Next you will undergo a training session with Mary. She will explain you various defects, their consequences on the final product and will show you the 'Mount Defects Display Board'.
