Seismic retrofitting of unreinforced masonry buildings

A REPORT

submitted in partial fulfillment of the requirements for the degree

GE Johnson Department of Architectural Engineering and Construction Science  
Carl R. Ice College of Engineering

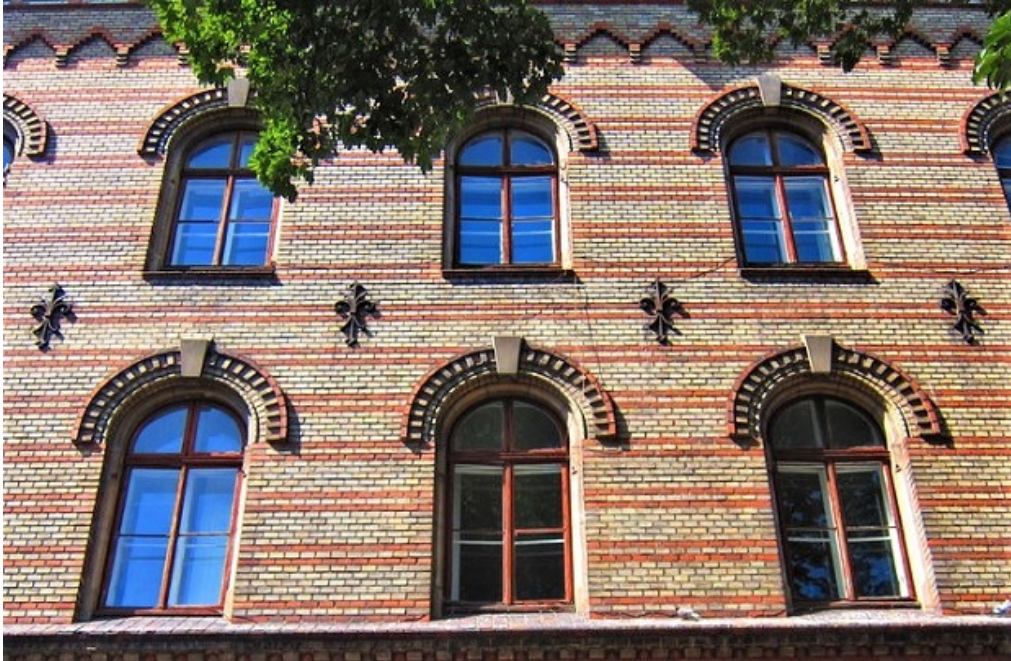
**Figure 7: Decorative Anchor Covers**

This method of retrofitting has several issues that need to be considered. The first issue is that the ties that are drilled completely through can have an effect on the aesthetics of the building because the bearing plate will be visible on the outside surface, (see Figure 6), although there are covers that can be purchased to add to the aesthetics of the building (Figure 7). Another consideration is where the ties need to be drilled. The ties can be installed from either the top or bottom of the diaphragm. “The choice of whether to install from above or below depends on whether there are finishes that need to be avoided, whether diaphragm strengthening is being done, and what type of diaphragm strengthening is planned. If there is a special plaster ceiling to be avoided, then access and installation would proceed from above. If there is no plaster ceiling and the floor or roof diaphragm is not being modified or is being enhanced by adding a wood structural panel overlay from above, then access and installation for wall diaphragm ties would be from below” (FEMA 547, 2006). The last issue to be covered is the disruption of installation that occurs. The disruption occurs because of the noise from drilling and that the floor or ceiling must be removed to install the dowels. This makes it impractical to install the dowels while a room is being occupied.

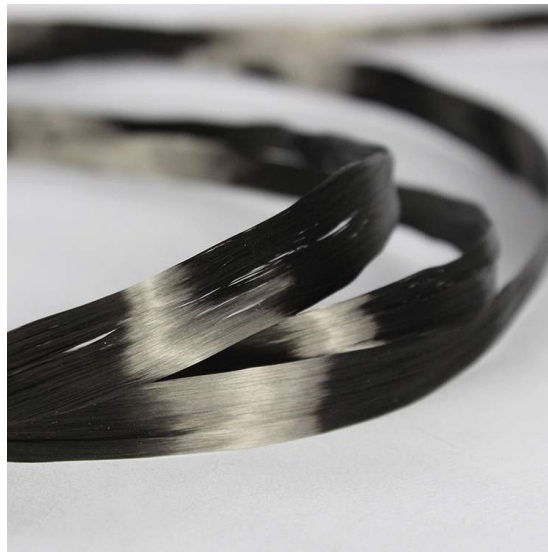
**Figure 9: Carbon Fiber Tow**

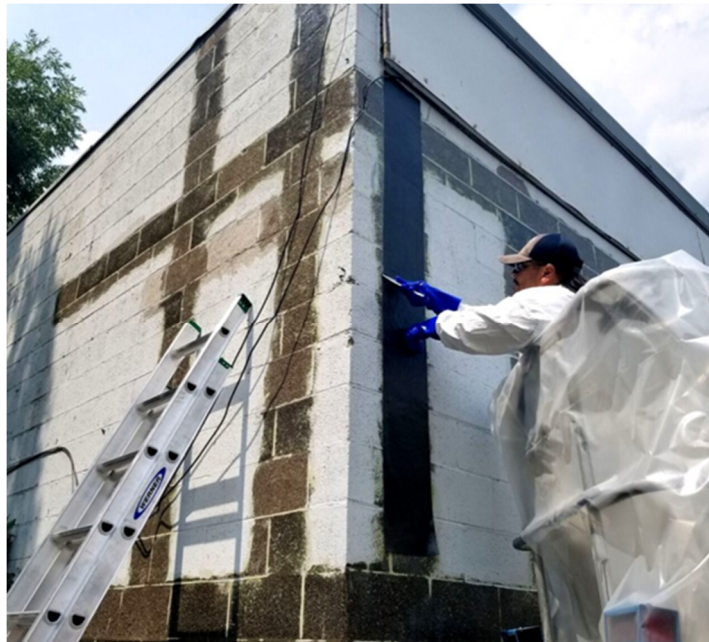
**Figure 12: CFRP on Exterior of Masonry Building**

The main purpose of the addition of CFRP is to improve a walls in-place capacity, but it has been shown to increase the out-of-plane capacity. CFRP can be installed on one side of the wall or both. An epoxy is needed to bond the CFRP to the wall and another layer of epoxy will be added to the top of the CFRP to ensure a proper bond and also provide moisture protection to the CFRP. To install the CFRP sheets to the walls, the walls will be roughened up usually by being blasted with an abrasive material and then cleaned to ensure an adequate connection between the epoxy and the wall surface. When the epoxy has been added the CFRP sheets are set on top of that initial coating of epoxy and then the second layer of epoxy is added (Figure 11). This process can be disruptive to the occupants due to the noise of the blasting and the fumes from the epoxy. The use of this method is not preferred to be used on the exterior of the building if the architectural aesthetics are an issue (Figure 12).

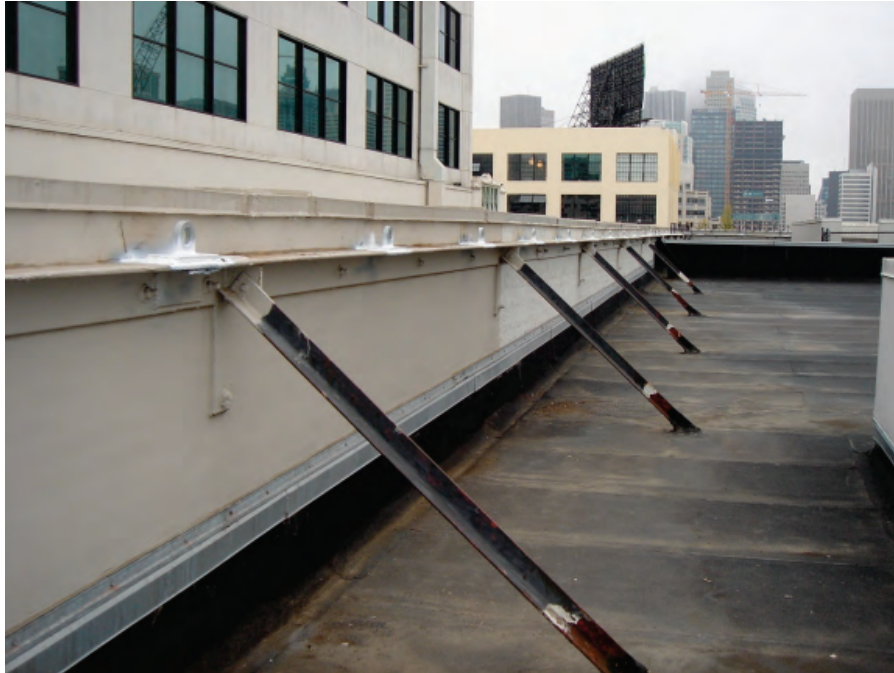
**Figure 14: Parapet Bracing**

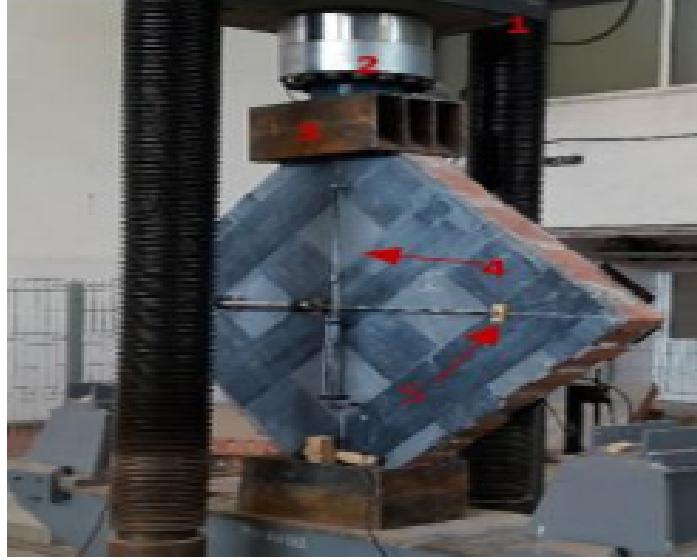
**Figure 20: Test Setup**

were placed into the testing machine at a 45-degree angle under monotonic compressive load to determine the diagonal tensile strength for each wall (Figure 20). The results of the loading of the walls where the initial cracking started to form is shown in Table 4 below.

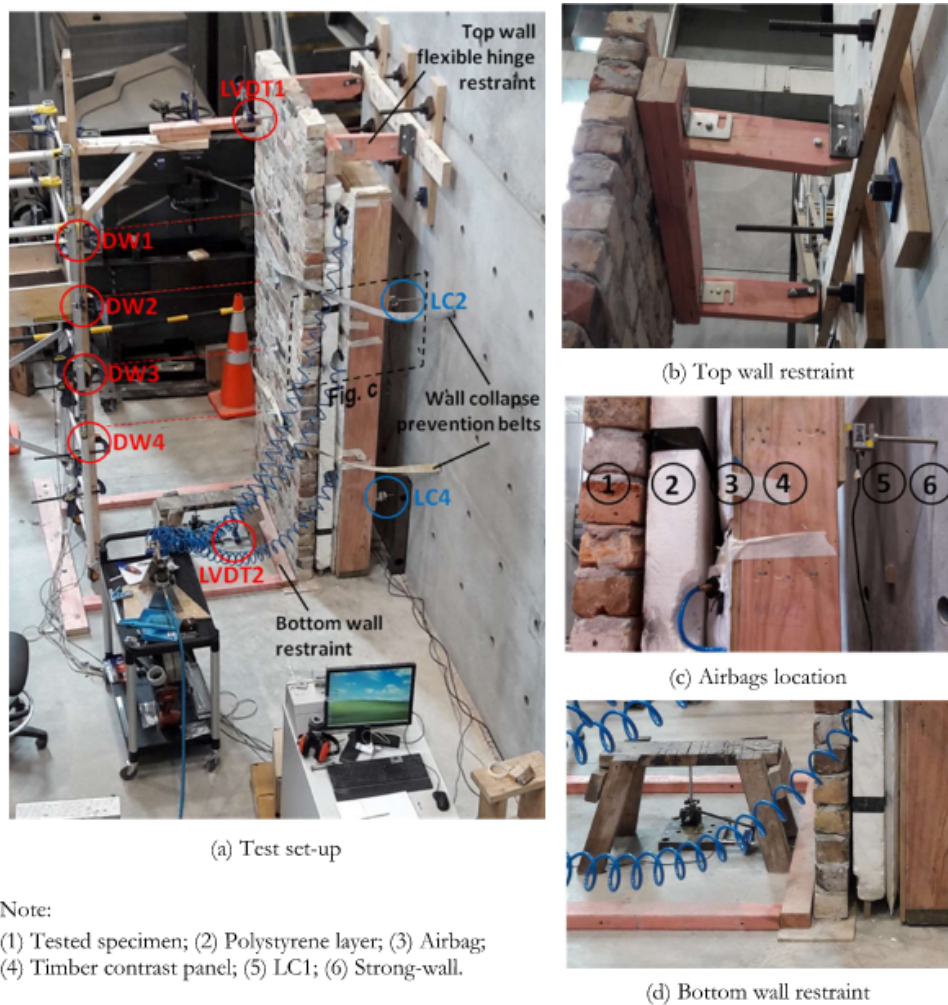
**Figure 23: Test Setup**

Cassol et al did an experimental study titled “*Seismic Out-of-Plane Retrofit of URM Walls Using Timber Strong-backs*” (2021). The experimental study was to test out-of-plane wall bracing using timber strong-backs as a cost-effective way to retrofit unreinforced masonry walls. Five walls were constructed for this experiment and were subjected to semi-cyclic out-of-plane loading using airbags. Four out of the five walls were built using clay bricks, two that were double leaf (2-wythe) walls, two were single leaf walls, and one wall that was constructed using concrete masonry units (CMU). The strong-backs that were attached to the walls by mechanical

screws were spaced at 600 mm (23.6 inches). The strong-backs were attached at each end by timber members that ran perpendicular at the top and bottom of each wall, very similar to a stud wall in timber construction with no blocking. The timber itself was New Zealand Radiata Pine, with a cross-section of 90 x 45 mm (3.54 x 1.77 inches). The timber members were placed on one side, and the loading was applied as if the timber was on the compression side or the tension side of the wall. The test was set up to mimic a single-story perimeter wall (Figure 23).

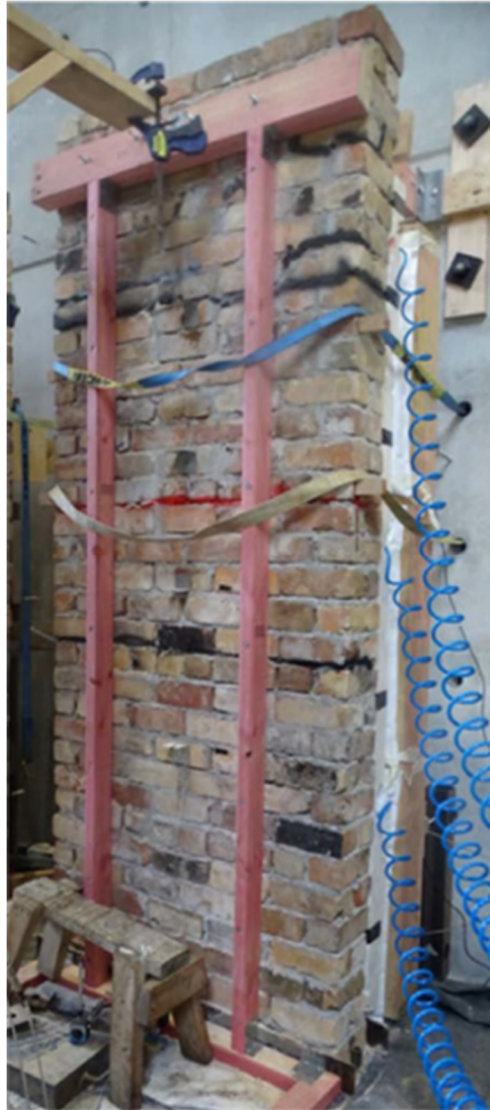
**Figure 24: Timber Strongbacks on Wall**

Once these tests were completed, the timber strongbacks were added (Figure 24), and the walls were tested in a way that the strongbacks were on the compression side. Walls 1 and 2 were retrofitted with members that had different cross sections. Wall 1 had a 45 mm x 90 mm (1.77 x 3.54 inches) member and wall 2 had a 90 mm x 90 mm (3.54 x 3.54 in) member, but both were spaced at the same distance. Wall 1's out of plane capacity increased to 16.41 kN (3.7 kips) and wall 2 increased to 40.61 kN (9.1 kips) "which represent an improvement in capacity by approximately 254% and 242% above the capacities of the as-built walls." (Cassol Et al, 2021). The CMU wall (Wall 3) was retrofitted with 45 mm x 90 mm (1.77 x 3.54 inches) members spaced at 500 mm (19.7 inches), which resulted in a capacity of 8.77 kN (2 kips), "an improvement of approximately 179% to the value achieved for the as-built wall." (Cassol Et al, 2021). The two single leaf clay brick walls were retrofitted with the same member at different orientations. Wall 4 was retrofitted with 45 mm x 90mm (1.77 x 3.54 inches) oriented in strong direction, while Wall 5 with the same member oriented in the weak direction. The strongbacks were spaced equally at 450 mm (17.7 inches) for both walls. Wall 4 achieved a capacity of 10.39

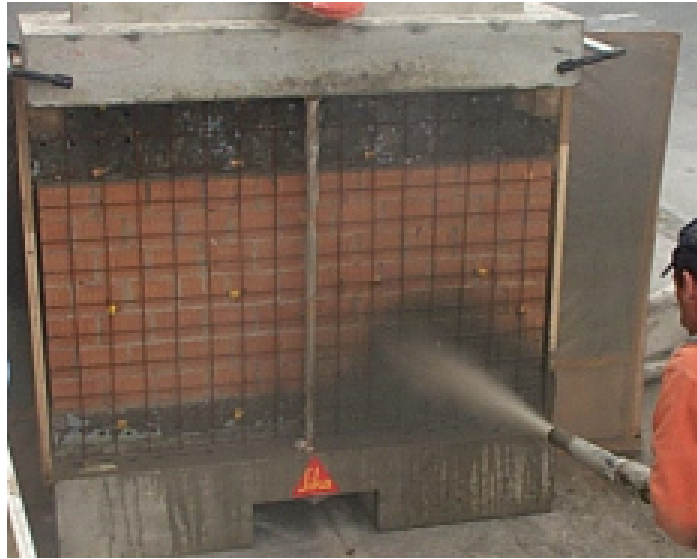
**Figure 25: Shotcrete Being Installed**

double layers of reinforcement on the same side. Thus, both walls had the same amount of reinforcement. Lastly, the walls were wetted and the shotcrete was applied (Figure 25).

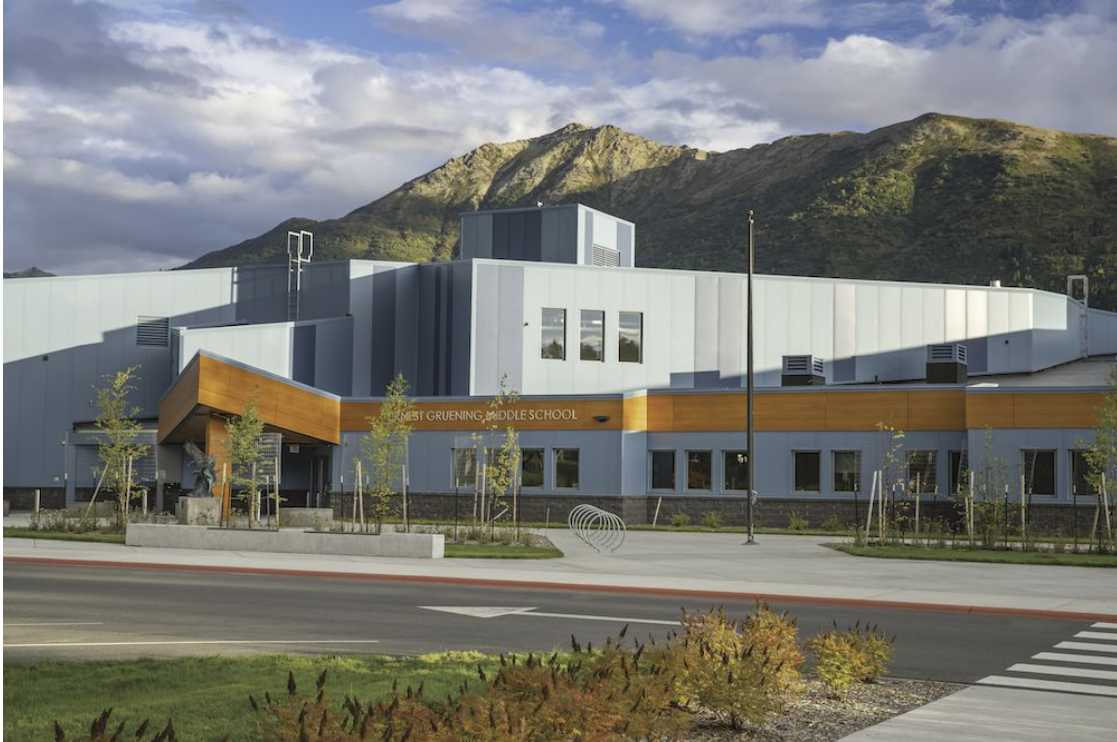
**Figure 27: Gruening Middle School Completed**

The information gathered for this case study comes from Hamel's article titled "*Seismic repair and retrofit in Alaska*" (2023). On November 30, 2018, an earthquake struck the town of Eagle River, Alaska. The earthquake had a magnitude of 7.1. The earthquake's epicenter was just 11 miles from Gruening Middle School. The earthquake caused significant damage to the school and forced the school to be shut down for nearly three years while seismic upgrades and repairs were done. The school was originally constructed in 1981 and is a two-story, 124,000 square foot building. The building utilizes CMU shear walls on the interior. The completed project can be seen below (Figure 27).

After assessing all these problems, it was determined to use a fiber reinforced cementitious matrix (FRCM). The engineers found that using FRCM would, "...upgrade existing stack bound CMU walls to meet current MSJC reinforcing requirements and strengthening tall walls to meet out-of-plane bending capacity requirements." (Hamel, 2023). FRCM is similar to shotcrete but instead of using a steel mesh it uses a carbon fiber grid. This method would not add significant weight or volume to the project. This was the first time that FRCM was used in the state of Alaska. The application of the FRCM went as follows: "Remove finishes from single (or both) sides of masonry shear walls as noted on plans. Remove paint from the surface. Fill the existing CMU flutes and place the fabric matrix. The anticipated added thickness to the CMU wall is a maximum of ½ inch. Trowel finish and paint as shown on Architectural Drawings" (Hamel, 2023). FRCM was used to cover around 36,000 square feet of wall. Most of the FRCM was single sided except for the tall walls. It was required on both sides to assist with out-of-plane bending reinforcing.

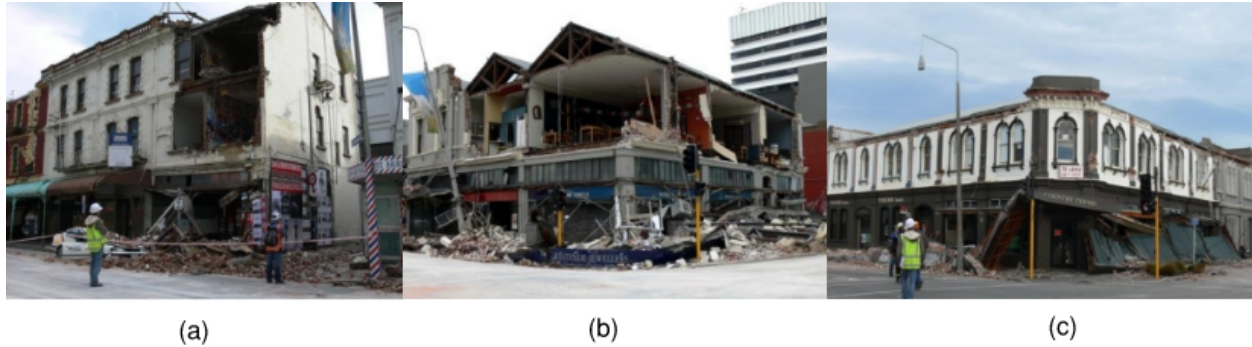
**Figure 28: (a) 135-139 Manchester Street (b) Welstead House (c) Cecil House**

the façade had pulled away from the side walls due to insufficient anchorage. The 135-139 Manchester Street building (Figure 28a) is a three-story “L” shaped building. The front façade had entirely collapsed out-of-plane. There was damage due to collapsed parapets except for two bays where the parapet still remained. The collapsed façade revealed severe water damage to the floor joists and roof rafters. The steel through-anchors around the gable were seen with the brickwork pulling away from the anchor plates. The parapet landed on the canopies below resulting in the canopy collapsing. The Welstead House (Figure 28b) is a two-story rectangular building. The damage observed was a complete out-of-plane collapse of the façade walls. Due to the extensive damage of this building, it was eventually demolished. The 192 Madras Street building is a two-story URM building. The spandrels on the first floor and the roof had extensive cracking. The façade appeared to move at the diaphragm. The side walls were shown to have suffered diagonal shear failures. The parapet had remained attached because of the support from masonry columns that extended up to the corners of the building. The Cecil House (Figure 28c) is an “L” shaped building with two-stories. The damage observed was that the parapet had toppled around the street front. The parapet landed on the canopies below, which caused the tension braces to overload and caused a punching shear failure in the masonry wall. There was no evidence of through-anchors connecting the roof diaphragm to the wall that could be observed. The 463-469 Colombo Street building is a two-story “L” shaped building. The parapet had completely collapsed. The external veneer had collapsed and revealed wire ties that were in good condition with just a few ties appearing to have rust.
