**An evaluation of low-cost wrong-way driving countermeasures at partial cloverleaf  
interchanges on Kansas interstates**

AN ABSTRACT OF A DISSERTATION

Department of Civil Engineering  
Carl R. Ice College of Engineering

KANSAS STATE UNIVERSITY  
Manhattan, Kansas

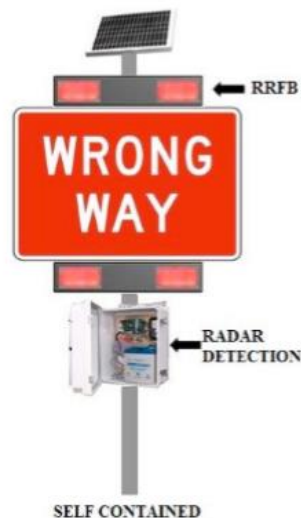
**Figure 2.1: Red RRFBs on Wrong-Way sign**

Sign supplements such as fluorescent red sheeting and retroreflective sheeting effectively increase sign visibility, especially during dawn and dusk hours when drivers need additional guidance (Staplin et al., 2001; Pour-Rouholamin, 2016; NTTA, 2009). Figure 2.1 illustrates the use of a Red Retroreflective Beacon (RRFB) to supplement a Wrong Way warning sign. A RRFB is a set of red lights that are attached above and below a sign that flashes when a vehicle is detected going the wrong way. RRFBs were found to effectively attract drivers' attention due to the beacon's high intensity and flashing light (Ozkul & Lin, 2017; Ponnaluri, 2015), and they were a more effective countermeasure for deterring WWD than red flashing beacons (Ozkul & Lin, 2017). Public surveys have shown that drivers prefer RRFBs over other countermeasures such as LED Wrong Way signs, especially if the Wrong Way signs were placed on the left and right sides of a roadway with RRFBs on the top and bottom sections of the signs, similar to Figure 2.1 (Sandt et al., 2015; Ozkul & Lin, 2017).

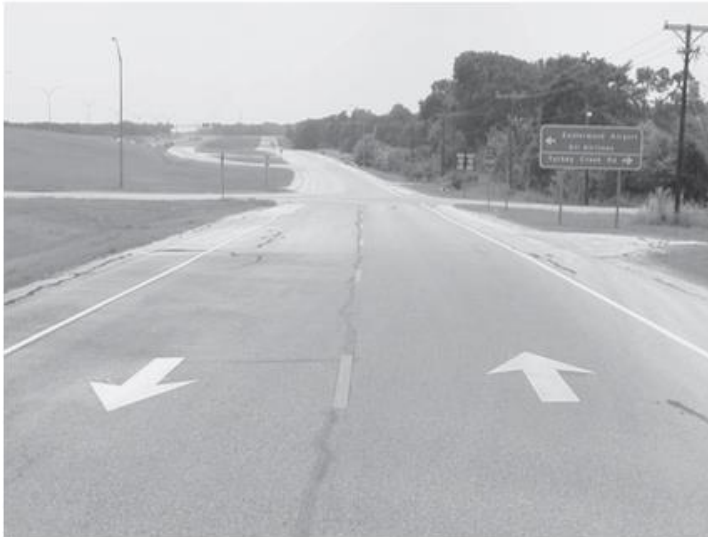
**Figure 2.2: Lane Direction Pavement Arrows on Two-Way Frontage Road**

The use of lane direction pavement marking arrows downstream from an exit ramp and on a two-way frontage road (Figure 2.2) was found to be an effective safety countermeasure that helps mitigate WWD incidents (Shrock et al., 2005; Zhou et al., 2014b). Installing reflectorized WW pavement arrows has also been found to be an effective countermeasure if they are placed upstream on the exit ramp and downstream near the crossroad (Cooner & Ranft, 2008; Das et al., 2017; Schrock et al., 2005; Monsere et al., 2017). Pavement arrows have been proven to be effective when placed on the left side exit ramps, locations known to be susceptible to WWD crashes (Cooner et al., 2003; Cooner et al., 2004). In a general, pavement marking arrows have been found to be an effective low-cost countermeasure because drivers can quickly and easily comprehend the markings.

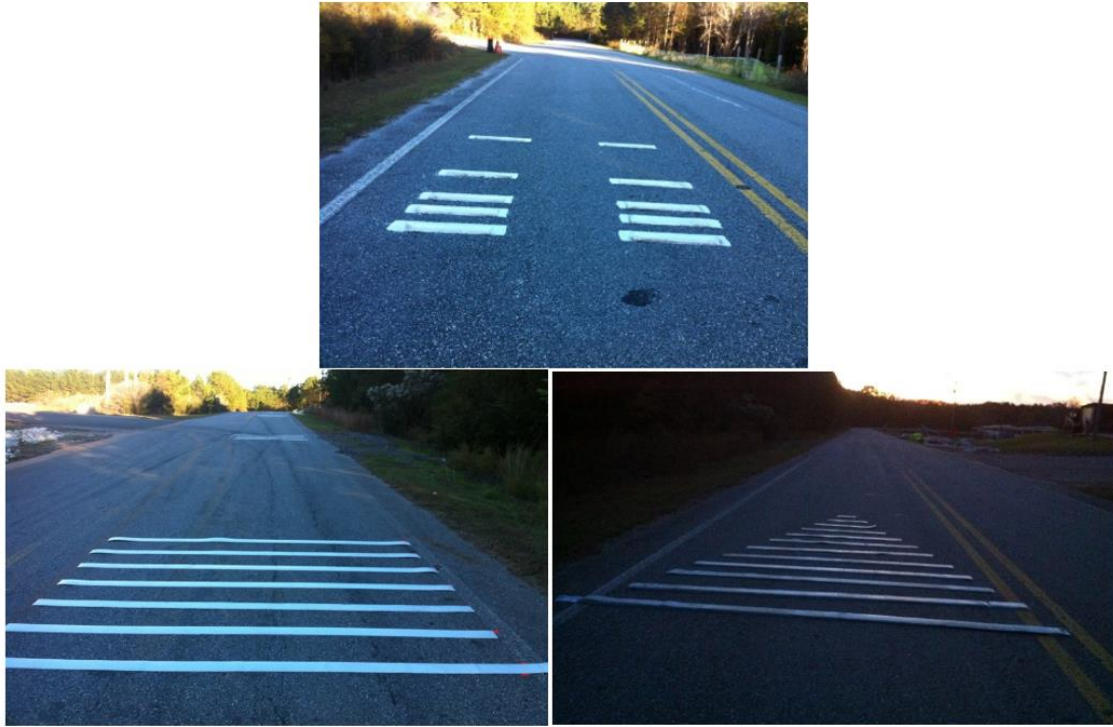
**Figure 2.3: Effective Directional Rumble Strips**

Directional rumble strips, which are variations of transverse rumble strips, are used to catch the attention of WW drivers. Zhou et al. (2018) compared different rumble strips to determine which strips were most effective. Figure 2.3 shows the directional rumble strip configurations that produced effective sound and vibration effects and increased visual alertness. These configurations produced an adequate sound increase for drivers traveling in the wrong direction compared to vehicles traveling in the correct direction.

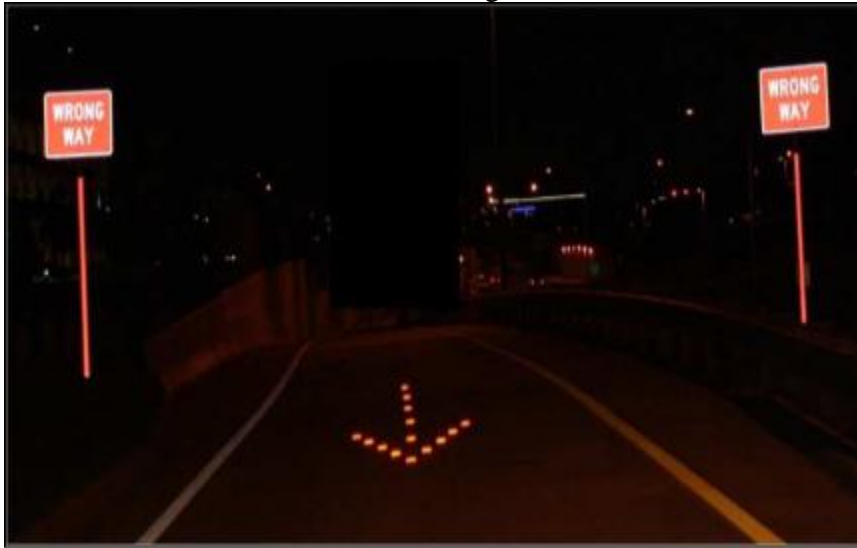
**Figure 2.4: Wrong-Way Arrow with RPMs and Supplemental Wrong-Way Signs**

Arrow markings may also be supplemented by Red Reflective Pavement Markers (RRPMs) and Wrong Way signs located along the exit ramp, as shown in Figure 2.4 (Caltrans, 2014; Vaswani, 1977; Cooner et al., 2004; Zhou & Pour-Rouholamin, 2014). RRPMs are small raised markers placed on the pavement that appear red to a driver traveling in the wrong direction and white to drivers traveling in the correct direction. These markers are typically placed in such a way as to form an arrow pointing in the correct direction of movement. A study by Ponnaluri showed quick driver recognition of RRPMs because RRPMs on the pavement are within the driver's cone of vision (Ponnaluri, 2015).

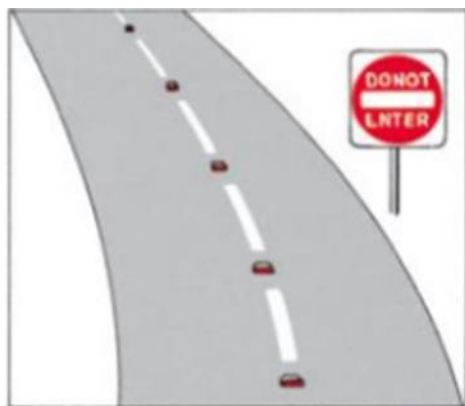
**Figure 2.5: Red Retroreflective Pavement Markings**

RRPMs, shown in Figure 2.5, are used on undivided highways to indicate that a driver is traveling in the wrong direction. The state of Hawaii uses these markings to remind tourists that they are not driving in a country that drives on the left side of the road (Miles et al., 2008). Although these markings were found to be most effective at night, concerns have been raised about whether

MUTCD Section 3B.13 states that RRPMs should not be used to supplement edge lines because drivers traveling in the correct direction on undivided highways can see the red RRPMs from the opposite side of the roadway, which can lead to driver confusion. However, Section 3B.14 states that the side of the RRPM that is visible to WW drivers may be red (FHWA, 2009).

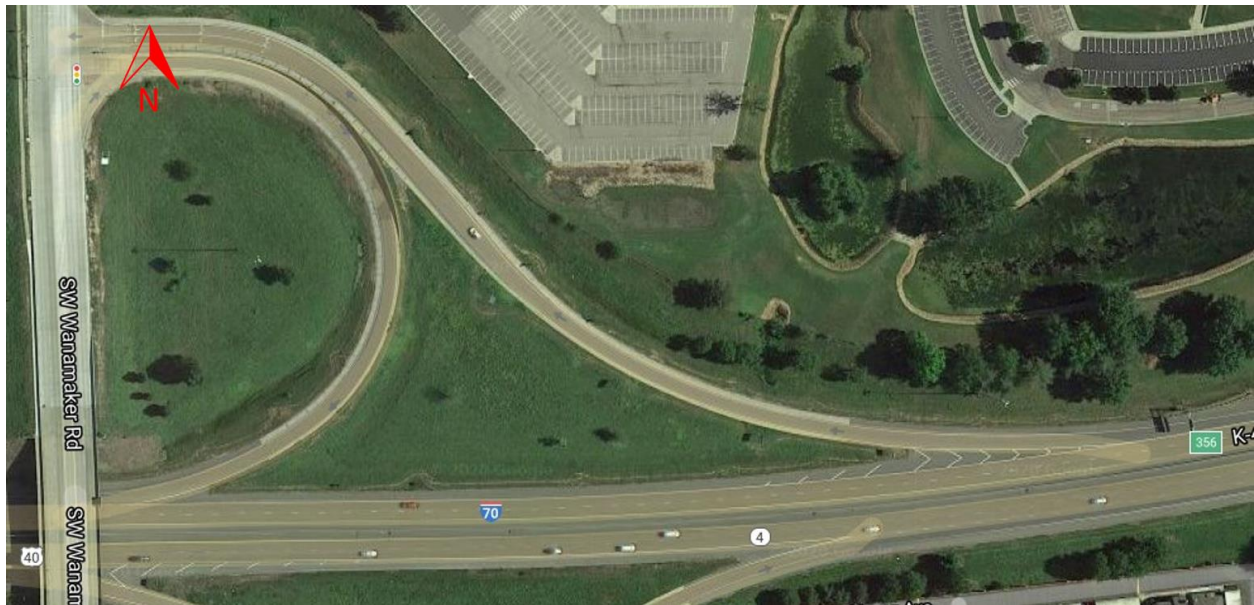
**Figure 5.5: Aerial View of Exit 356, Wanamaker Rd North**

The Wanamaker Rd North exit, shown below in Figure 5.5, is the westbound exit from I-70 to Wanamaker Rd. Wanamaker Rd North is a ParClo A interchange, and the crossroad crosses over I-70. The other side of the interchange is a ParClo B and another treatment site. The Wanamaker Rd interchange covers two quadrants. The exit ends with two lanes, one left-turn-only and one left and right turn. The exit contains a traffic signal where the exit ramp intersects the crossroad, and the exit and entrance ramps are divided by a continuous barrier until the entrance ramp bears right away from the exit ramp. Prior to the study, a Do Not Enter sign was located on the left side of the exit ramp, along with a Keep Right sign on the right, as well as a

Wrong Way sign on the left approximately 350 ft from the crossroad and a second Wrong Way sign on the right side approximately 160 ft past the first sign.

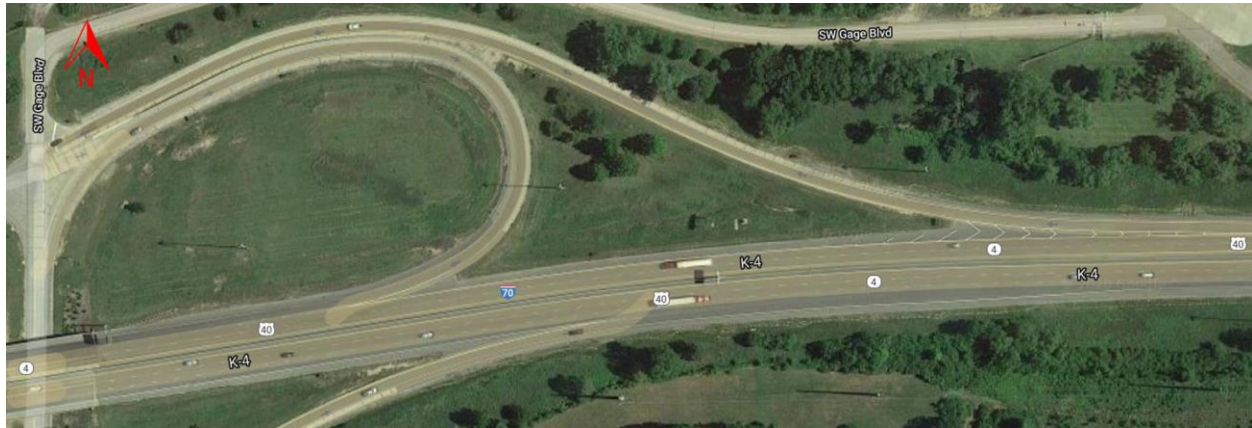
**Figure 5.6: Aerial View of Exit 358, Gage Blvd**

The Gage Blvd exit, shown below in Figure 5.6, is the westbound exit from I-70. Gage Blvd is a ParClo A interchange that crosses underneath I-70. The exit to Gage Blvd on the eastbound side is also the exit to US-75 North and includes a weaving area for traffic to merge onto US-75 North and traffic exiting from US-75 South to merge with I-70 or exit to Gage Blvd. The treatment exit ramp is divided by a curb-height raised median that becomes a barrier dividing the exit and entrance ramp. Prior to the study, there was a Do Not Enter sign on the left side of the exit, a Keep Right sign on the median on the right side of the exit, a Wrong Way sign

approximately 300 ft from the crossroad on the left side, and another Wrong Way sign approximately 350 ft from the first sign on the right side.

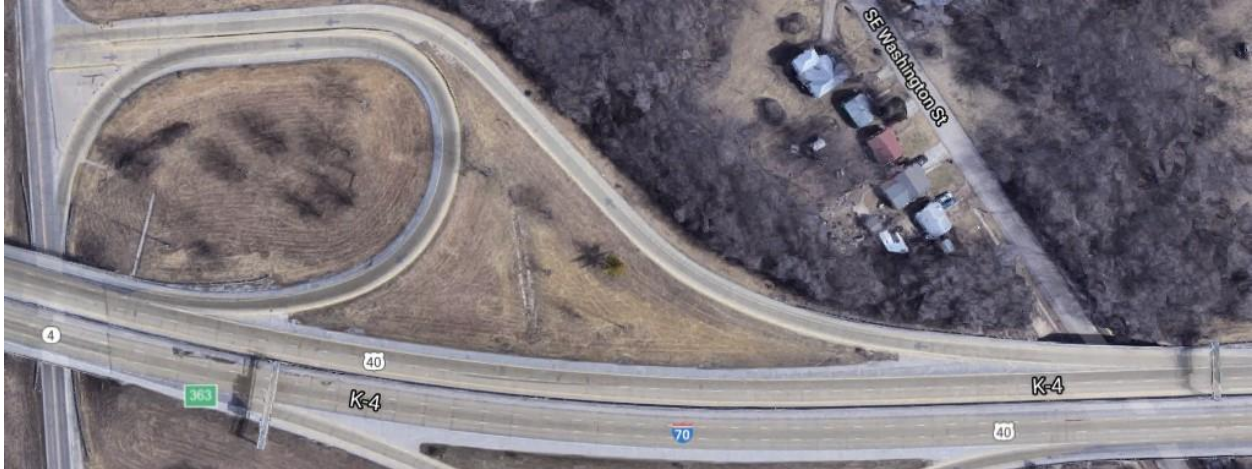
**Figure 5.7: Aerial View of Exit 363, Adams St North**

The Adams St North ramp, shown below in Figure 5.7, is located on the east side of Topeka on the westbound side of I-70. The exit is approximately three miles west of where I-470 ties into I-70 and the turnpike begins. The exit is a ParClo A interchange, and the crossroad crosses underneath I-70. The other side of the interchange is a ParClo B and was included in this study. Because this exit ramp was a control ramp, no changes were made to the sign configurations. The exit contains a Do Not Enter sign on the left, approximately 10 ft in front of the stop line on the right side, angled slightly to face traffic coming from the north. In addition, a Keep Right sign is located on the median on the right side of the exit ramp, a Wrong Way sign is on the left about 325 ft from the crossroad, and another Wrong Way sign is on the right side about 225 ft further up the exit ramp. The entrance and exit ramps are divided by a curb-height median for approximately 50 ft, which then rises to a barrier that divides the two ramps.

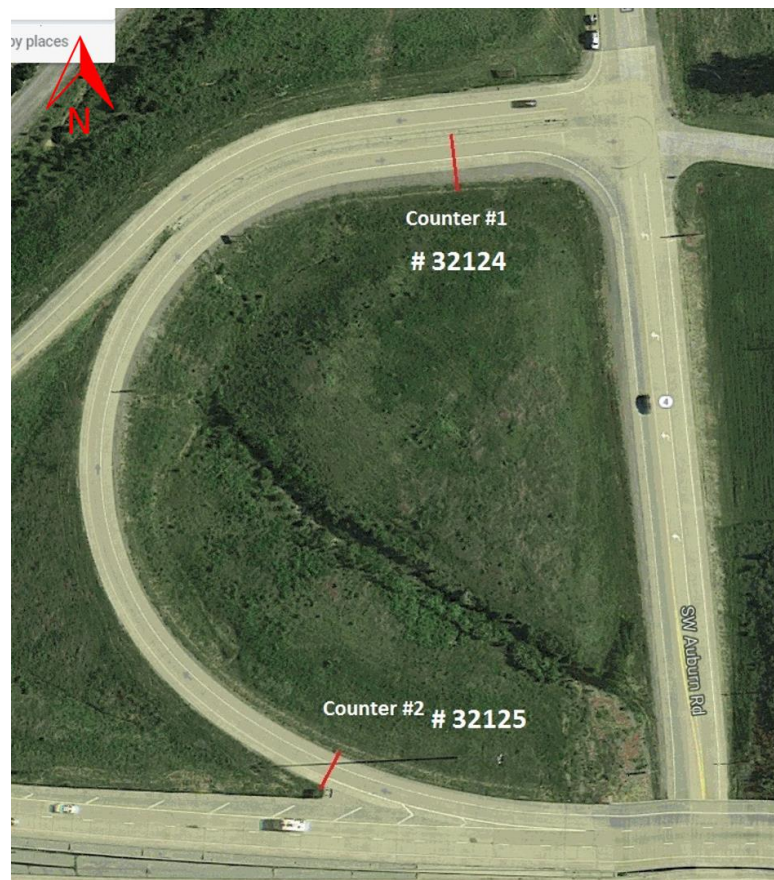
**Figure 5.10: Road Tube Layout Used for Data Collection (Google 2020)**

Figure 5.10 shows the general layout for the pneumatic road tubes. The first counter was placed near the crossroad but far enough back so vehicles in the queue would not be standing on the tubes. The second set of road tubes was placed near the exit from the interstate. Road tubes were placed in the same spots for all studies, and data were collected before and after for data analysis. Since previous research reached different conclusions on when was the best time to conduct the after study (Howard, 1980; Campbell et al., 1988), it was determined to collect the after data immediately after installation and then again at least 90 days later.

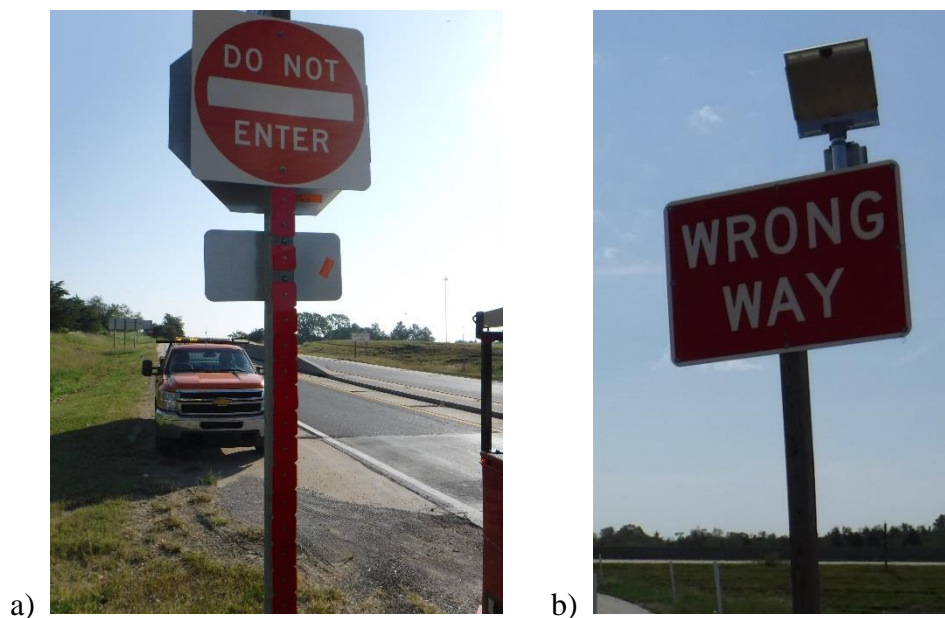
**Figure 5.15: Preliminary Countermeasures: a) RRFD; b) Flashing LED Wrong Way Sign**

Results showed that countermeasure effectiveness varies depending on region. Countermeasures that worked well in the southern states, may not be as effective in the eastern or western states. In addition to researching the countermeasures, each ramp was investigated to determine what countermeasures were already in use as well as the surrounding area and businesses. The collected information was combined with the results from the before study to develop a working list of countermeasures that included Red Retroreflective Delineators (RRFDs) on posts with Do Not Enter and Wrong Way signs, Wrong Way signs with red flashing LEDs, and oversized and lowered Wrong Way signs, as shown in the figures below. These signs were chosen because, when examining the before data, three ramps were identified for countermeasure evaluation that had several daytime incidents. The RRFDs, shown in Figure 5.15a, are red delineators that are small reflective signs that are typically used on sign posts or

median barriers and were chosen for their low light and nighttime effectiveness. Research conducted on nighttime driving has shown that RRFDs are effective at drawing the eye to the post and leading drivers to notice the signs (Finley et al., 2014). Research has also shown that drunk drivers shift their focus to the lower right area of the road where RRFDs can draw attention to the Wrong Way signs. This research also showed that flashing LED signs (Figure 5.15b) are effective at attracting driver's attention, both intoxicated and sober (Finley et al., 2014). The use of oversized, lowered signs (Figure 5.16) have also proven to effectively reduce WWD incidents, particularly in the daytime (Baratian-Ghorghi & Zhou, 2017; Cooner & Ranft, 2008; Das et al., 2017; Staplin et al., 2001; Cooner et al., 2004; Kaminski Leduc, 2008). The MUTCD allows signs along interstates and ramps to be lowered to 3 ft, the height used in this study, which places the sign at the driver's height, thereby increasing sign prominence.

After considering previous research, the WWD Working Group results, and discussions with the KDOT Project Manager, the following countermeasures were selected. RRFDs were selected as a countermeasure to be used on the Auburn Rd and Gage Blvd ramps. The RRFDs were installed on the Do Not Enter sign at the entrance of the ramp and on the first Wrong Way sign. Because WWD incidents at Auburn Rd occur primarily at night and incidents at Gage Blvd occur in the early morning and late afternoon, RRFDs were determined to be most effective during low light and dark conditions.

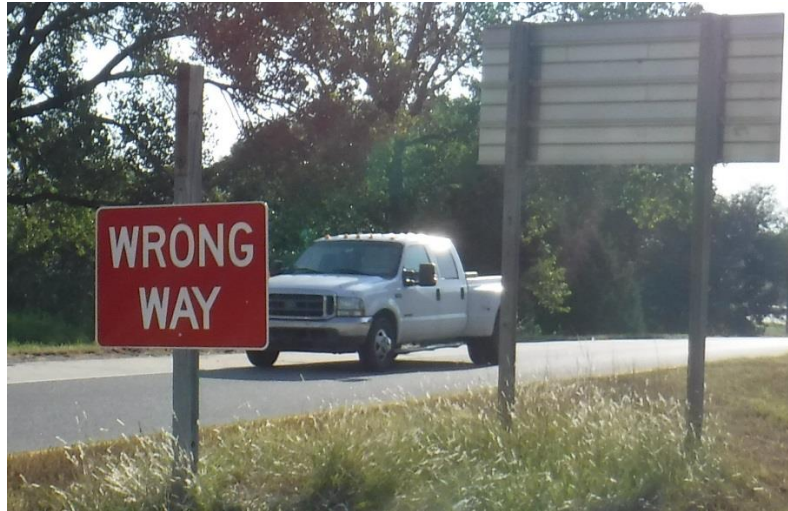
**Figure 5.16: Preliminary Countermeasures: Oversized and Lowered Wrong Way Sign**

The second countermeasure used was oversized Wrong Way signs. These signs were installed lower than normal, at a height of 3 ft above the pavement, meaning the signs were at approximately the same height as a driver sitting in a car. The oversized signs were placed at Wanamaker Rd North, Wanamaker Rd South, and Gage Blvd. At the two Wanamaker Rd ramps, two existing Wrong Way signs were replaced by the oversized signs and lowered to 3 ft. One existing Wrong Way sign was replaced and lowered on Gage Blvd. Fortunately, the geometry of the Wanamaker Rd South ramp allowed the first lowered sign to be eye level to the driver on the left, while the second sign, when lowered, was directly in front of the vehicle as it entered the curve. The other two locations allowed for similar placement of the lowered signs, although they were not quite as prominent as the Wanamaker Rd South ramp. Because WWD incidents at both Wanamaker ramps primarily occur during daylight hours and most incidents at Gage Blvd occur early in the morning or late afternoon in lighted conditions, enlarging and lowering the Wrong Way sign was expected to increase sign visibility.

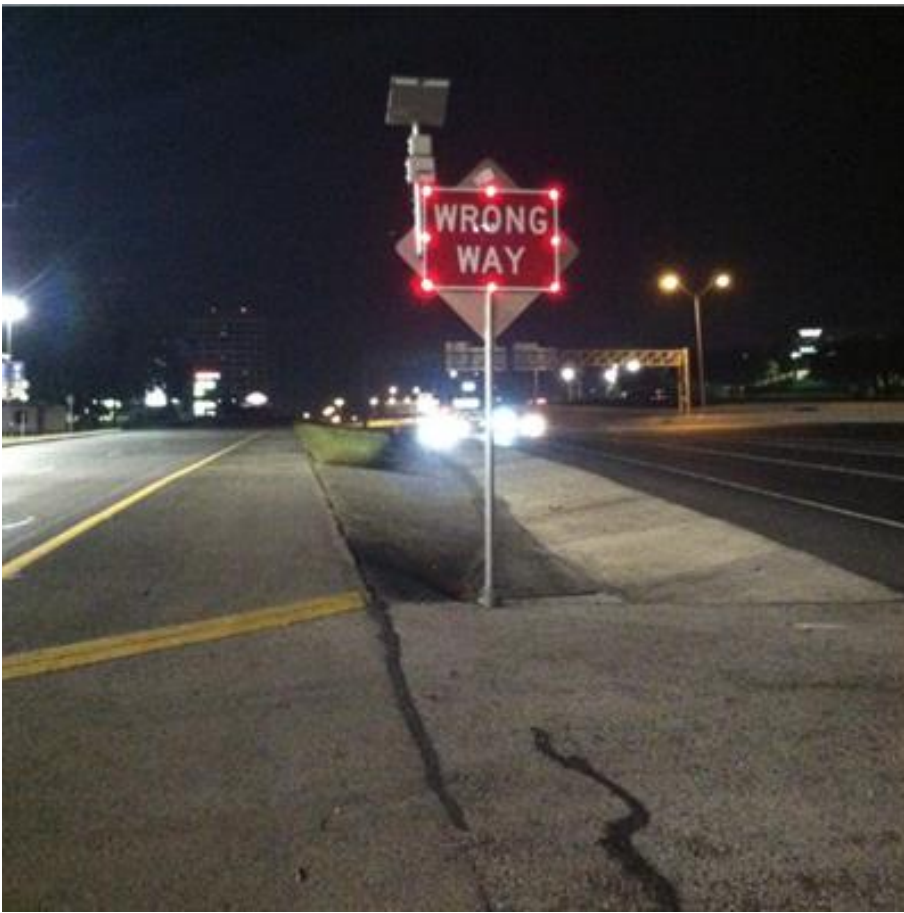
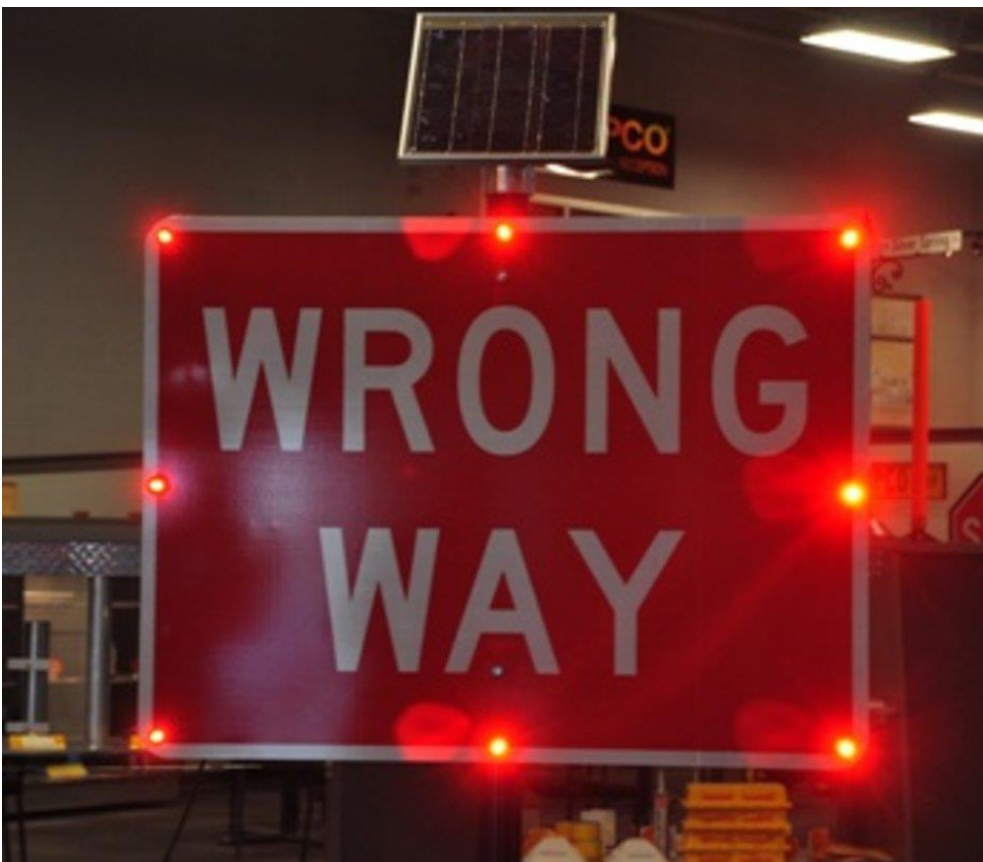
Time actuated Flashing LED Wrong Way sign

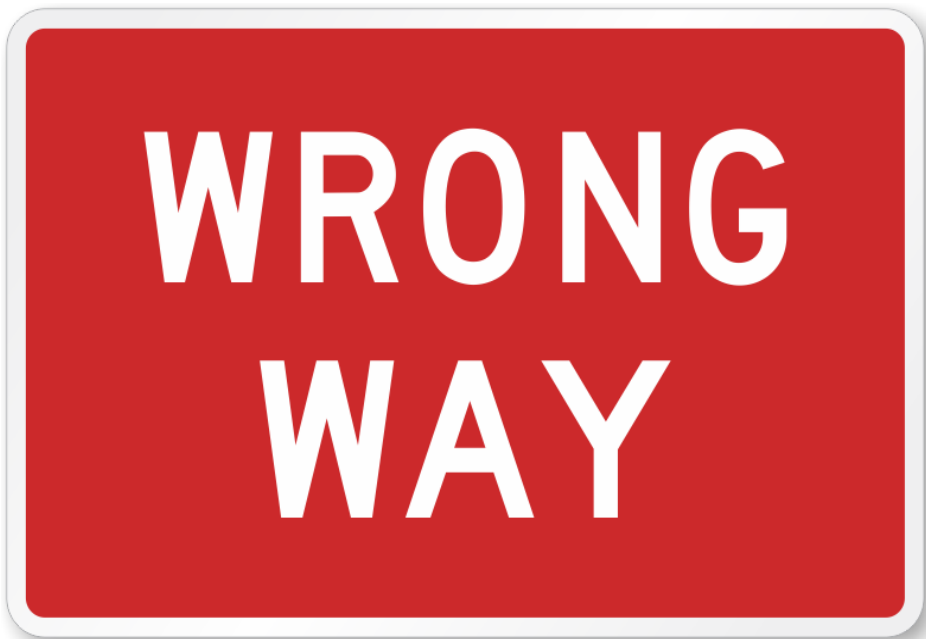
Oversized Wrong Way sign (42 X 30)

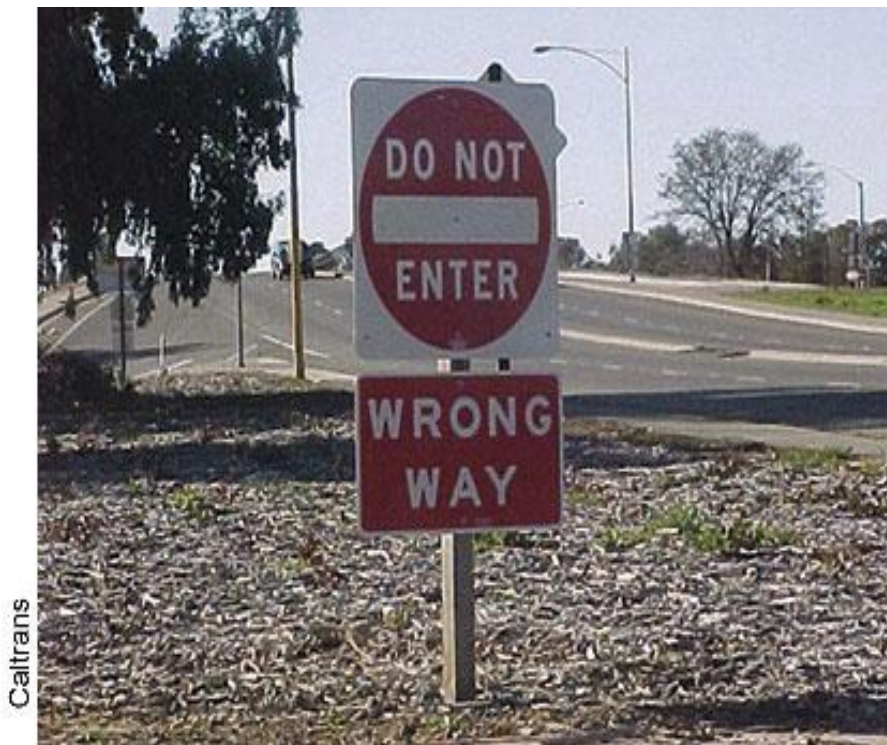
Oversized and Lowered signs

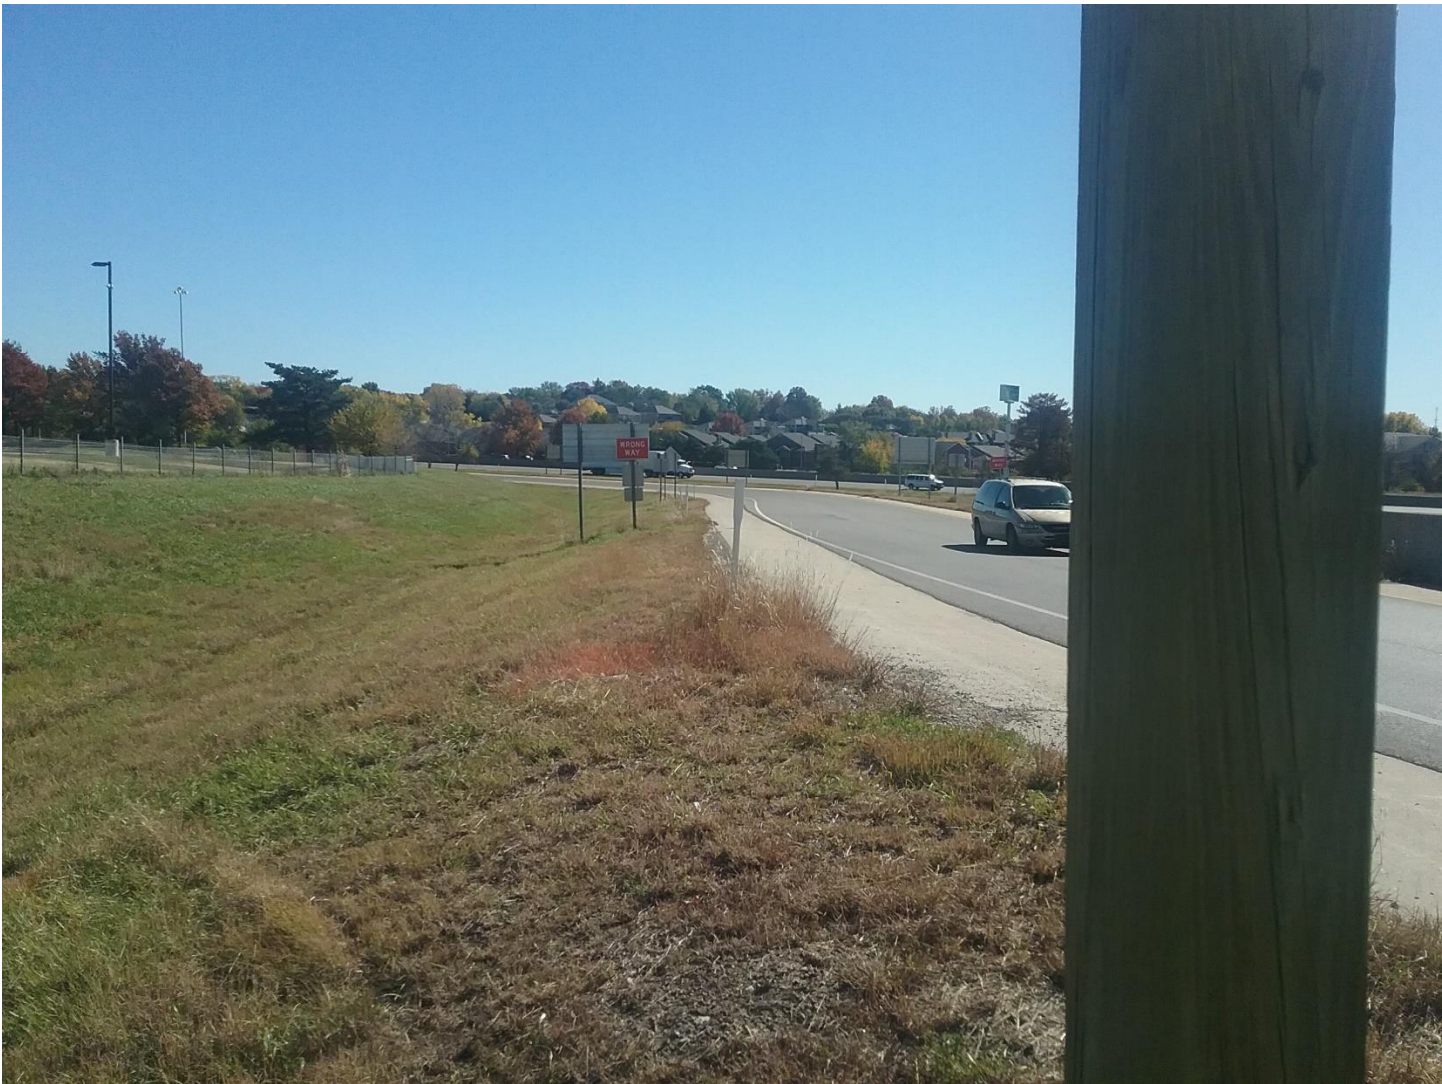
**Figure C. 15: Wanamaker North Counter 1**

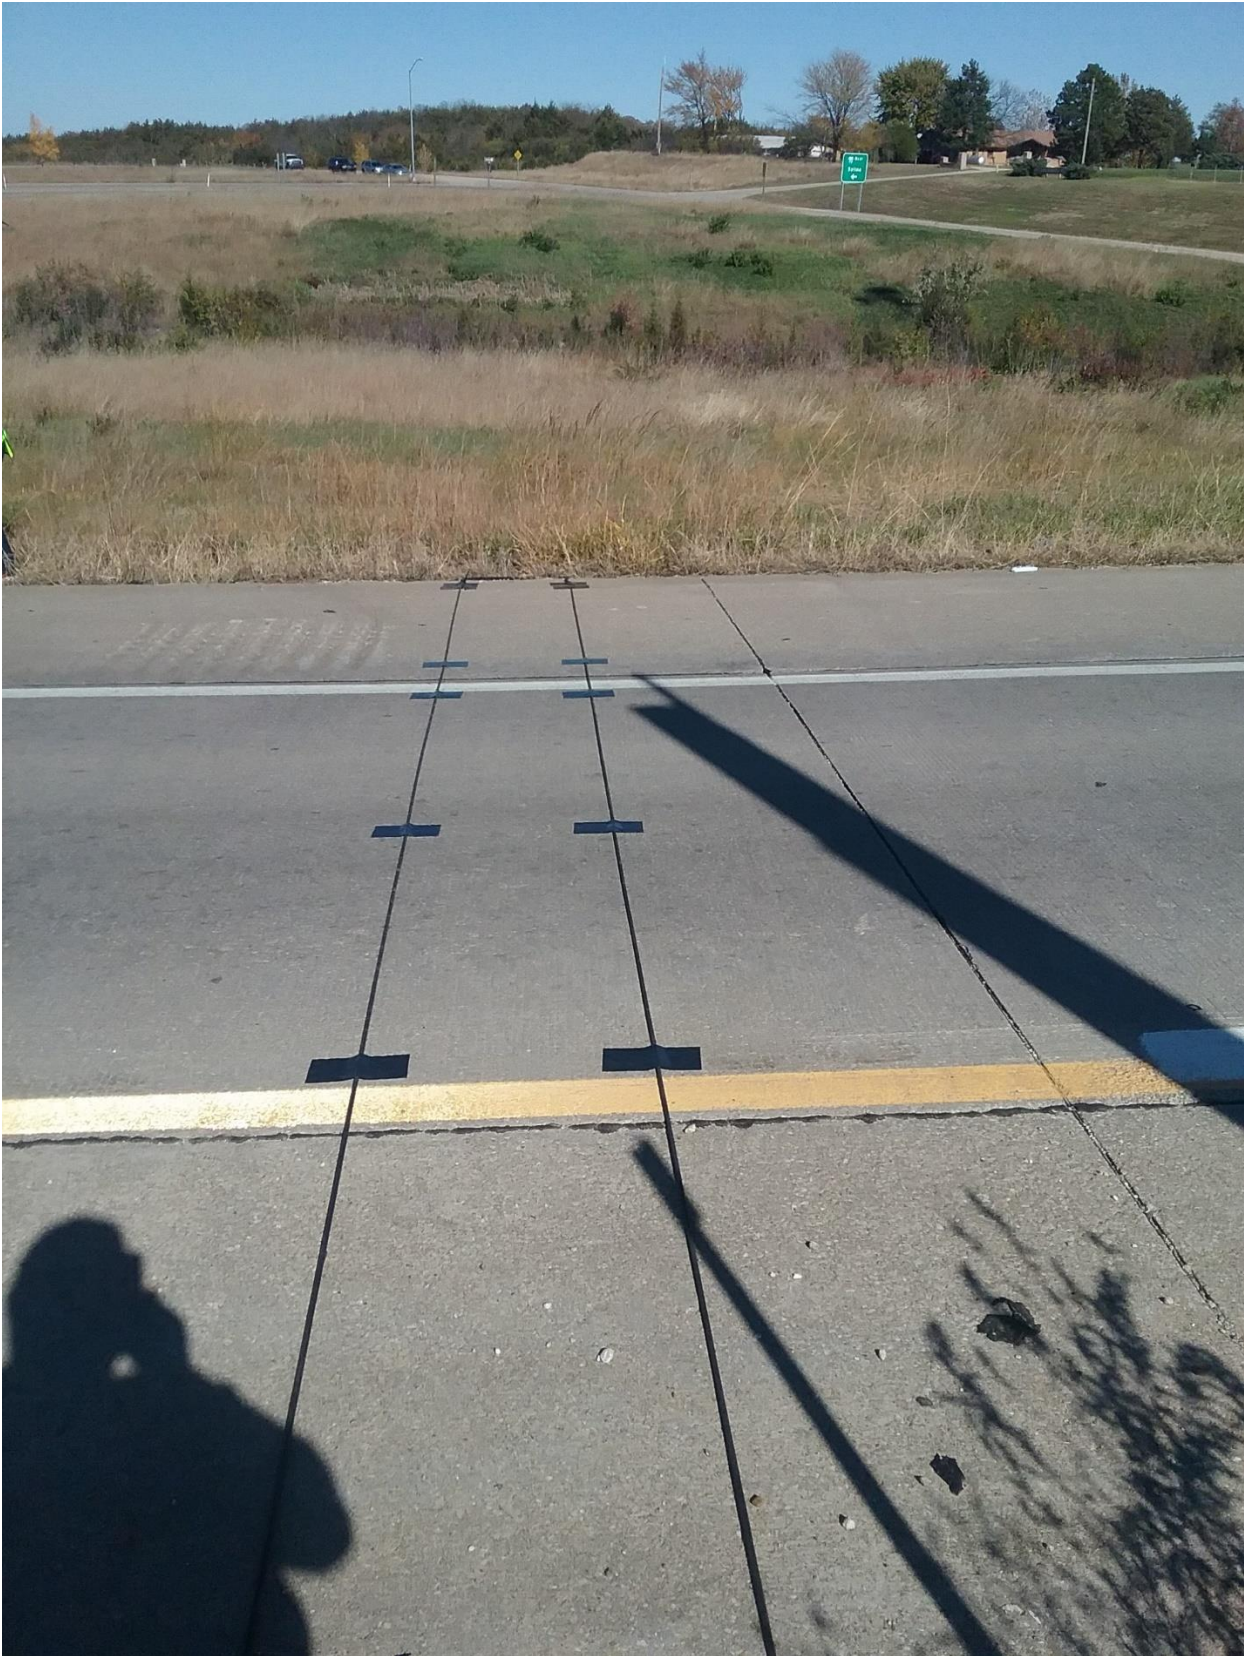
**Figure C. 16: Auburn Rd Counter 2**

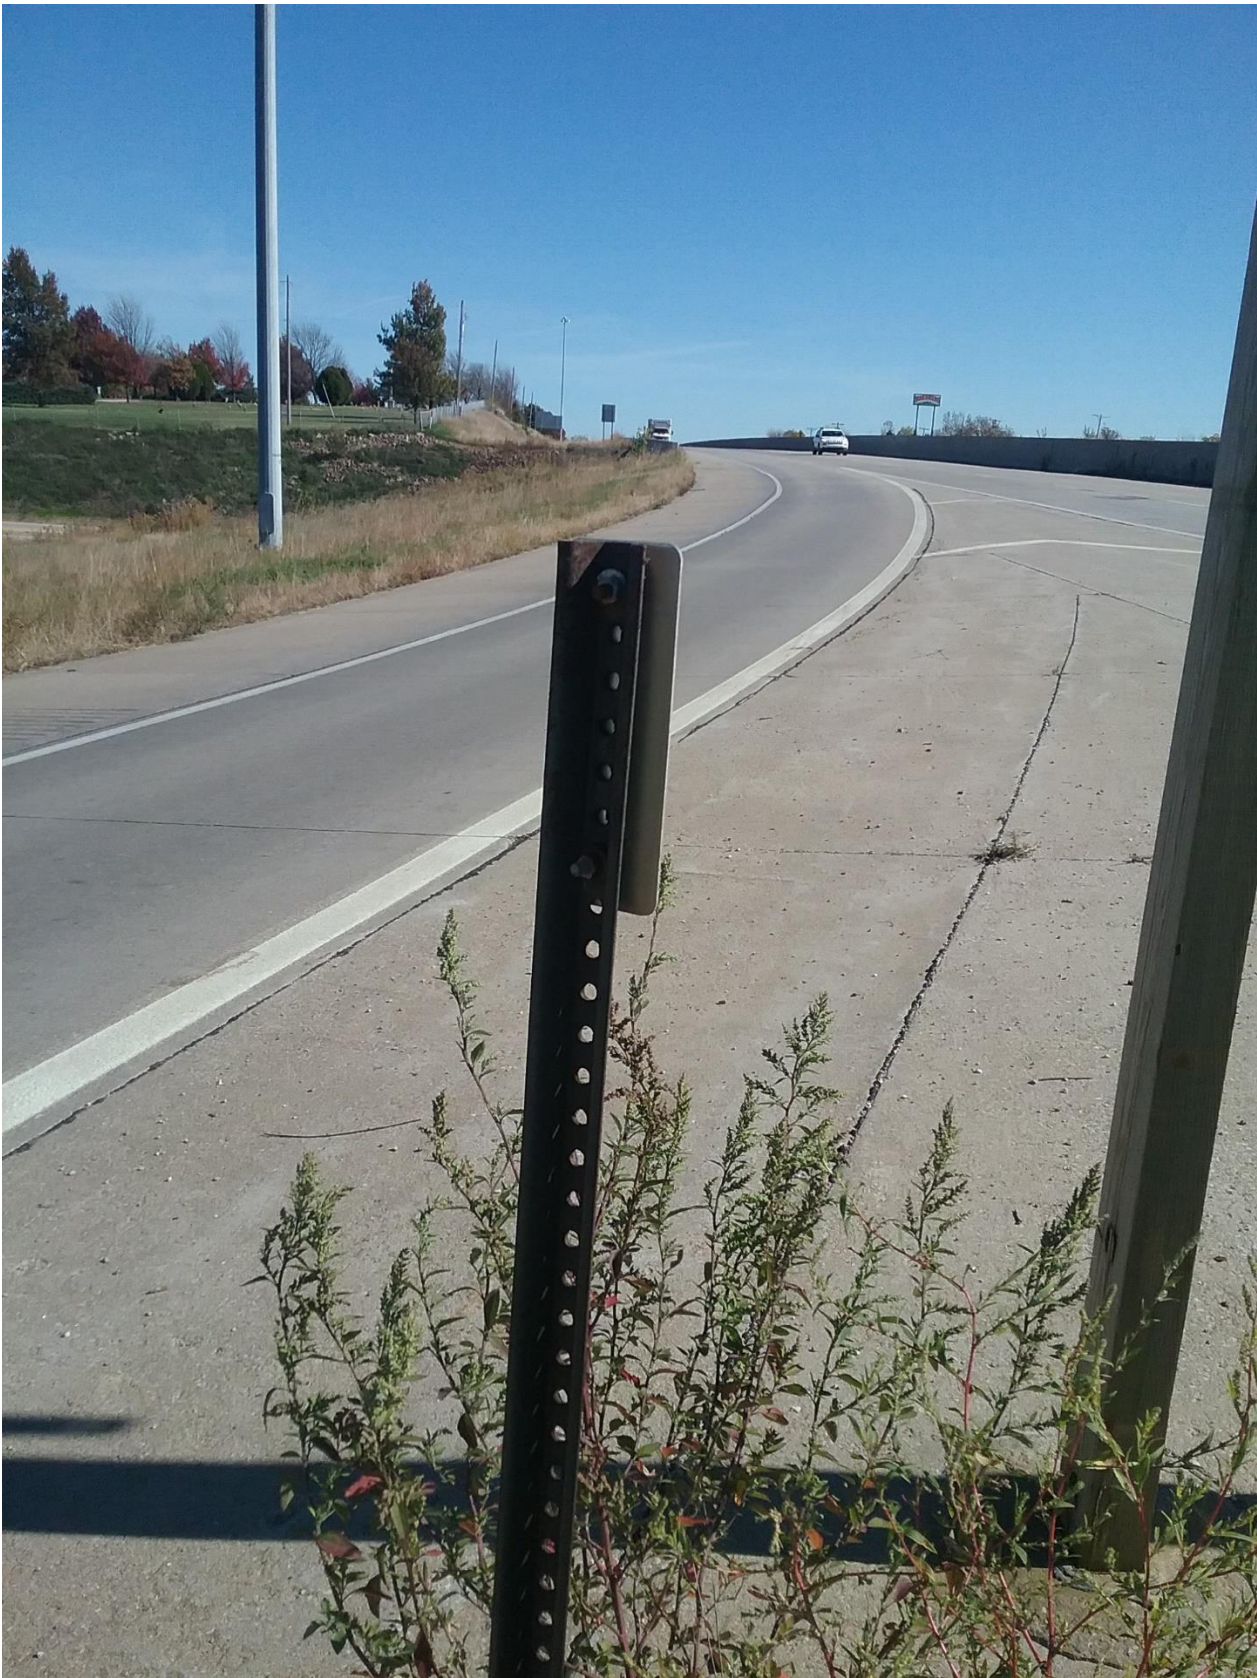
**Figure C. 17: Auburn Rd Counter 2**

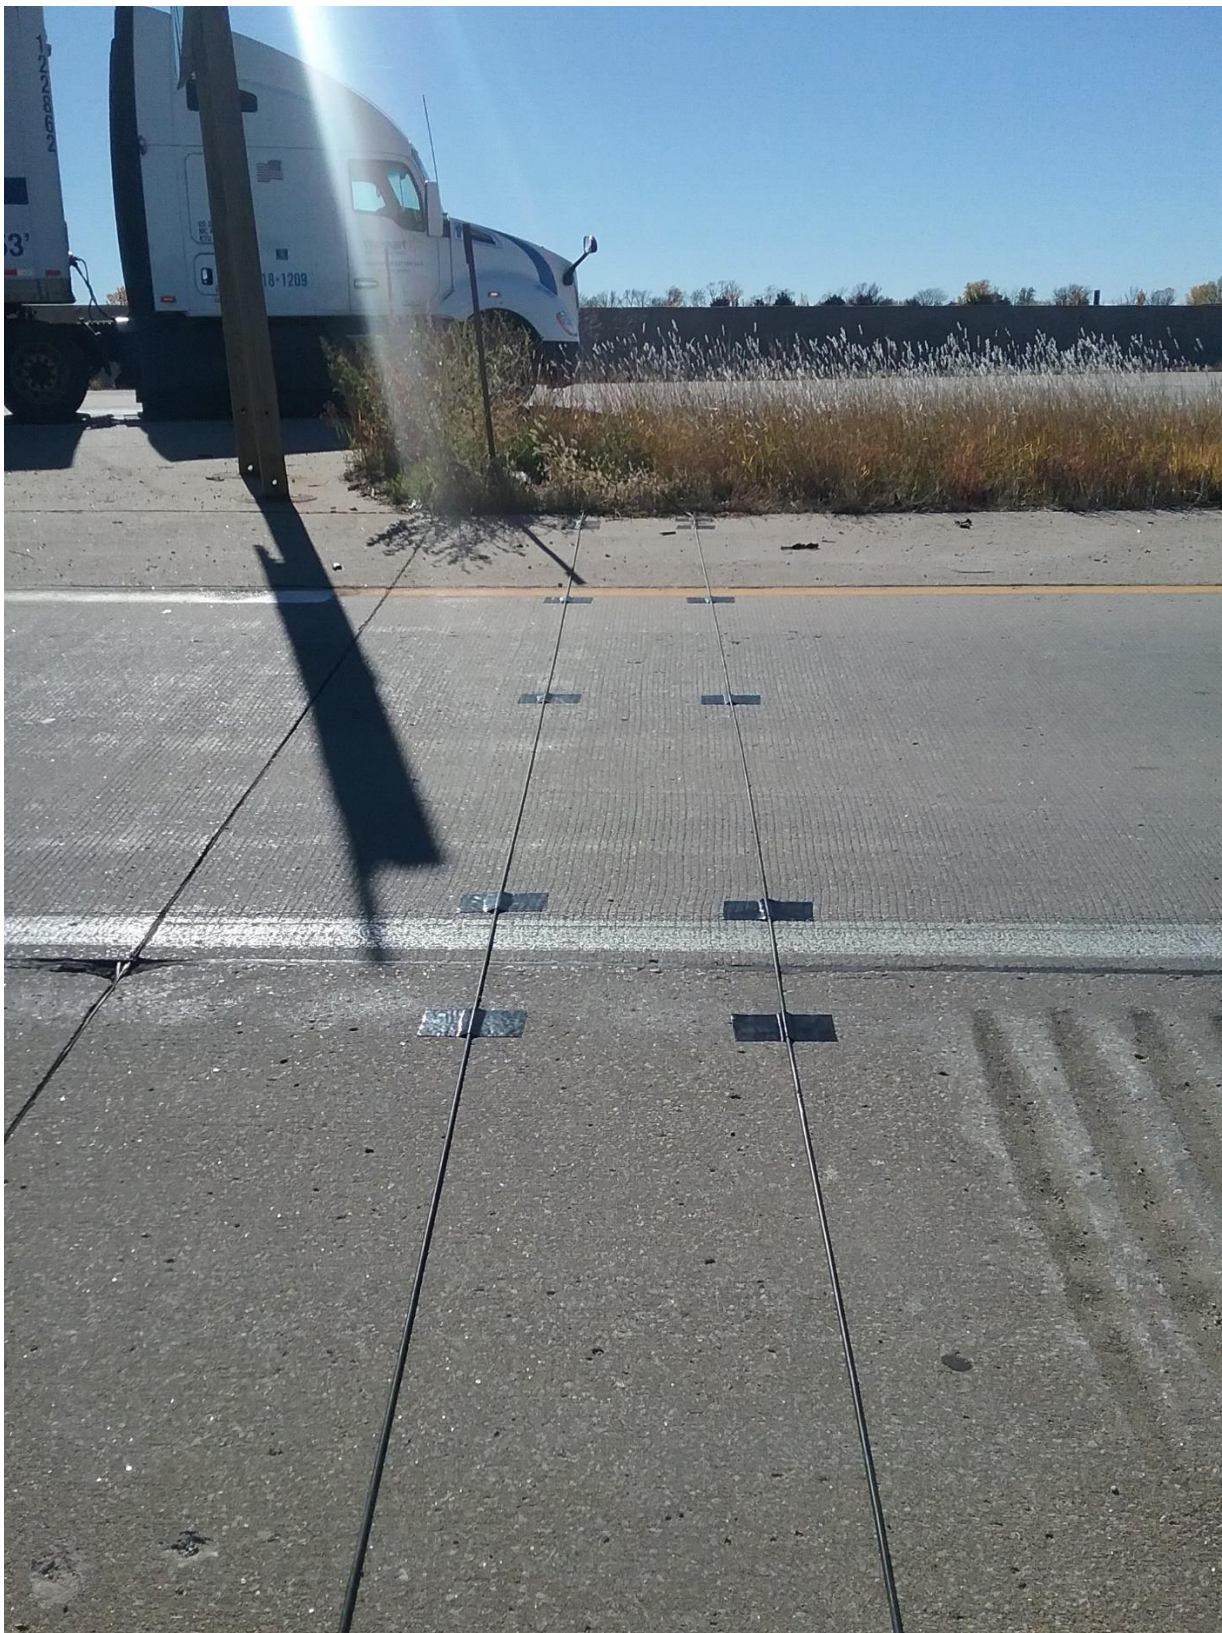
**Figure C. 18: Auburn Rd Counter 2**

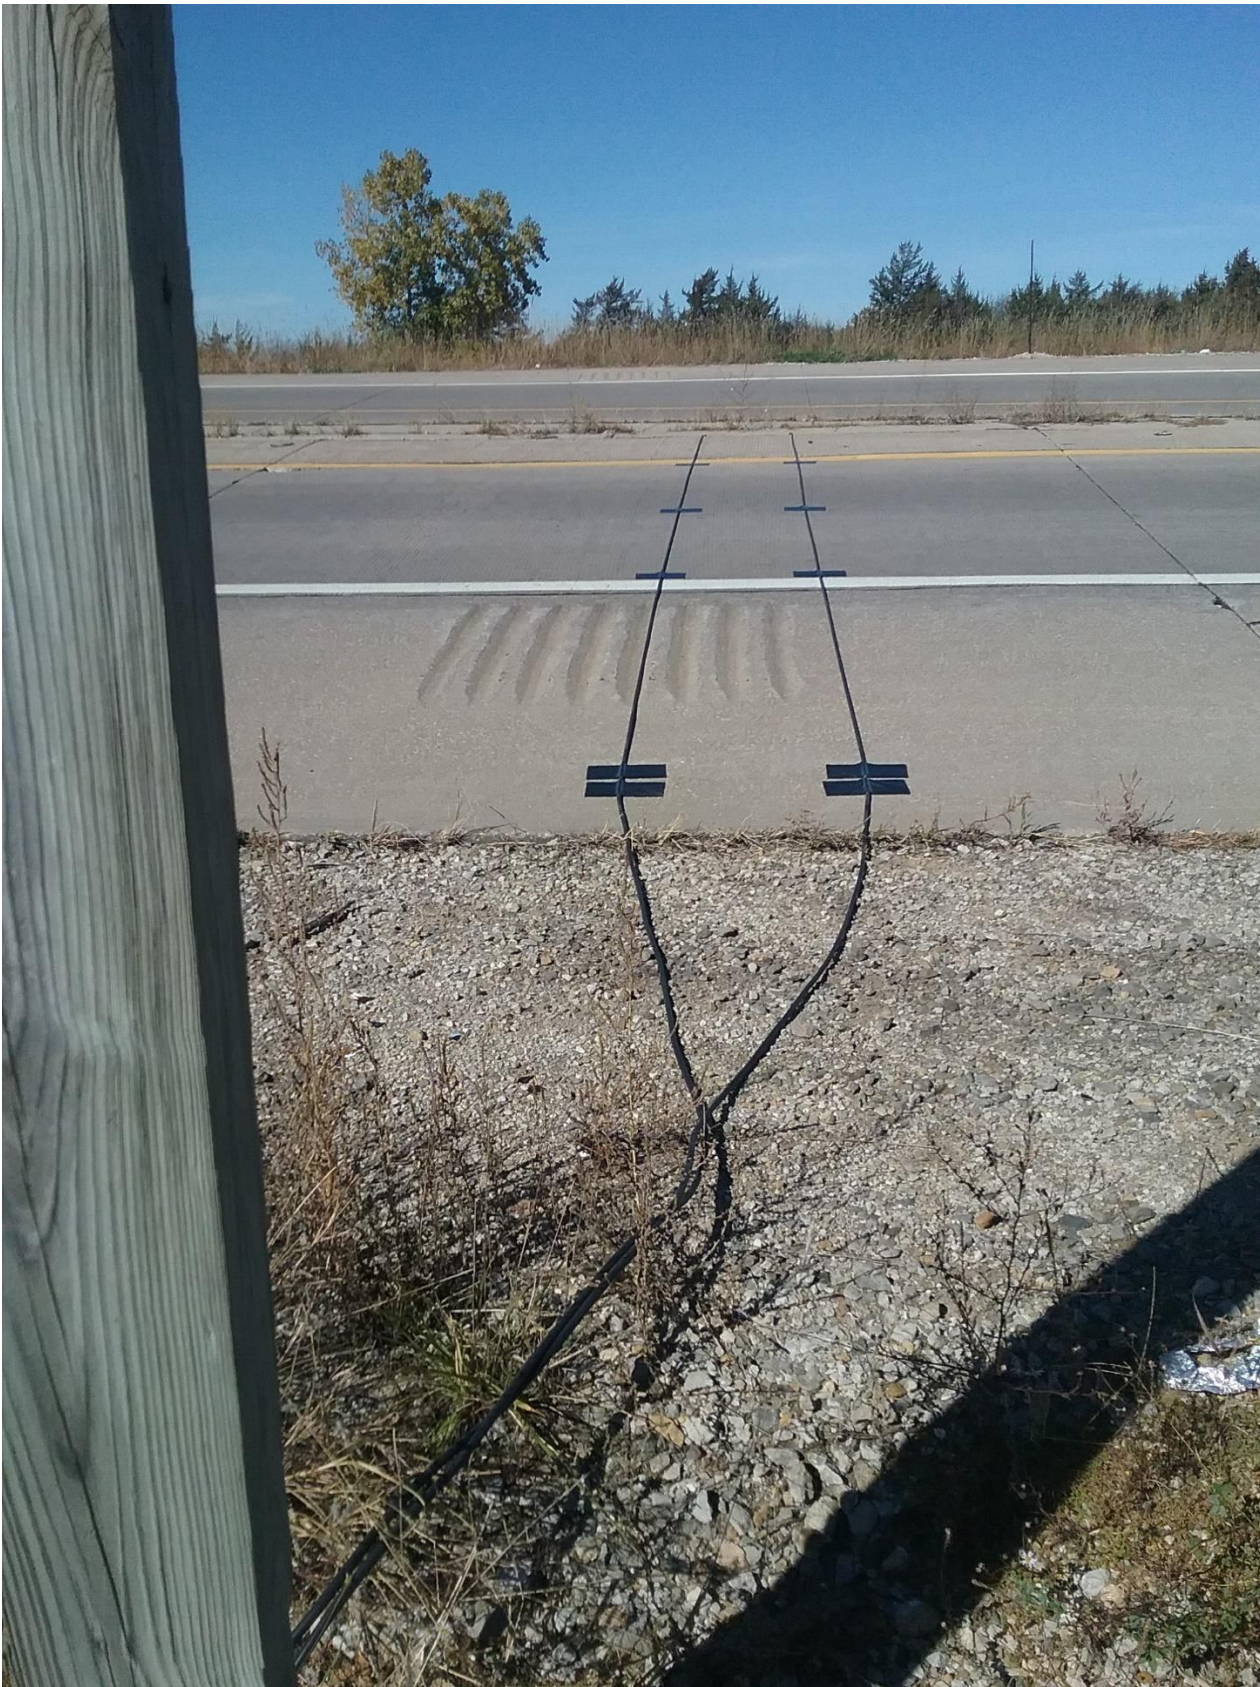
**Figure C. 19: Auburn Rd Counter 1**
