**An evaluation of low-cost wrong-way driving countermeasures at partial cloverleaf  
interchanges on Kansas interstates**

AN ABSTRACT OF A DISSERTATION

Department of Civil Engineering  
Carl R. Ice College of Engineering

KANSAS STATE UNIVERSITY  
Manhattan, Kansas

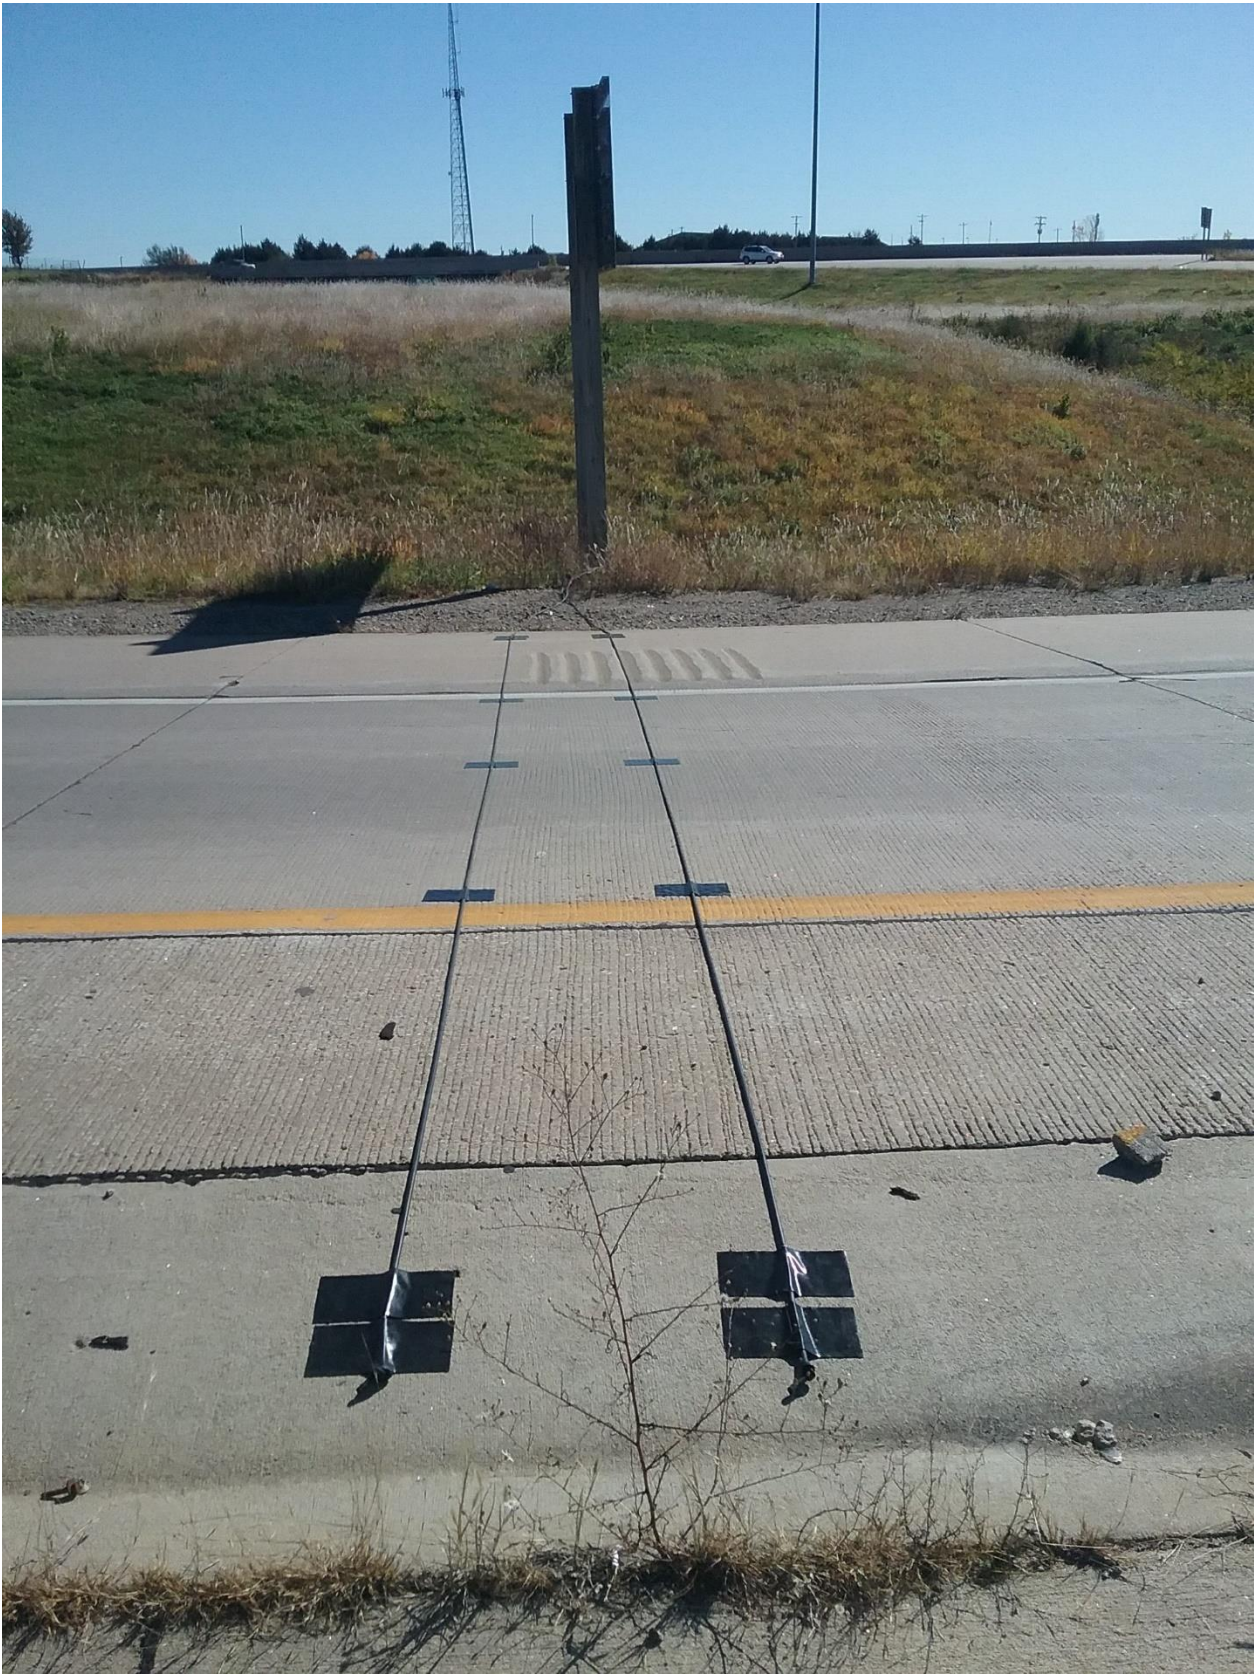
**Figure C. 20: Auburn Rd Counter 1**

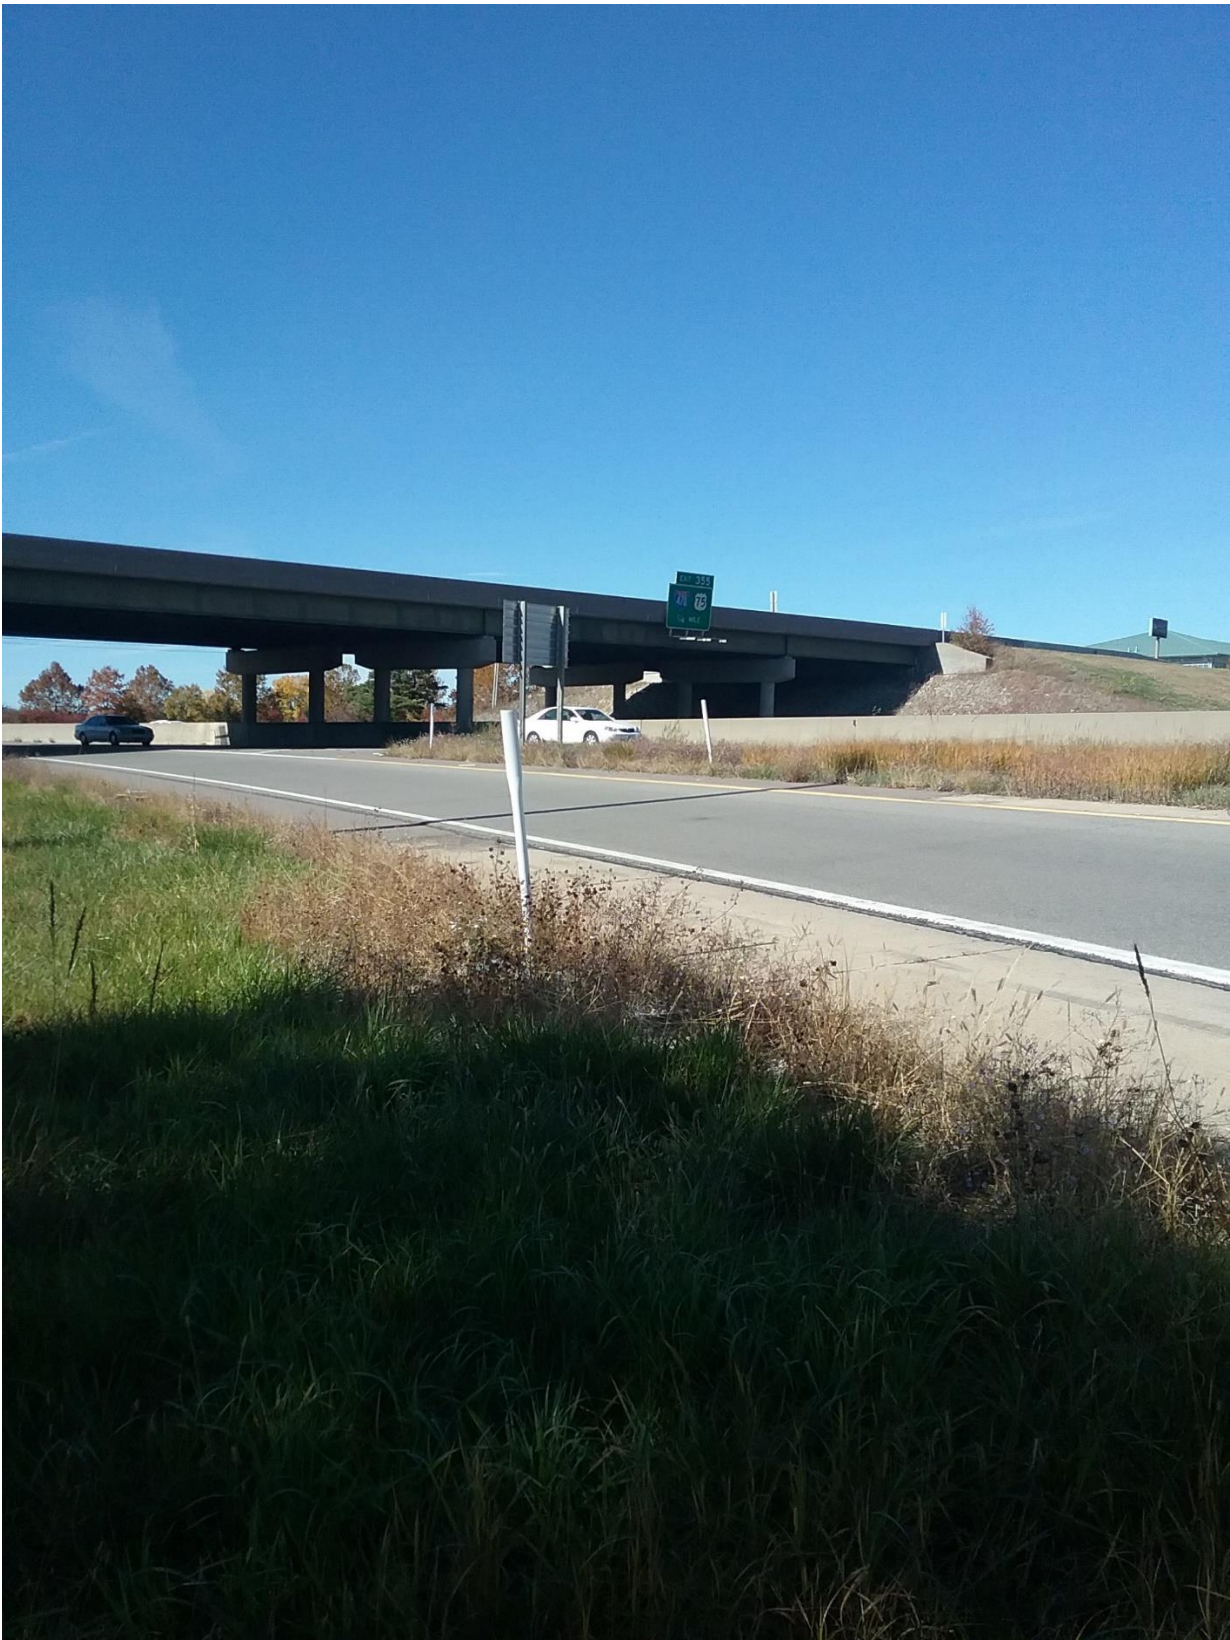
**Figure C. 21: Wanamaker South Counter 2**

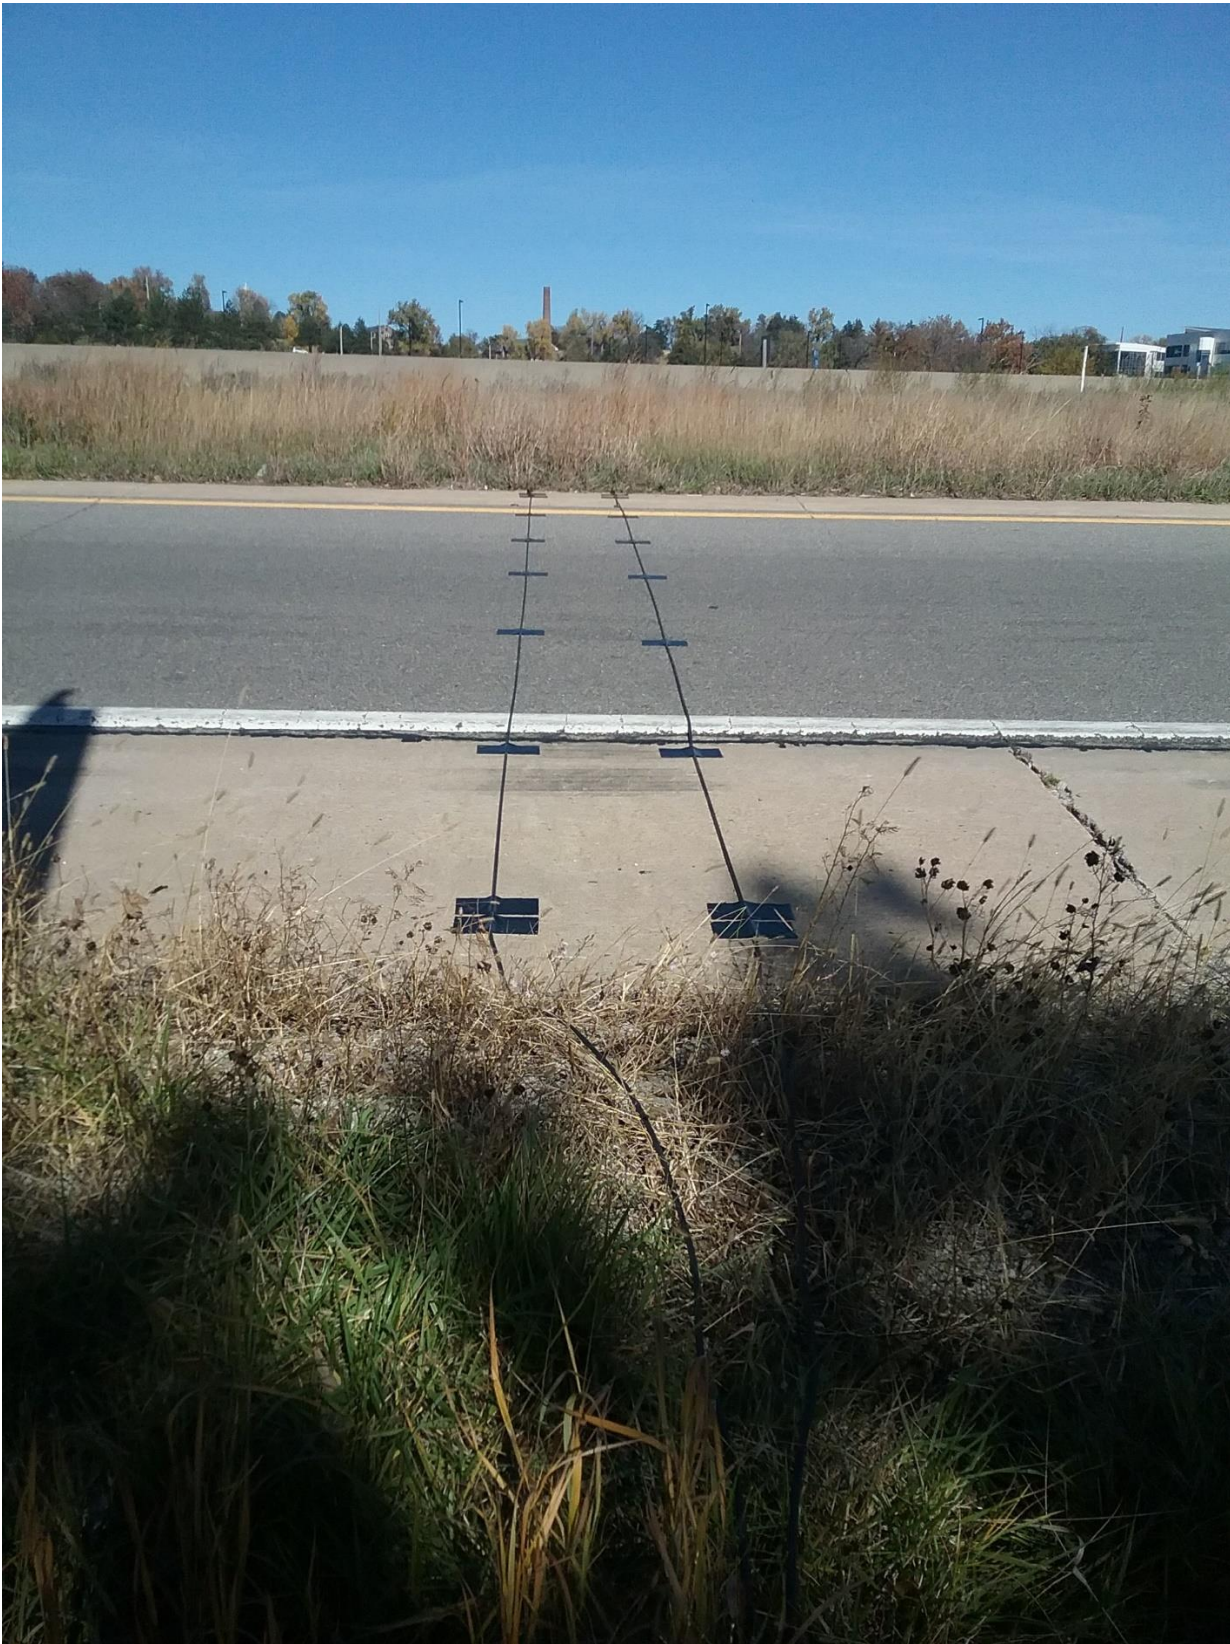
**Figure C. 22: Wanamaker South Counter 2**

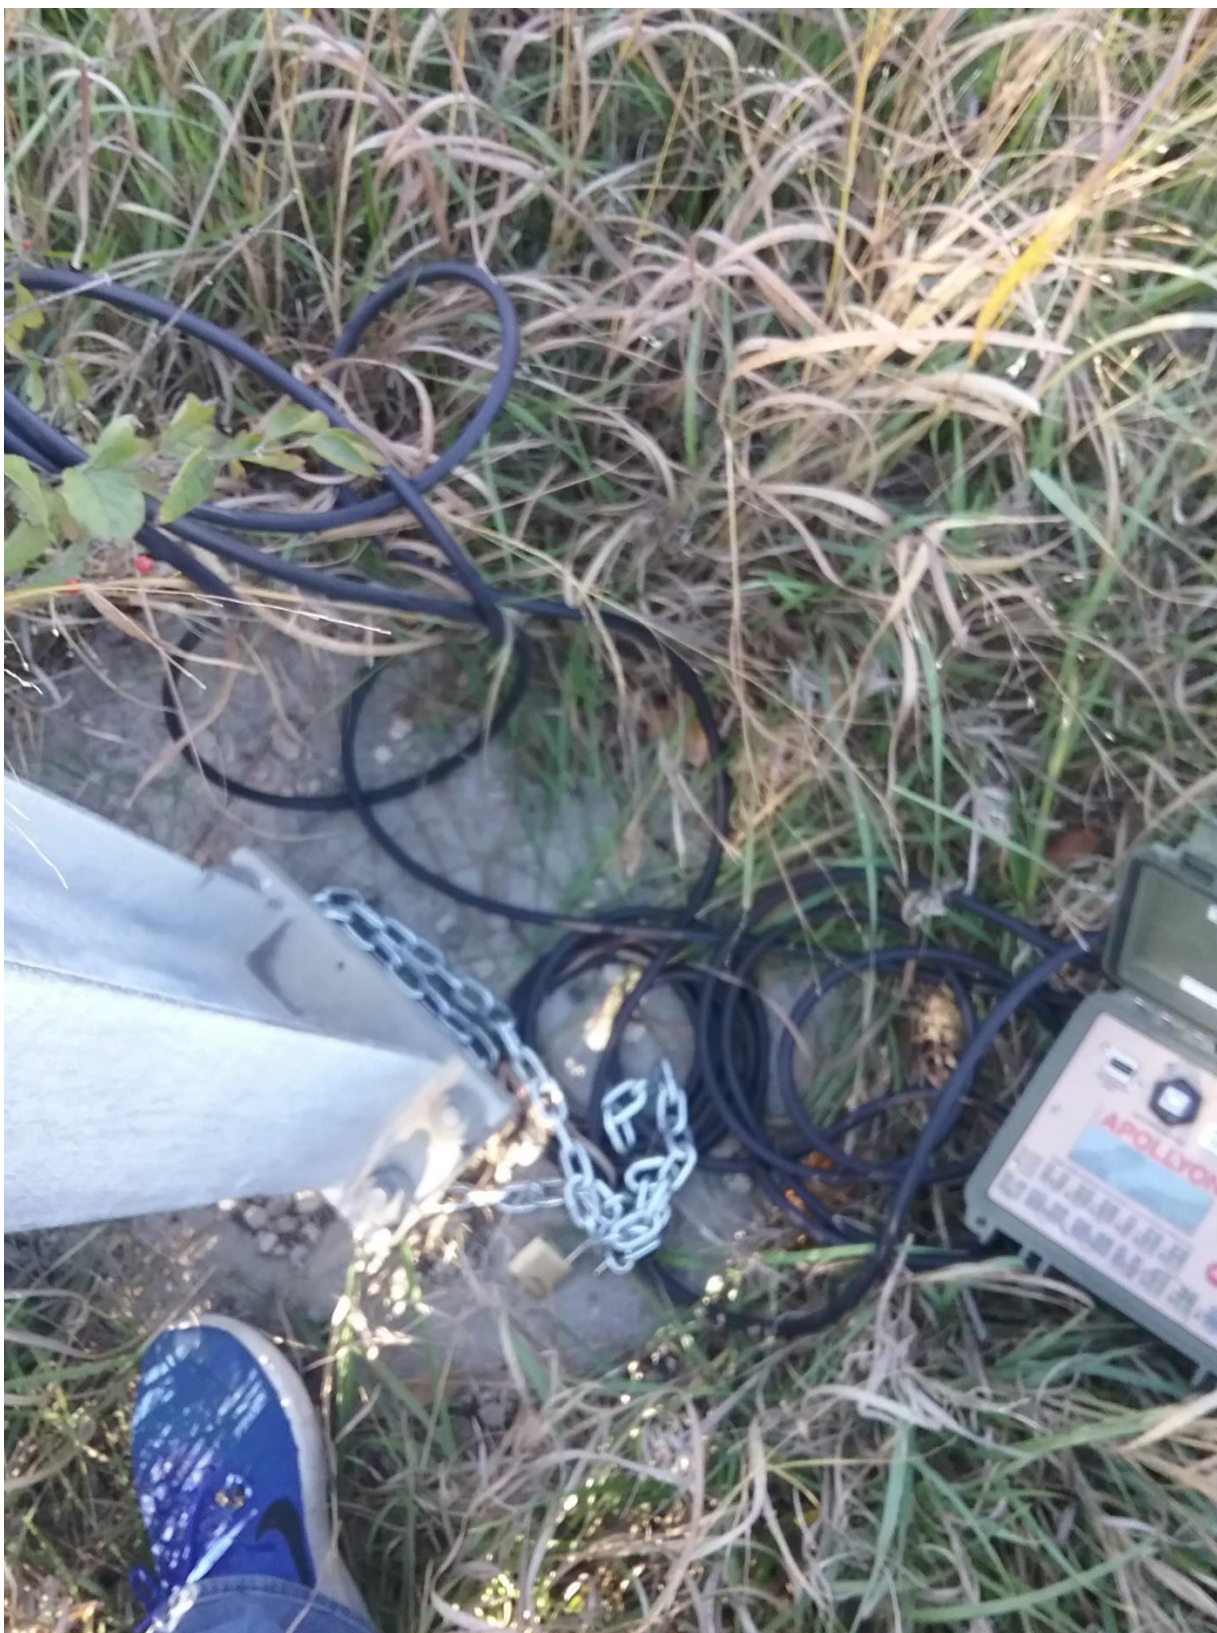
**Figure C. 23: Wanamaker South Counter 2**

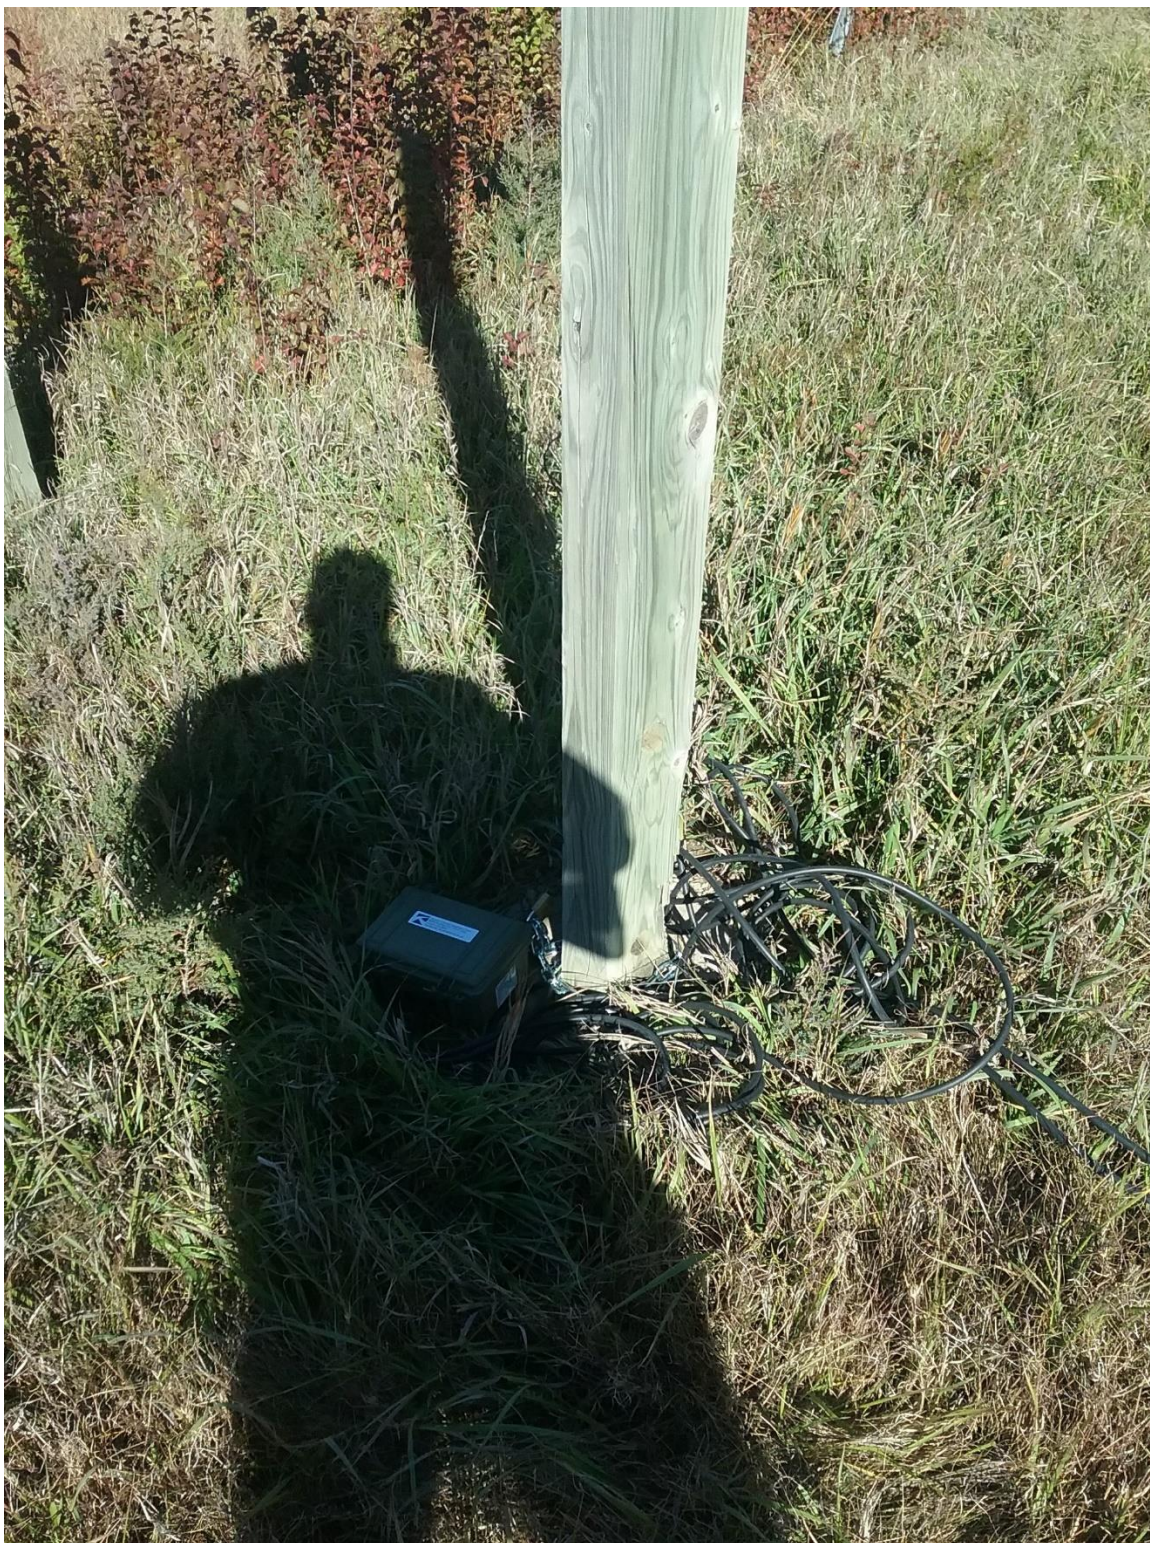
**Figure C. 24: Wanamaker South Counter 1**

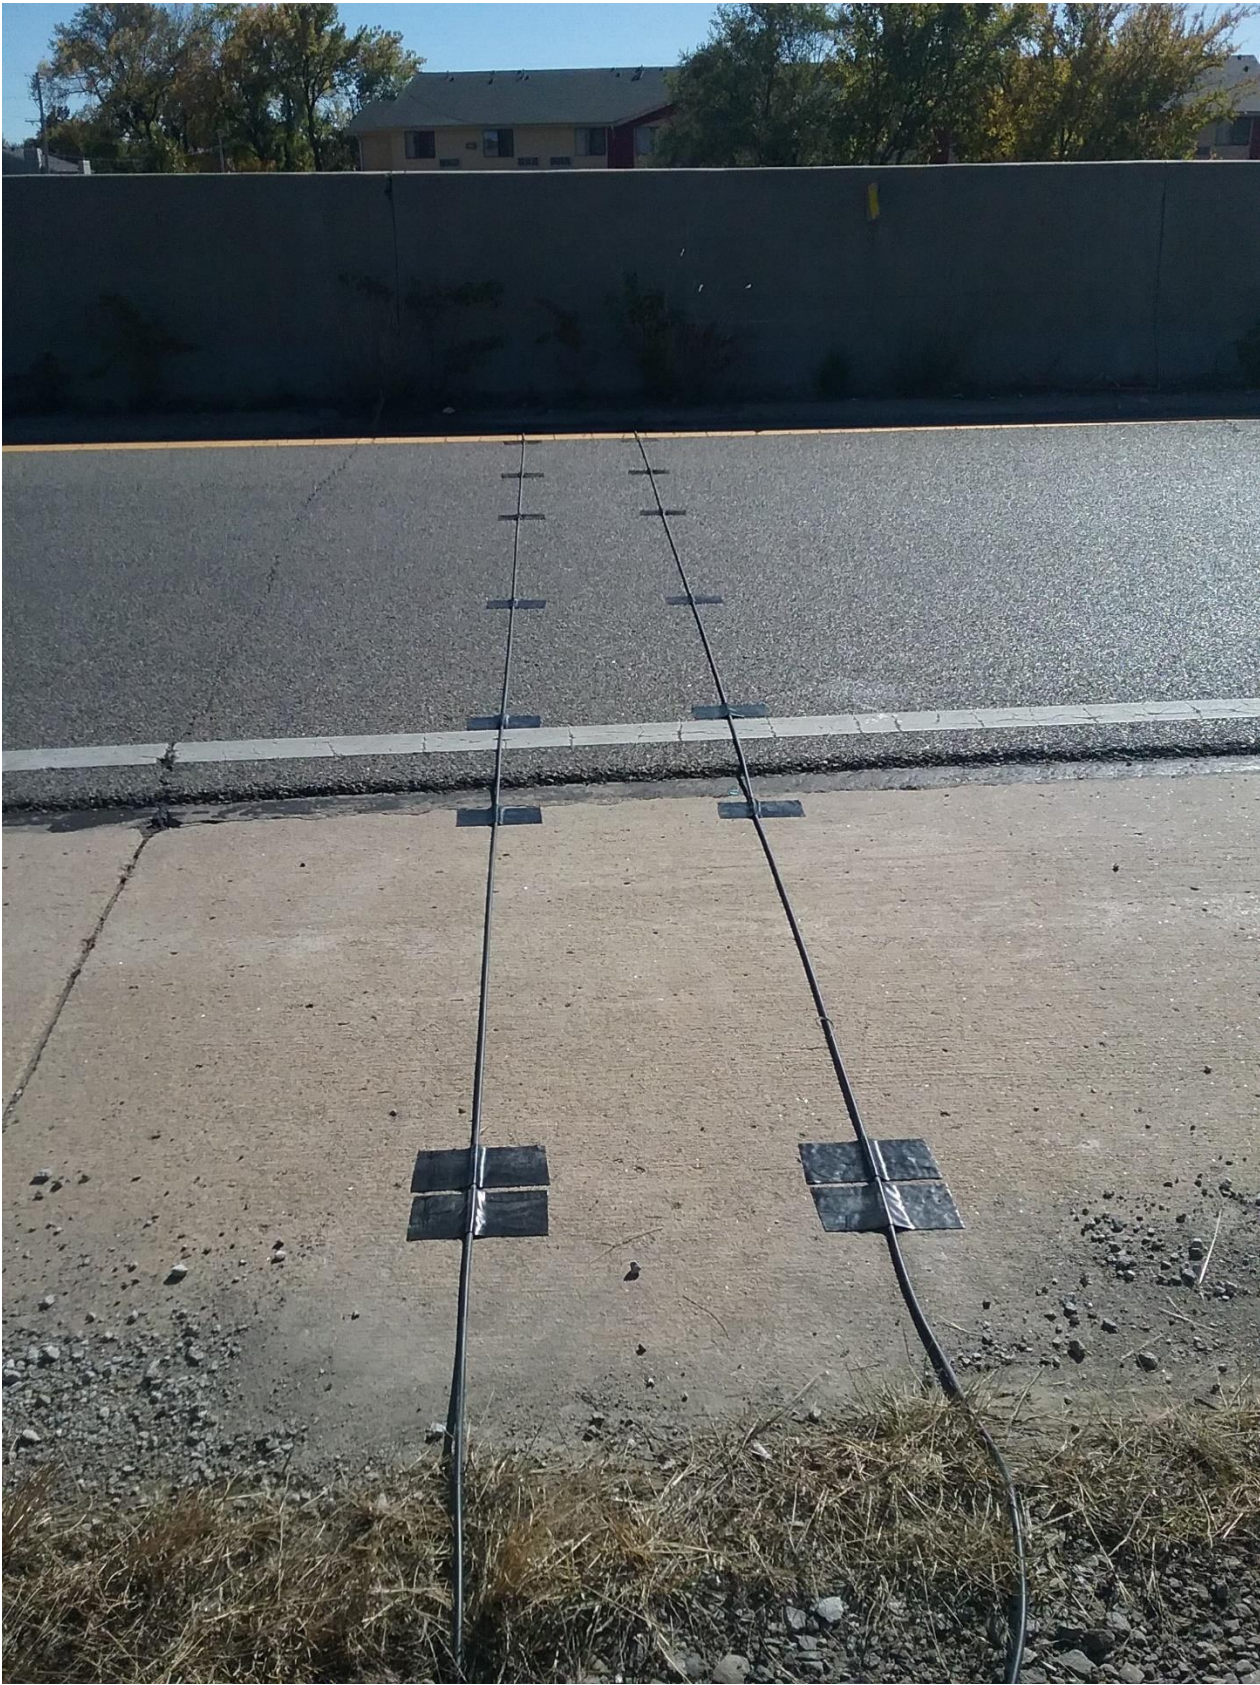
**Figure C. 25: Wanamaker South Counter 1**

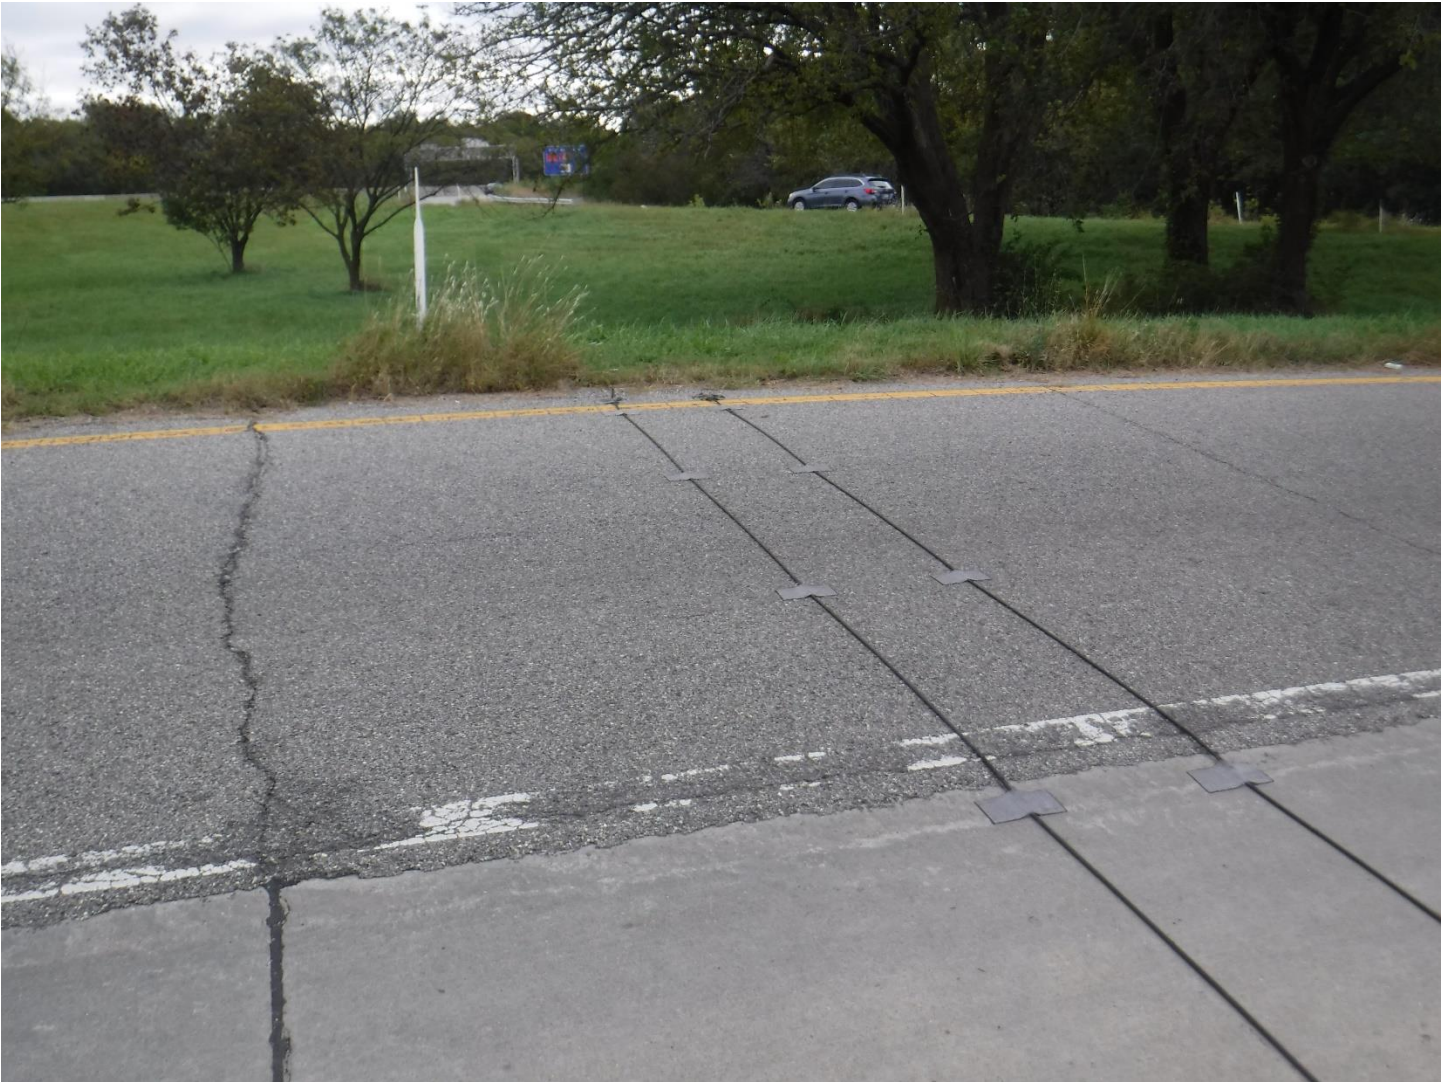
**Figure C. 26: Adams Street South, Later Discovered Road Tube Damaged**

- It should be noted that although road tubes are very effective in determining WWD incidents, they are susceptible to false-positives, damage if left on the roadway for more than two weeks, or significant damage caused by a mowing crew, objects hanging from a vehicle, or vandalism.

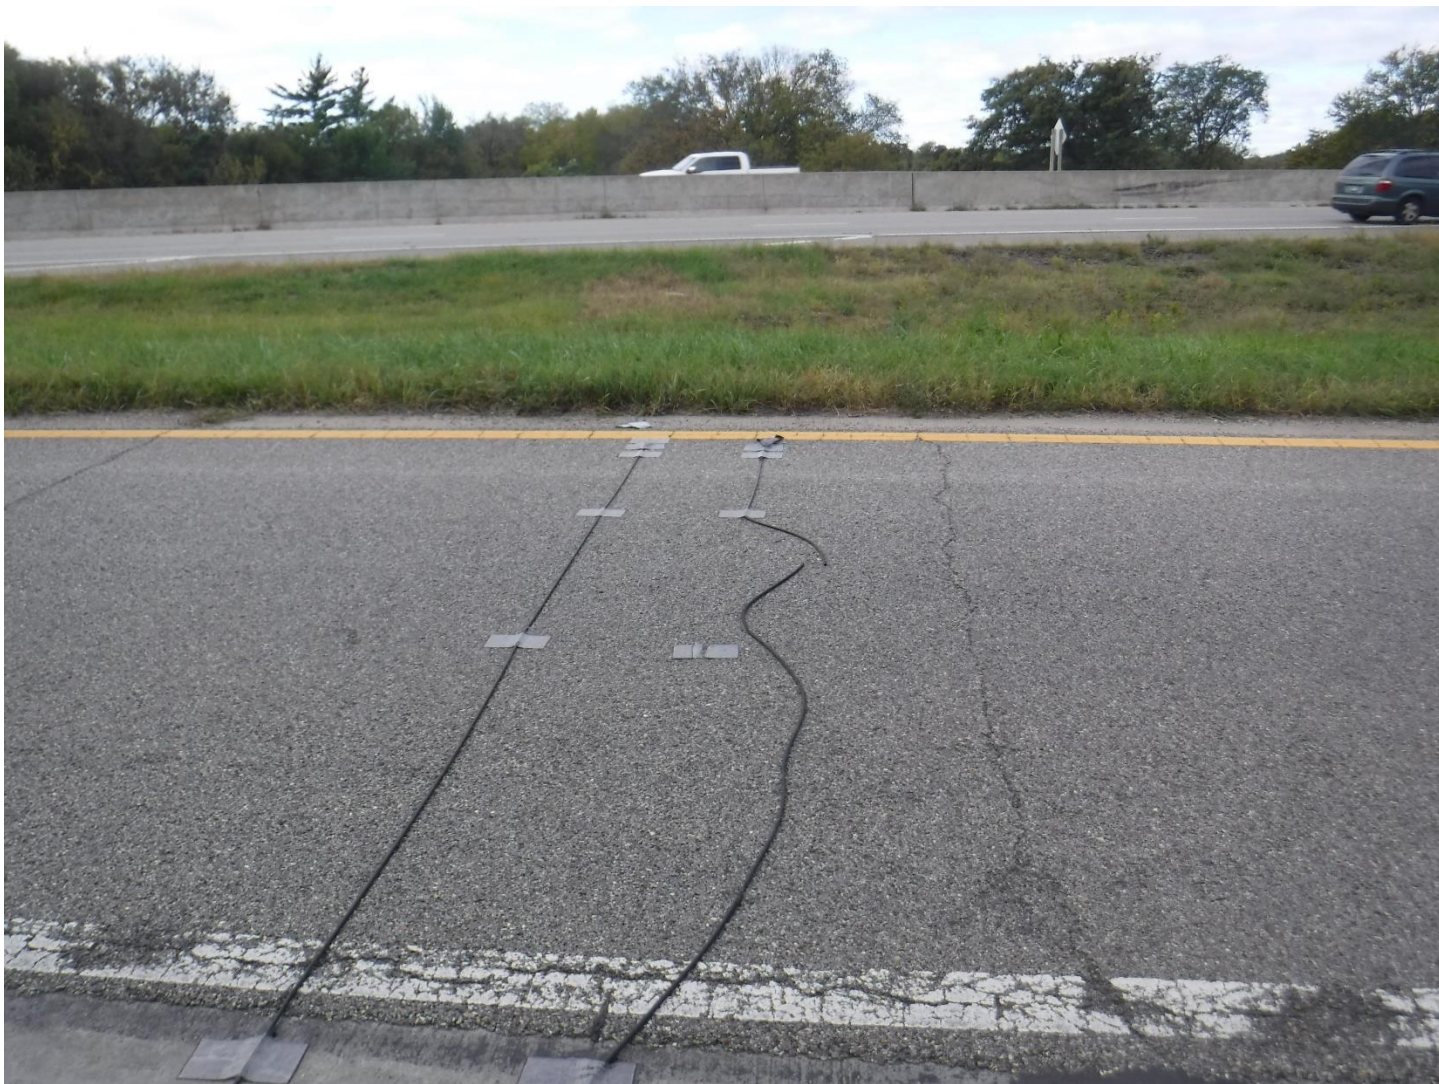
**Figure C. 27: Adams St North Counter 2, Broken Road Tube**

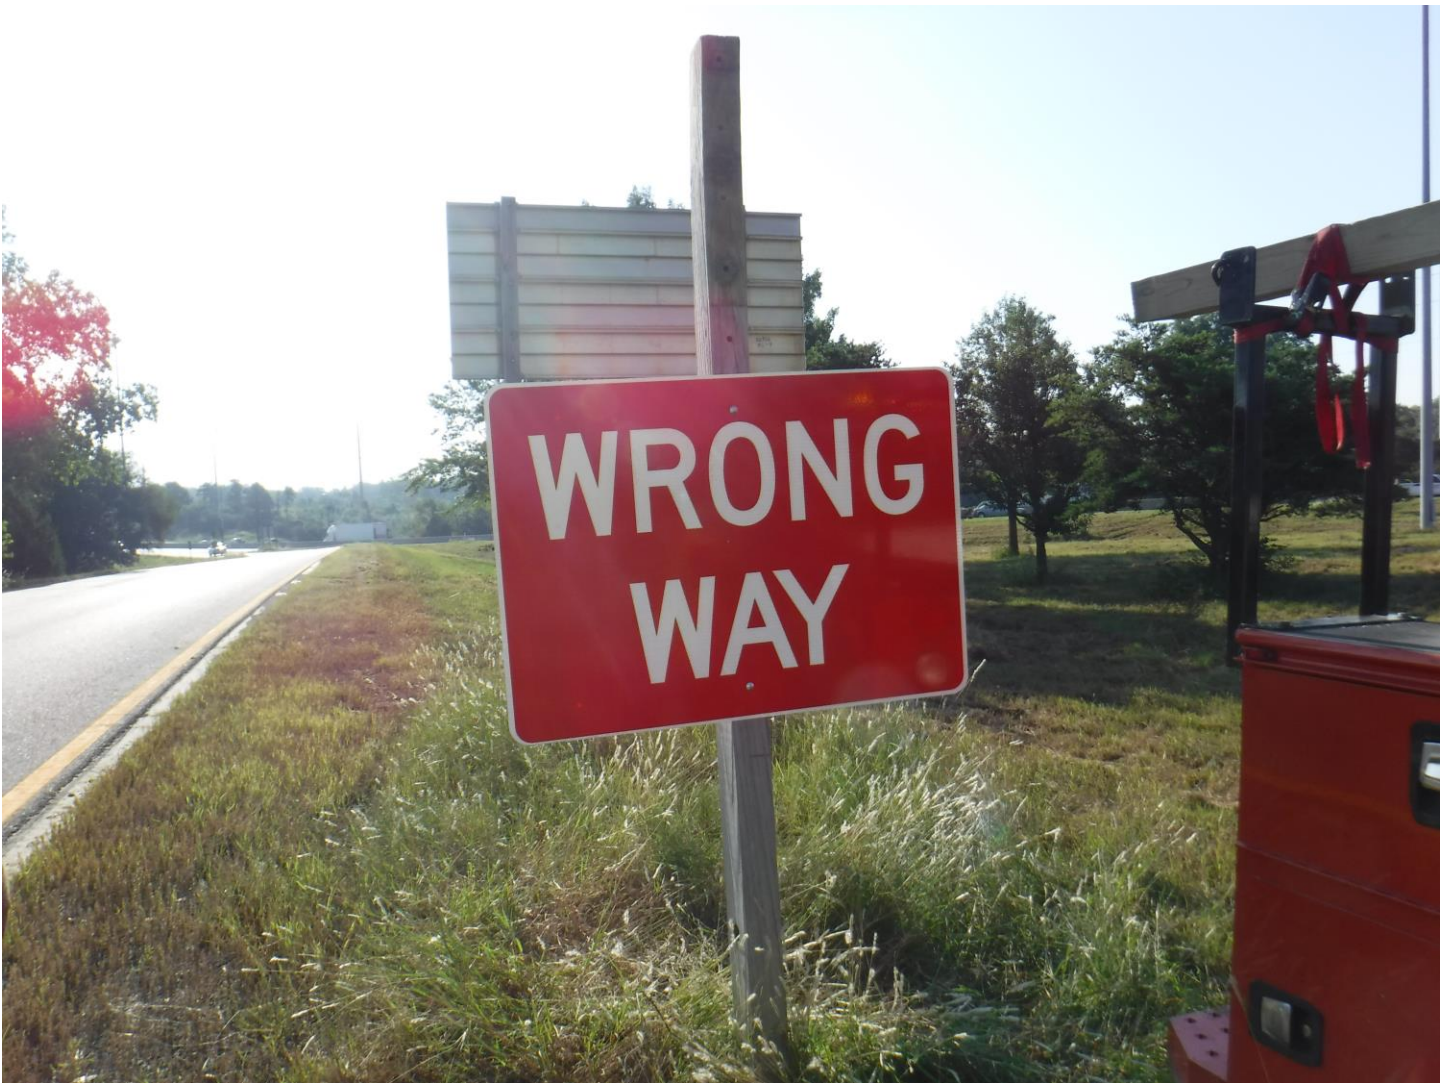
**Figure C. 28: Installation of Oversized and Lowered Wrong Way Sign at Gage Blvd Ramp**

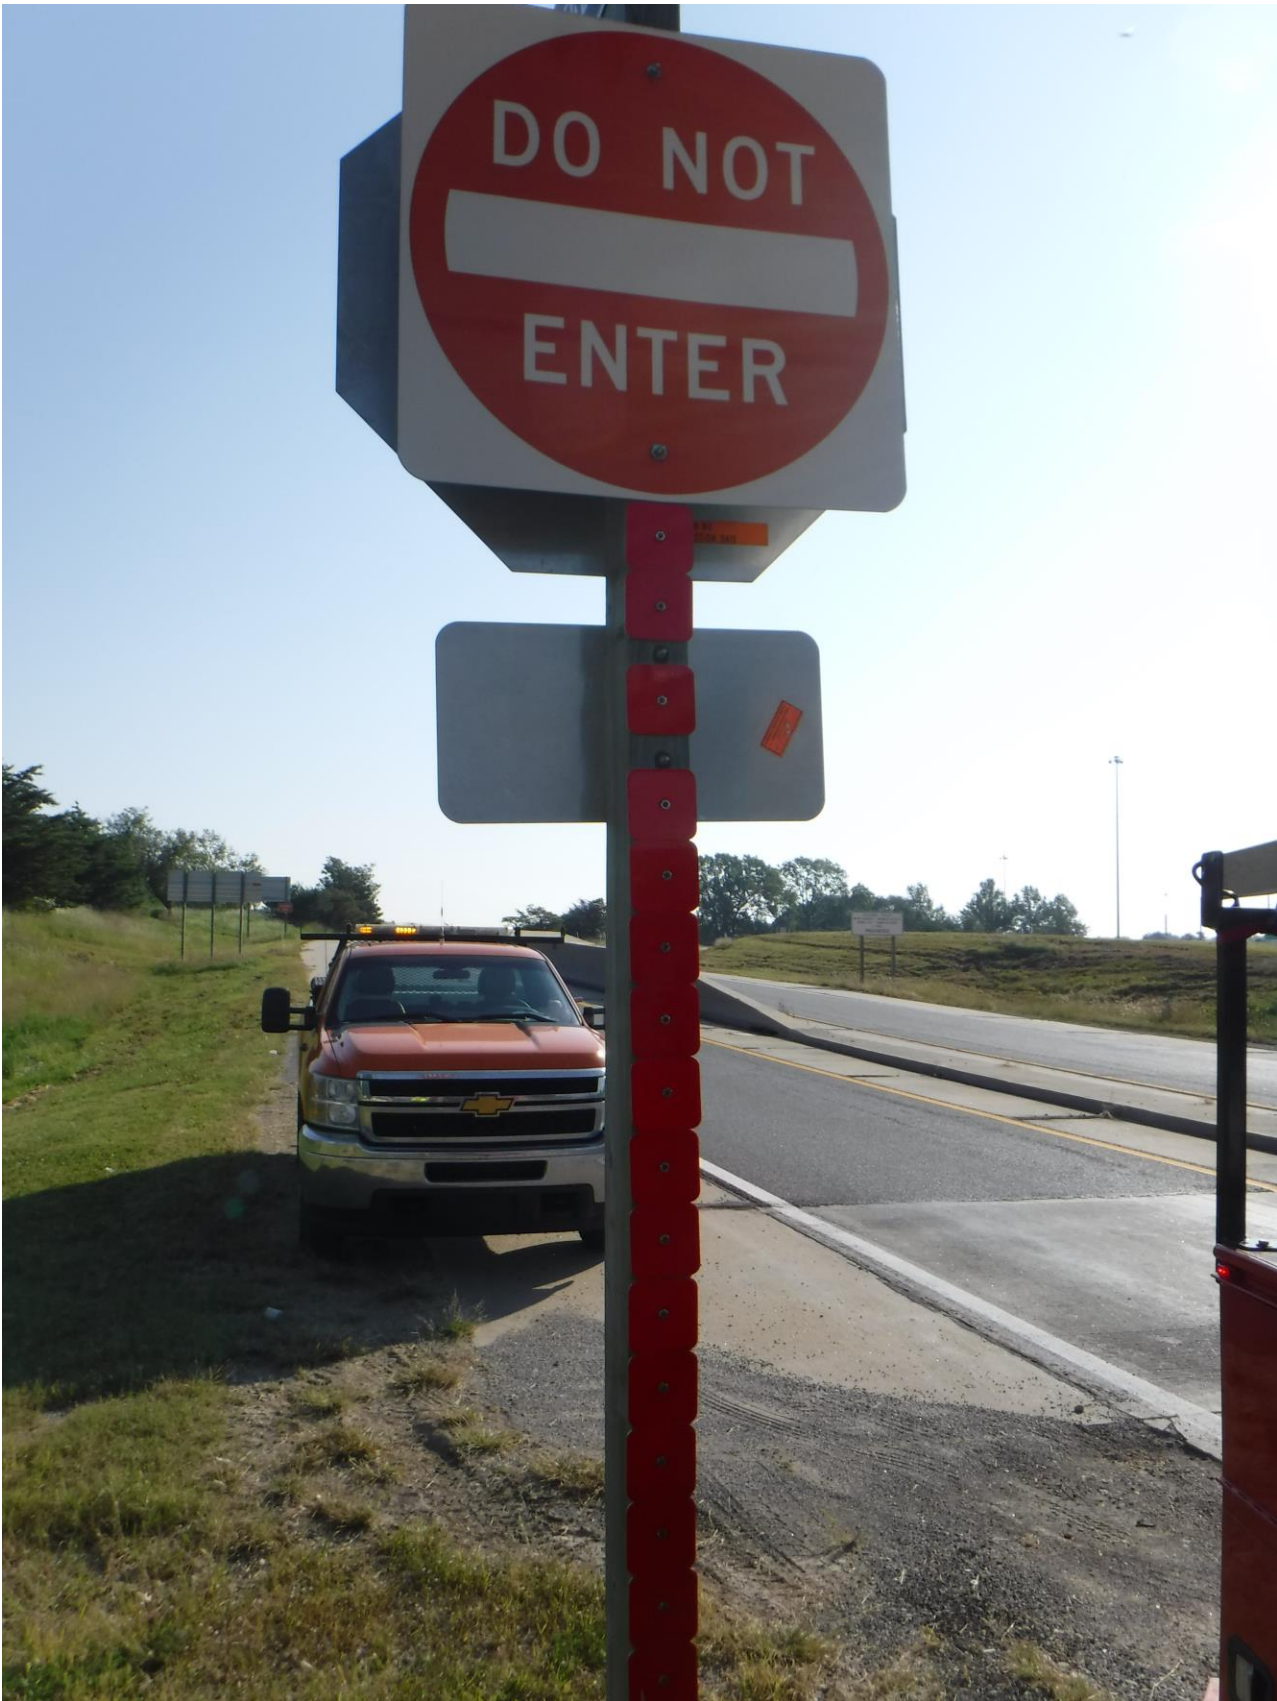
**Figure C. 29: Installation of RRFDs on Gage Blvd**

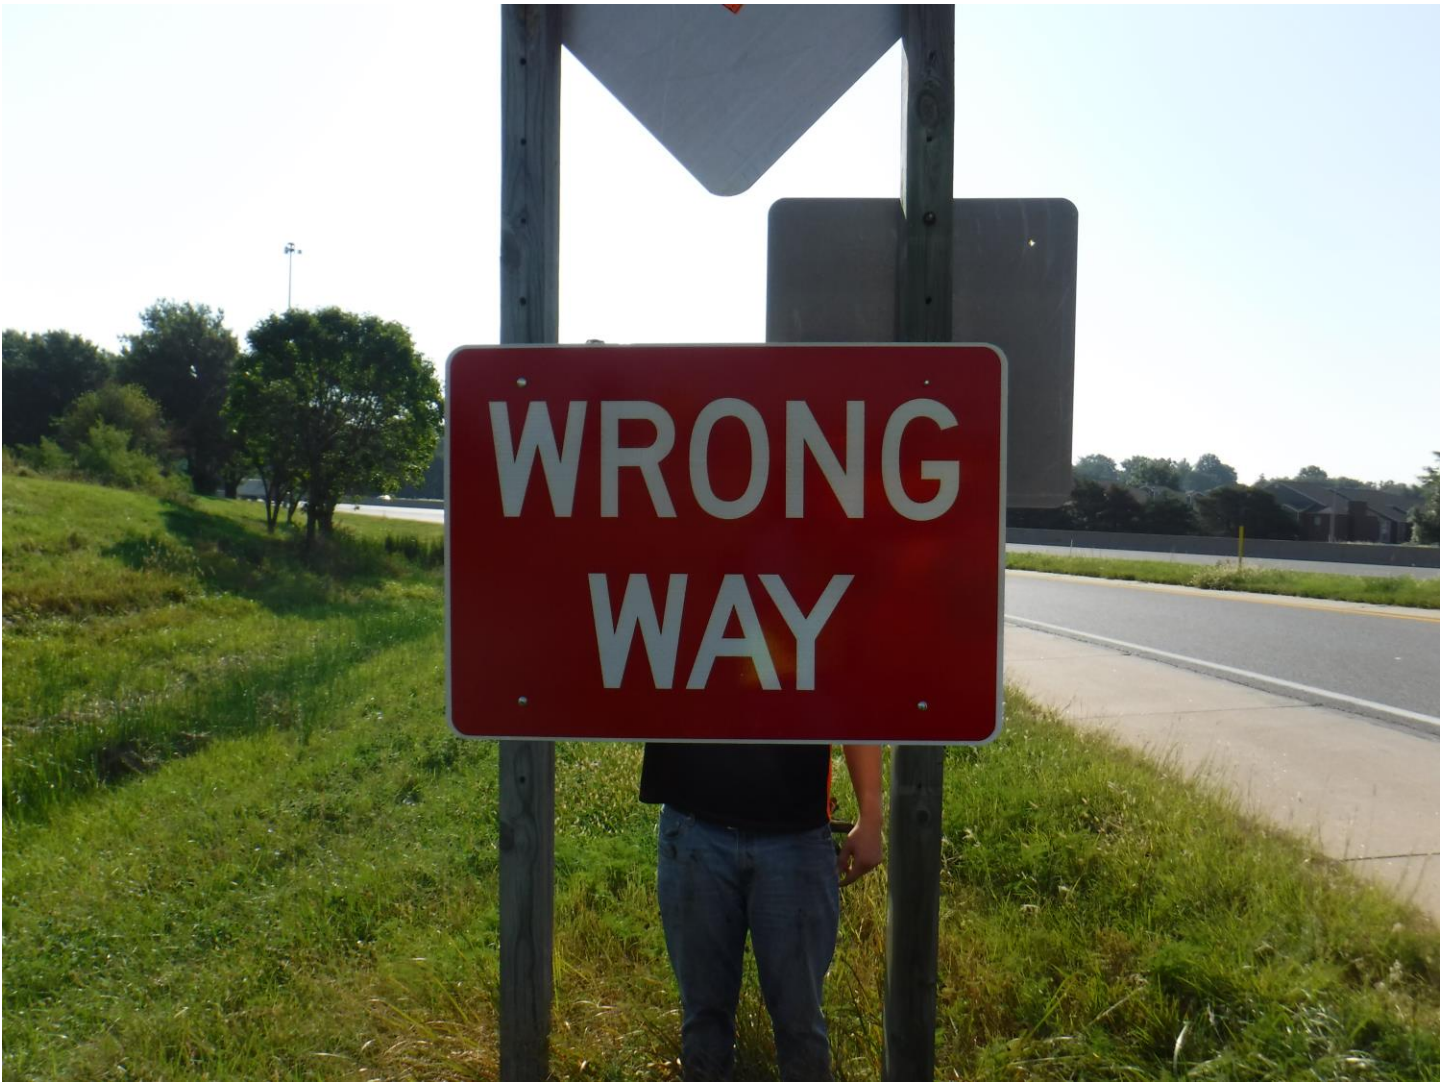
**Figure C. 30: Installation of 2nd Oversized and Lowered Wrong Way Sign on Wanamaker Rd North**

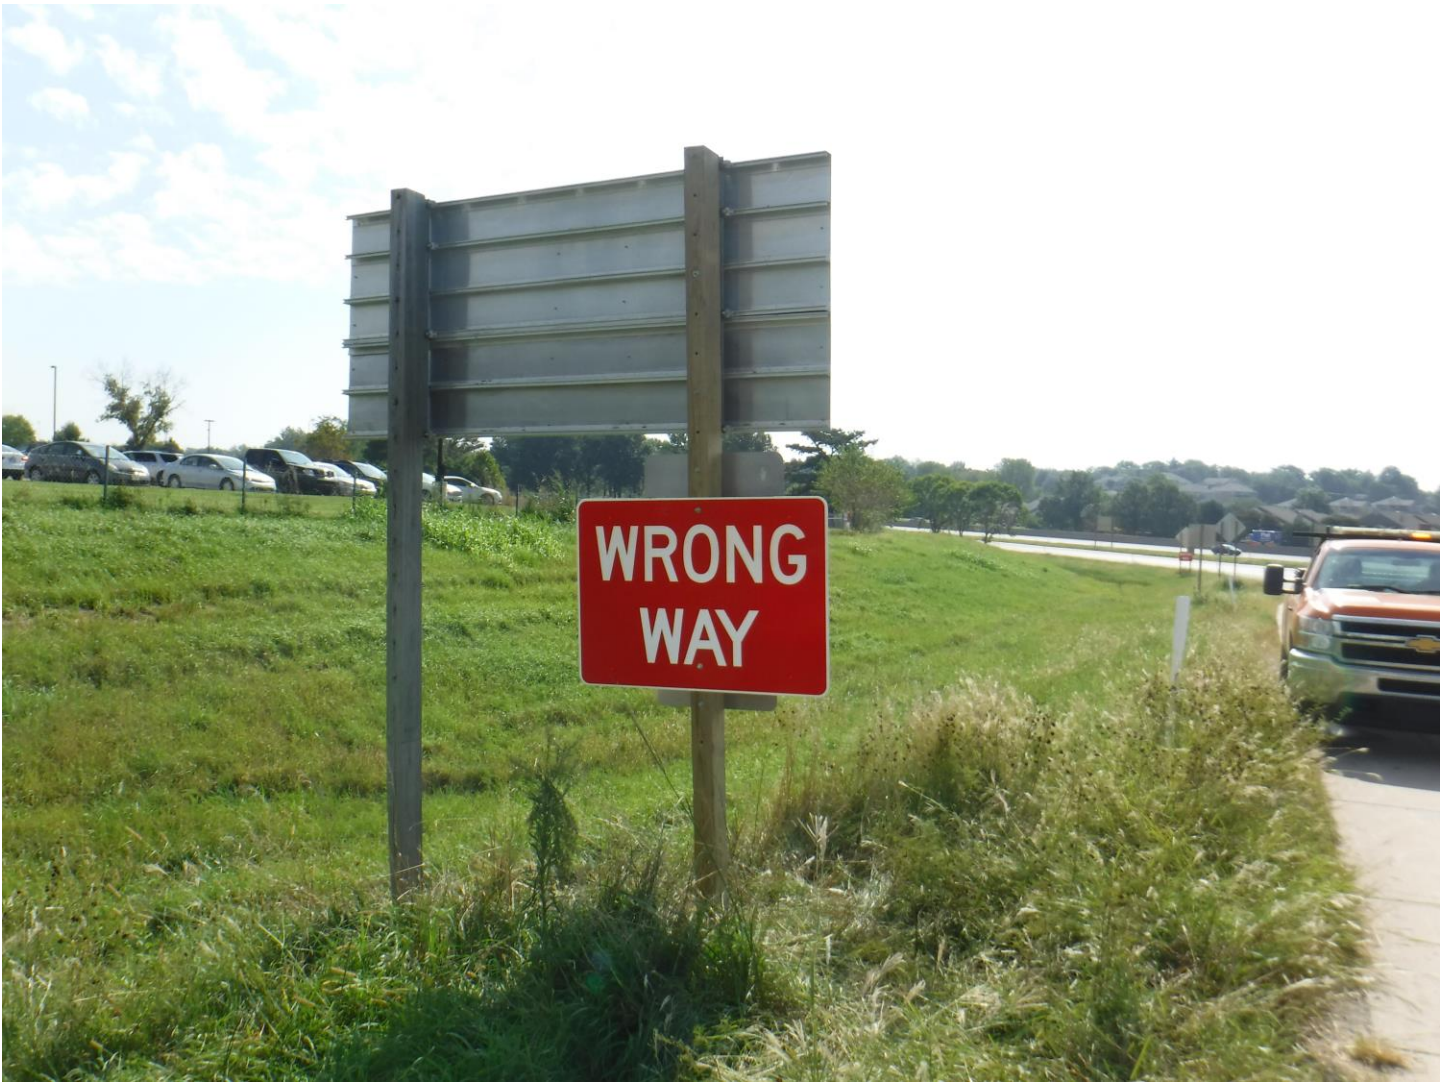
**Figure C. 31: Installation of 1st Oversized and Lowered Wrong Way Signs on Wanamaker Rd North Ramp**
