**An evaluation of low-cost wrong-way driving countermeasures at partial cloverleaf  
interchanges on Kansas interstates**

AN ABSTRACT OF A DISSERTATION

Department of Civil Engineering  
Carl R. Ice College of Engineering

KANSAS STATE UNIVERSITY  
Manhattan, Kansas

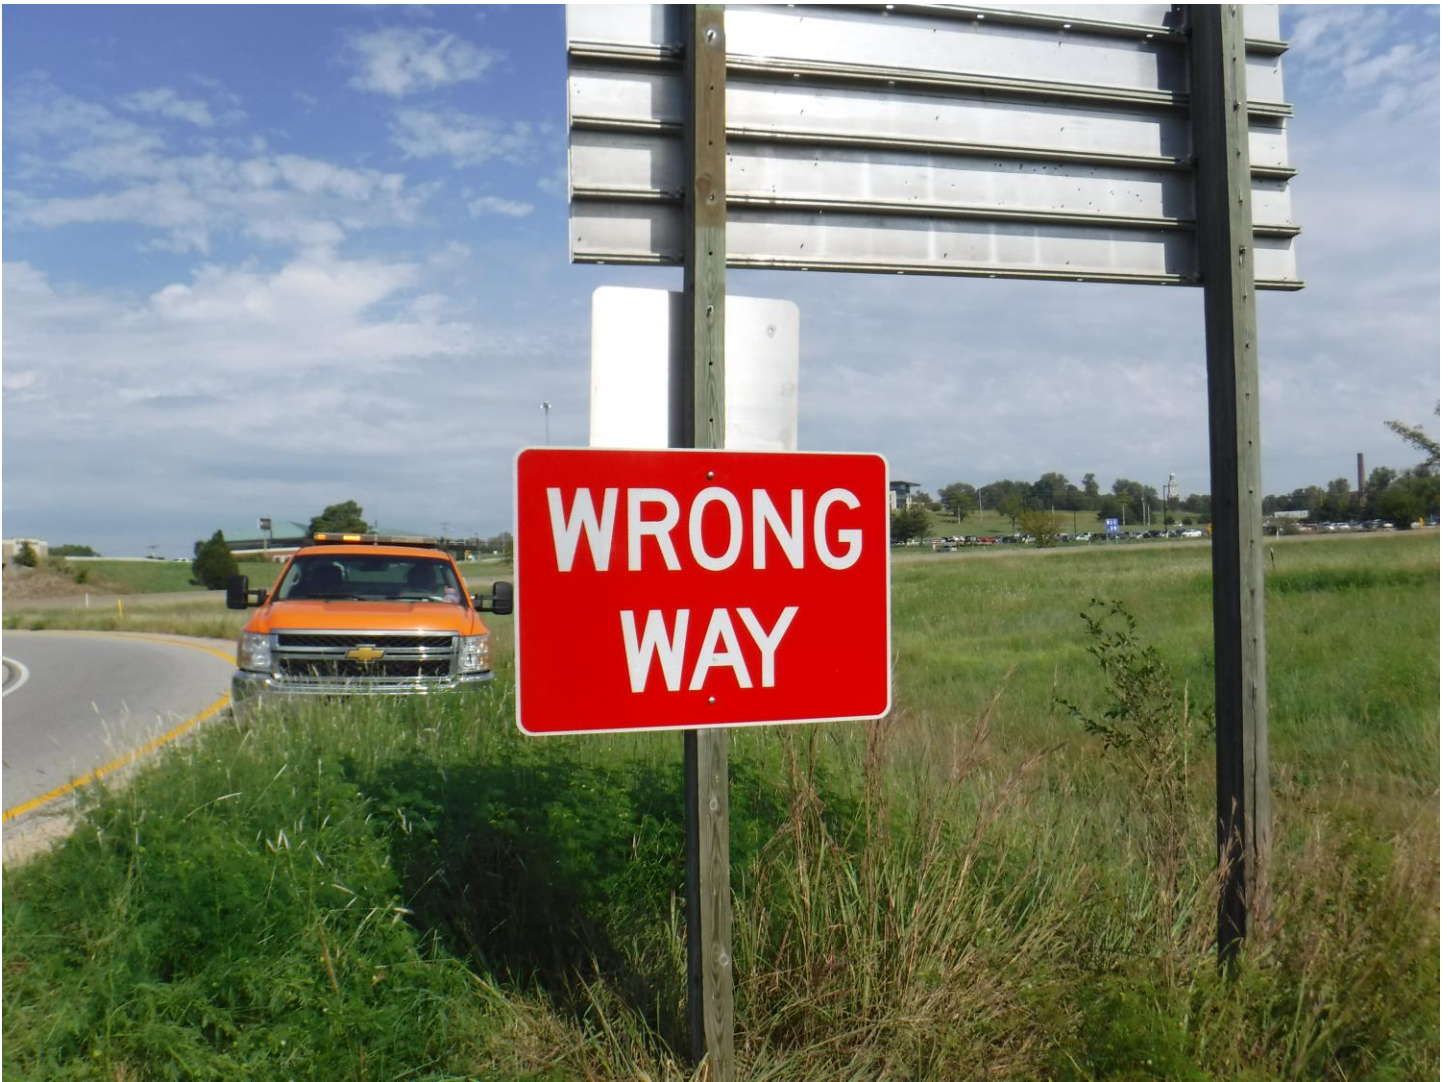
**Figure C. 32: Installation of 1st Oversized and Lowered Sign at Wanamaker Rd South ramp**

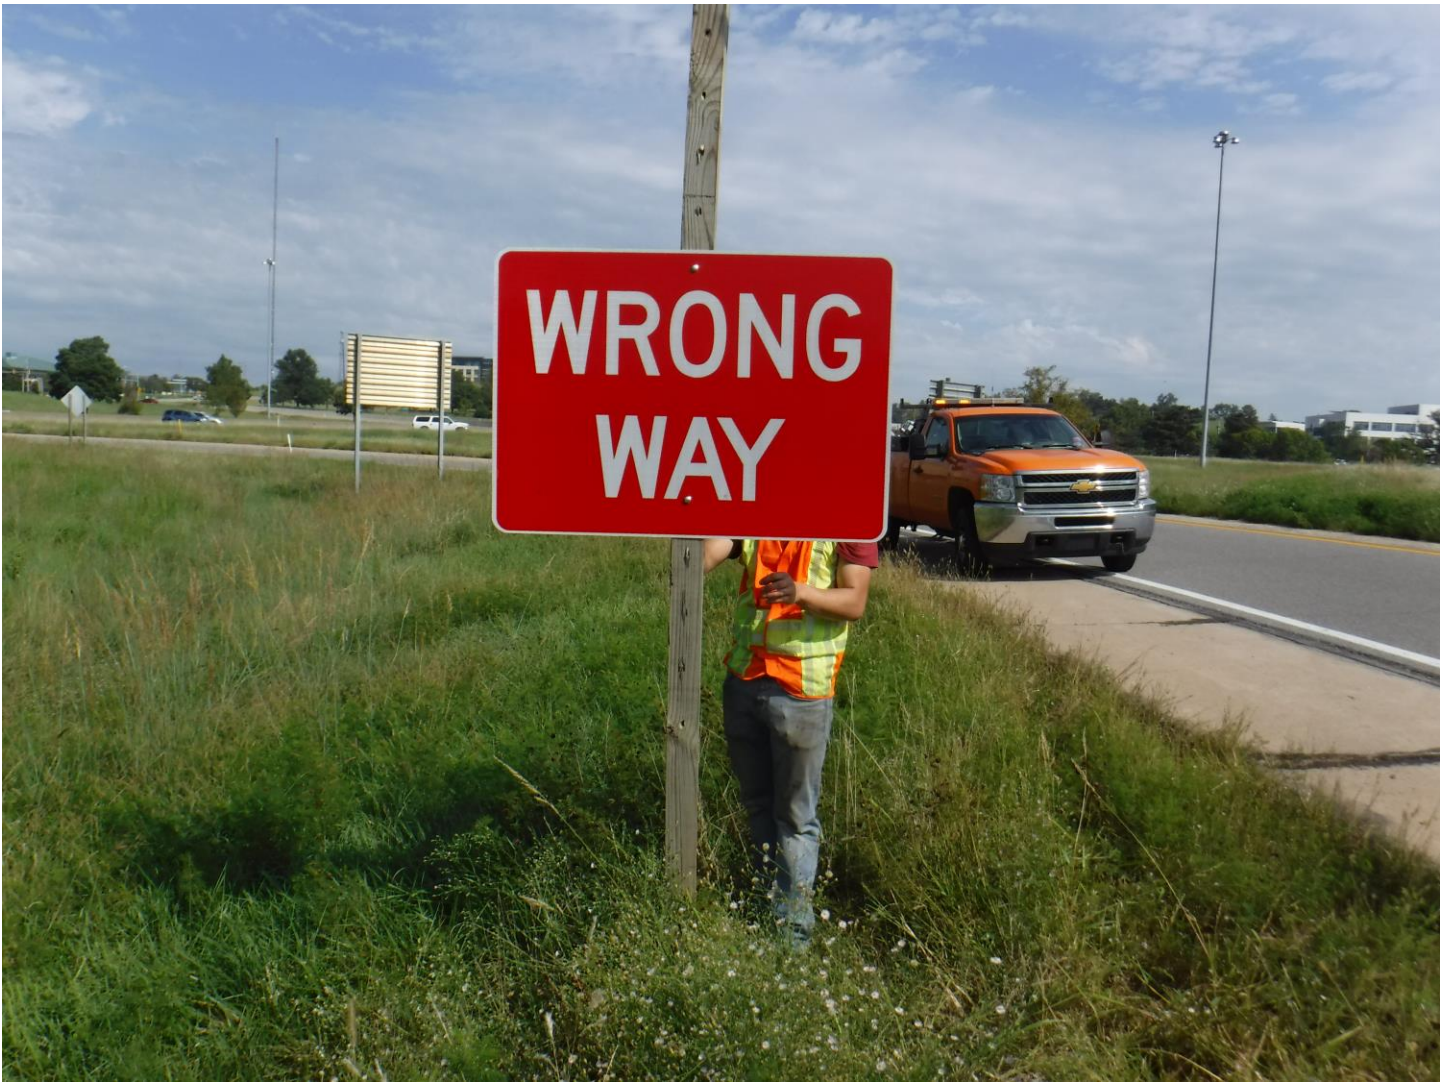
**Figure C. 33: Installation of 2nd Oversized and Lowered Wrong Way Sign on Wanamaker South Ramp**

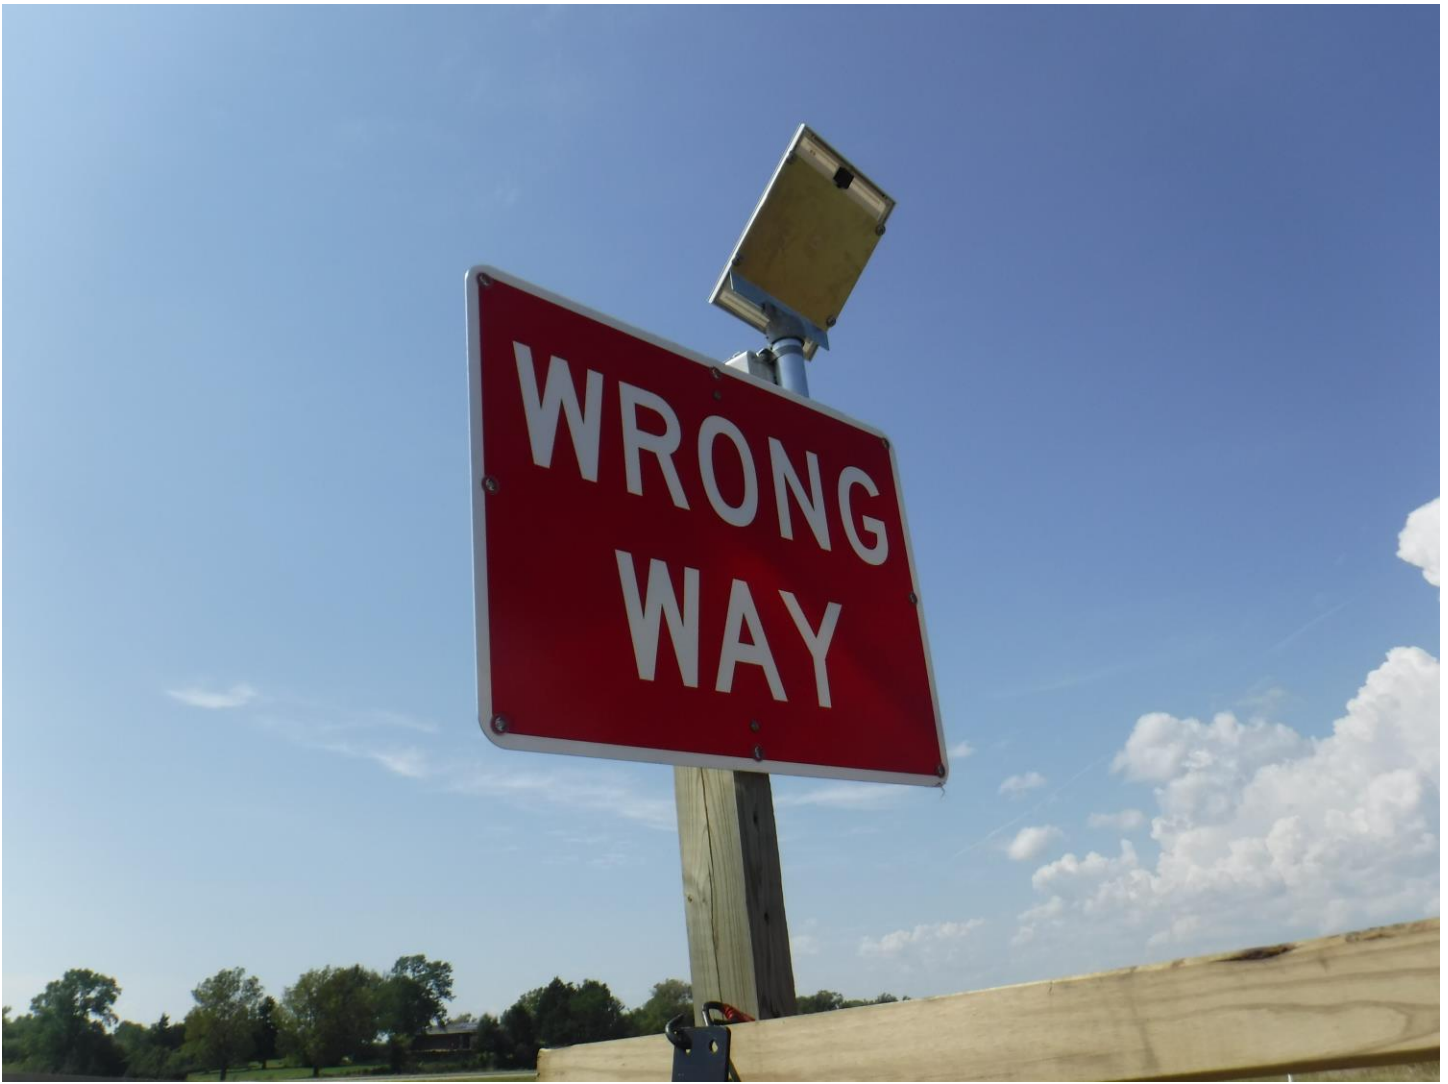
**Figure C. 34: Installation of Flashing LED Wrong Way Sign at Auburn Rd Ramp**

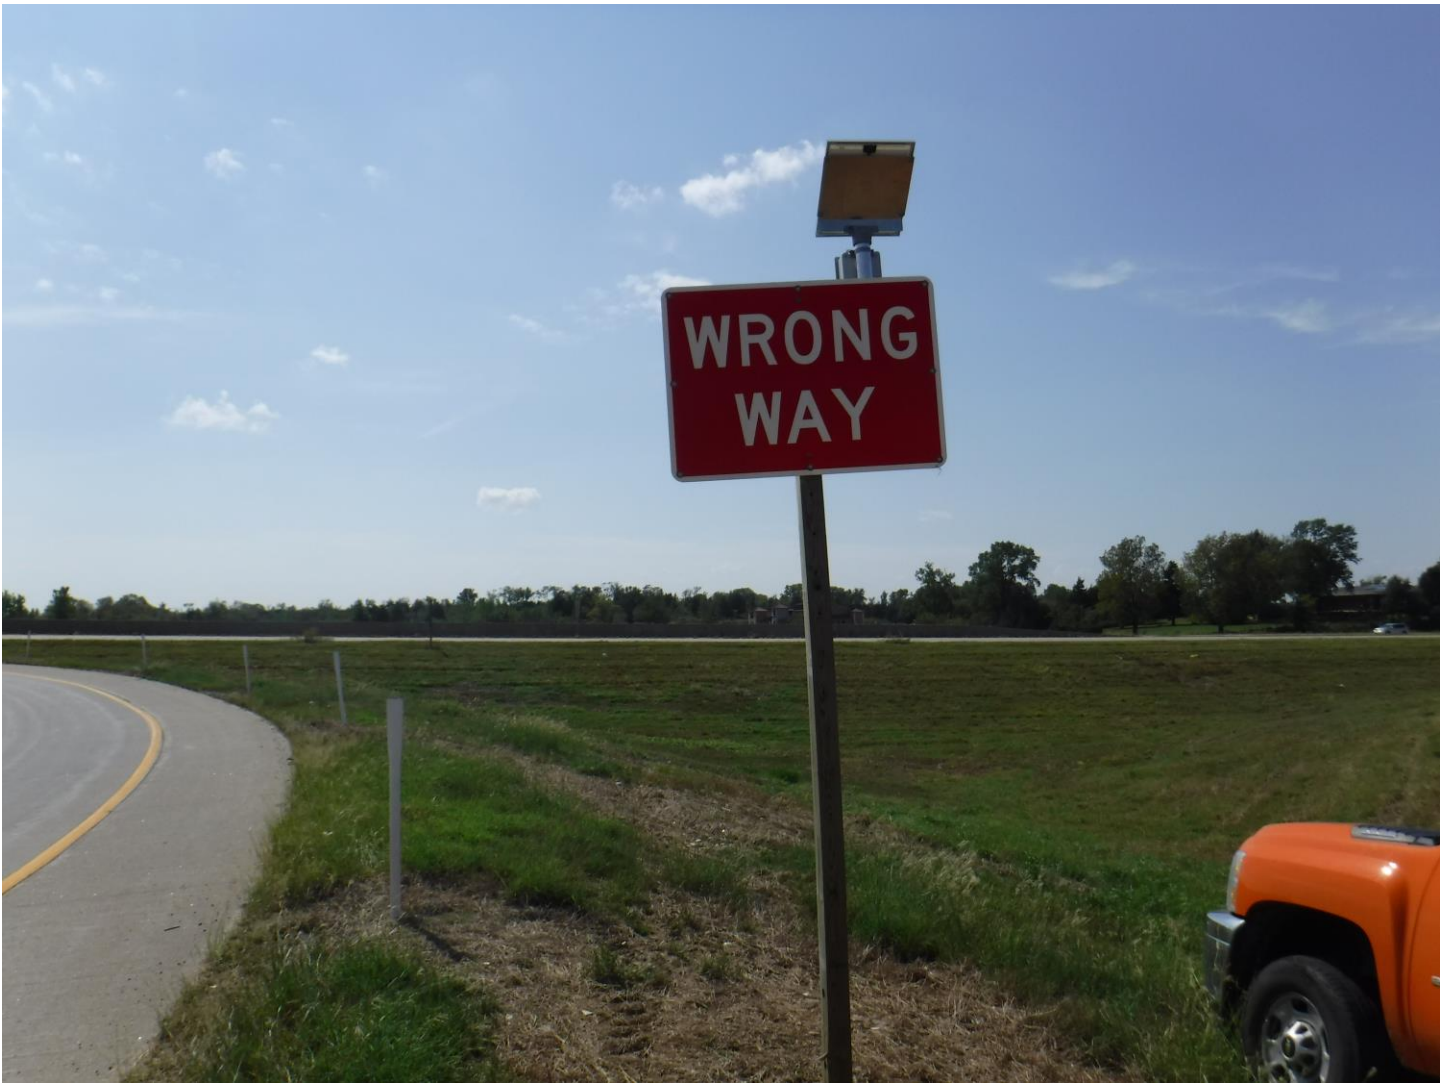
**Figure C. 35: Installation of Flashing LED Wrong Way Sign at Auburn Rd Ramp**

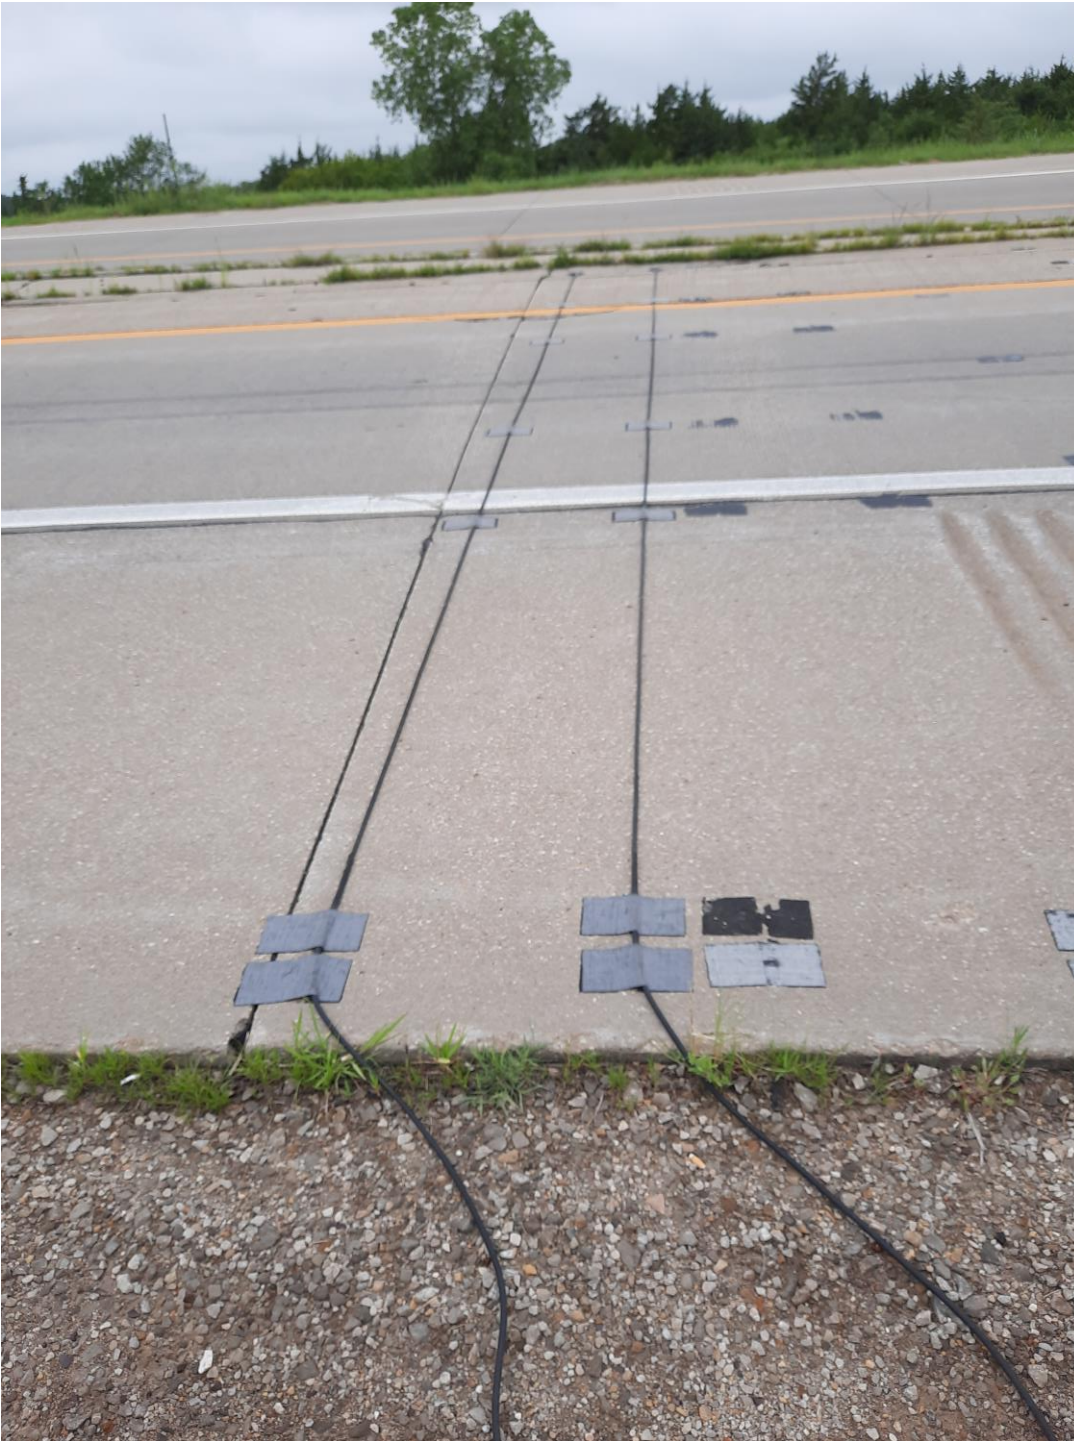
**Figure C. 36: Counter 1 Location on Auburn Rd Ramp**

- Two setups of pneumatic road tubes are recommended to be installed on the interstate off ramp to detect WWD. One counter located near the intersection, and one located near the interstate / gore area.

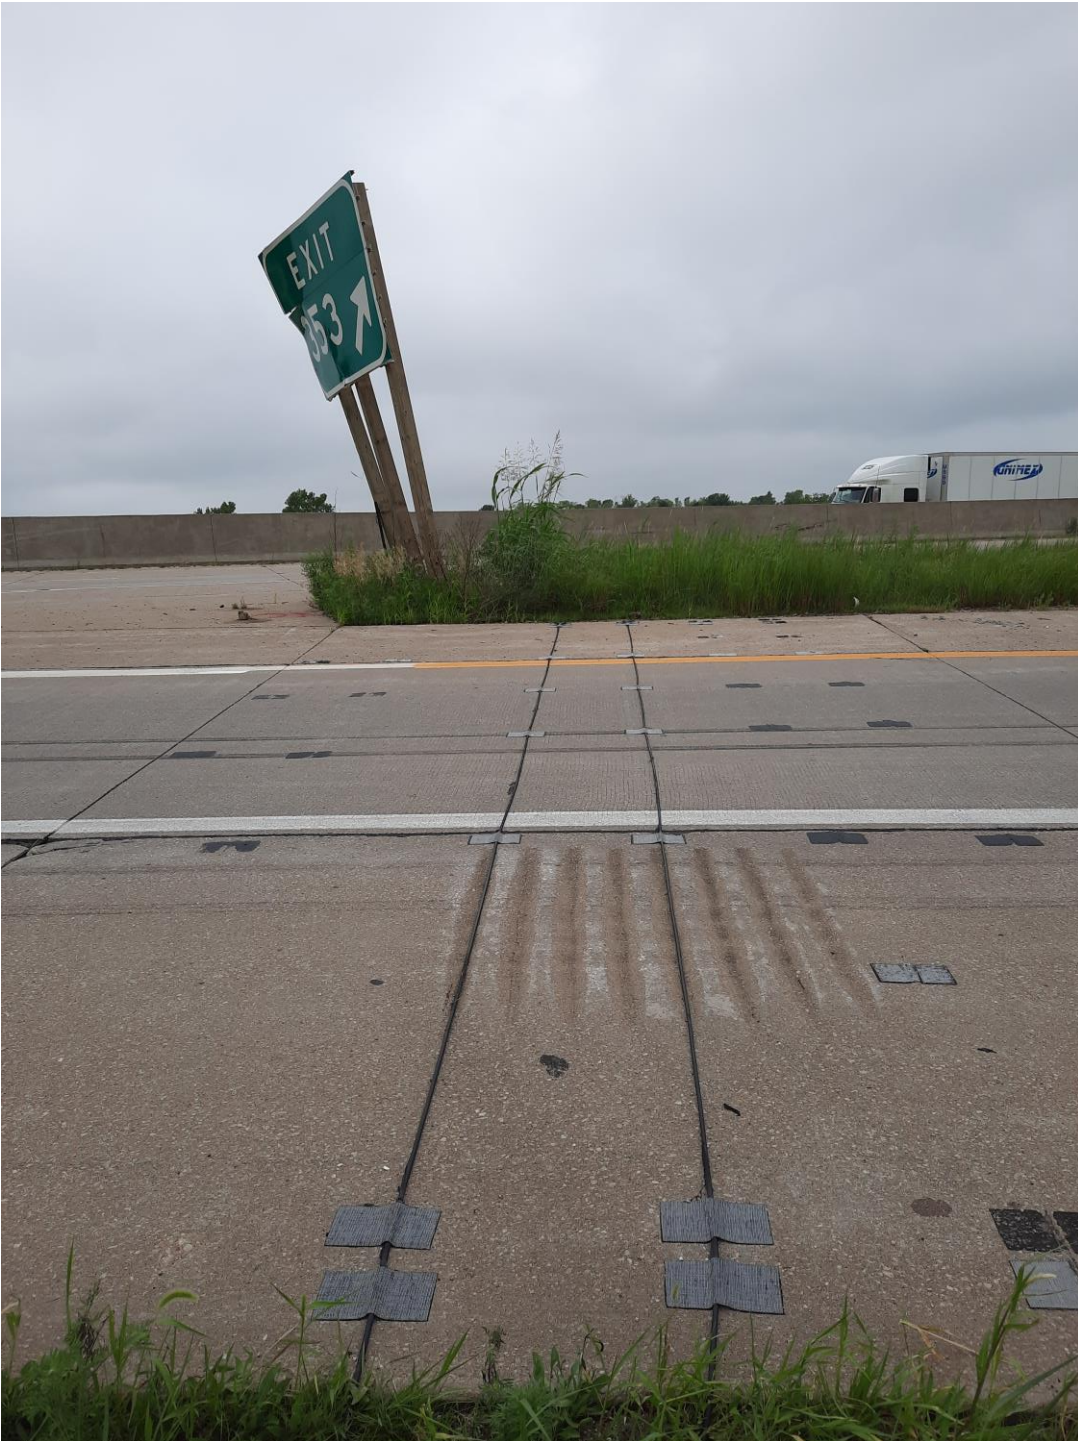
**Figure C. 37: Counter 2 Location on Auburn Rd Ramp**

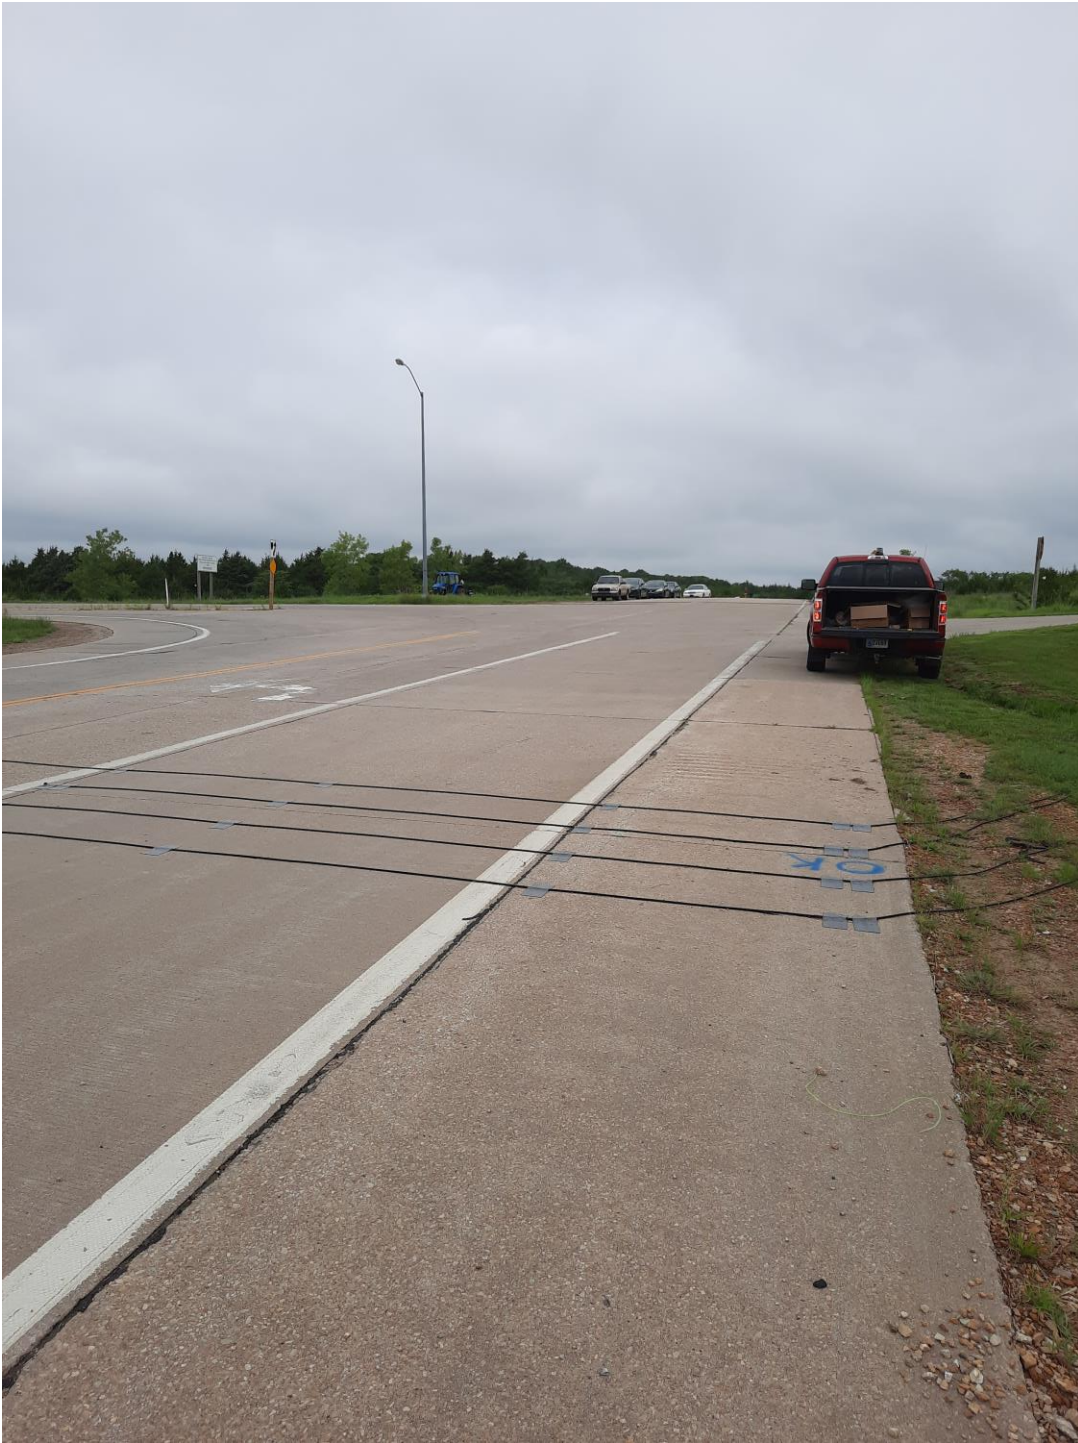
**Figure C. 38: Counter 3 Location on Northbound Auburn Rd**

The second part of this dissertation involved the development of an enhanced data collection method. The objective of this effort was to determine if multiple sets of pneumatic road tubes could assist with determining the turning movement where a WWD incident started. As noted in Chapter 7, this was performed at the Auburn Rd partial cloverleaf interchange months after the first of the dissertation was completed. This study did produce some useful results including: 1) it verified the turning movement volume to support the WWD rates; and 2) it also supporting that almost all of the WWD started from the northbound left turning lane where vehicles could be traced between pneumatic road tube counters. Although this data collection methodology may not be suitable for all study sights, it did provide a way to investigate WWD incidents further.

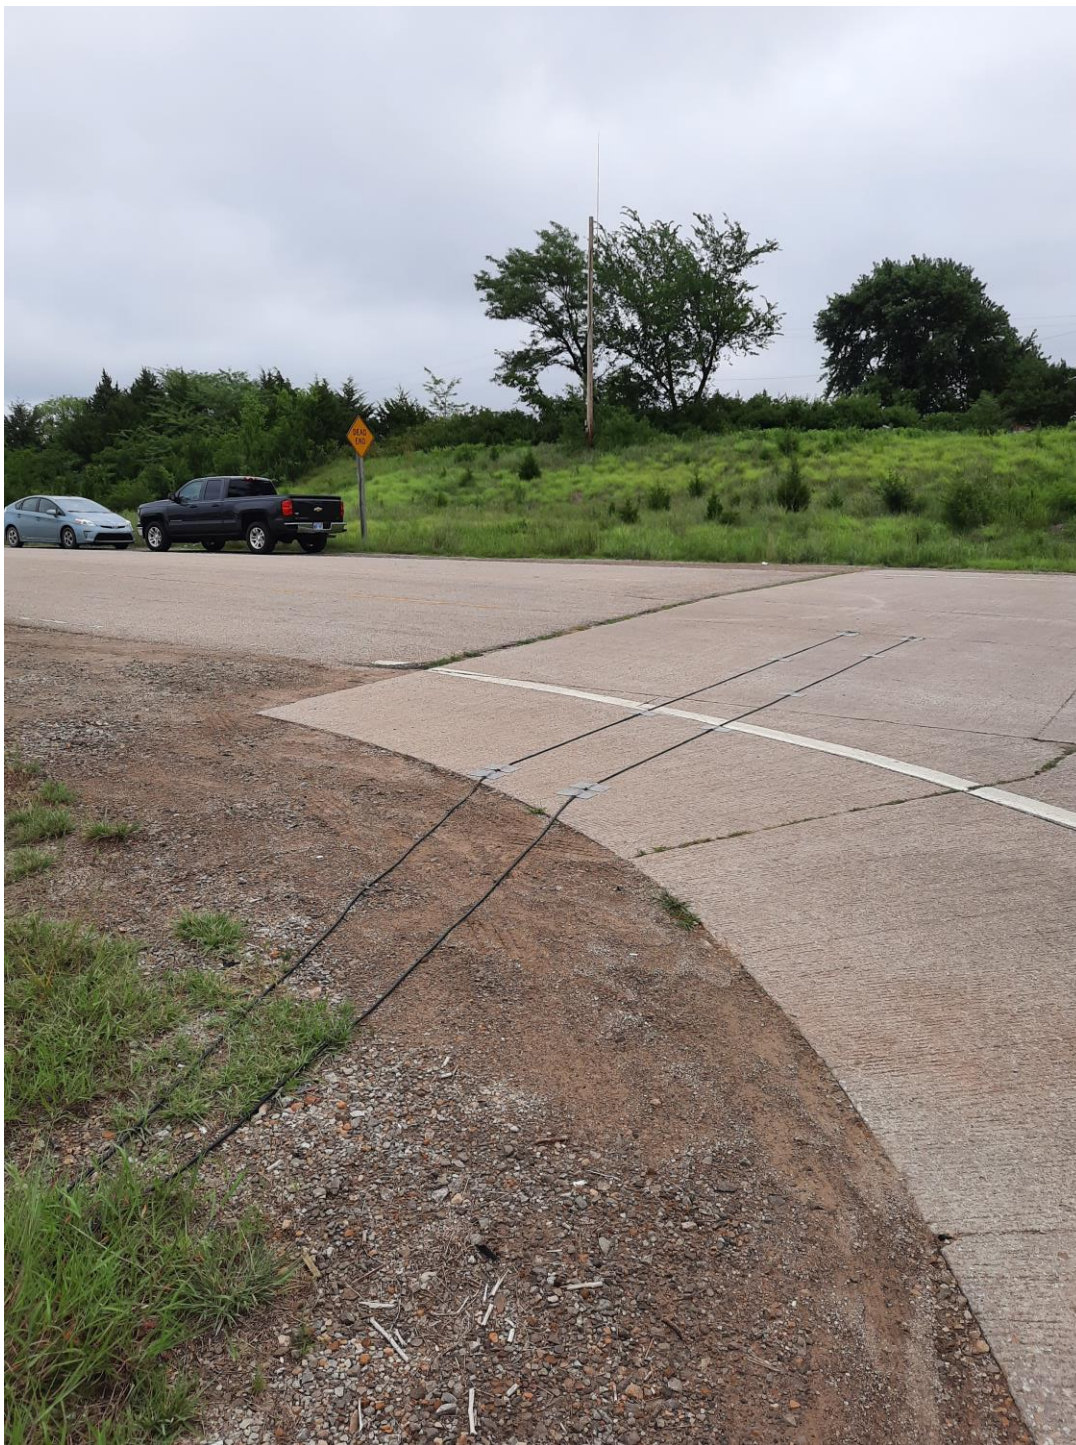
**Figure C. 40: Counter 4 Location on Southbound Auburn Rd**

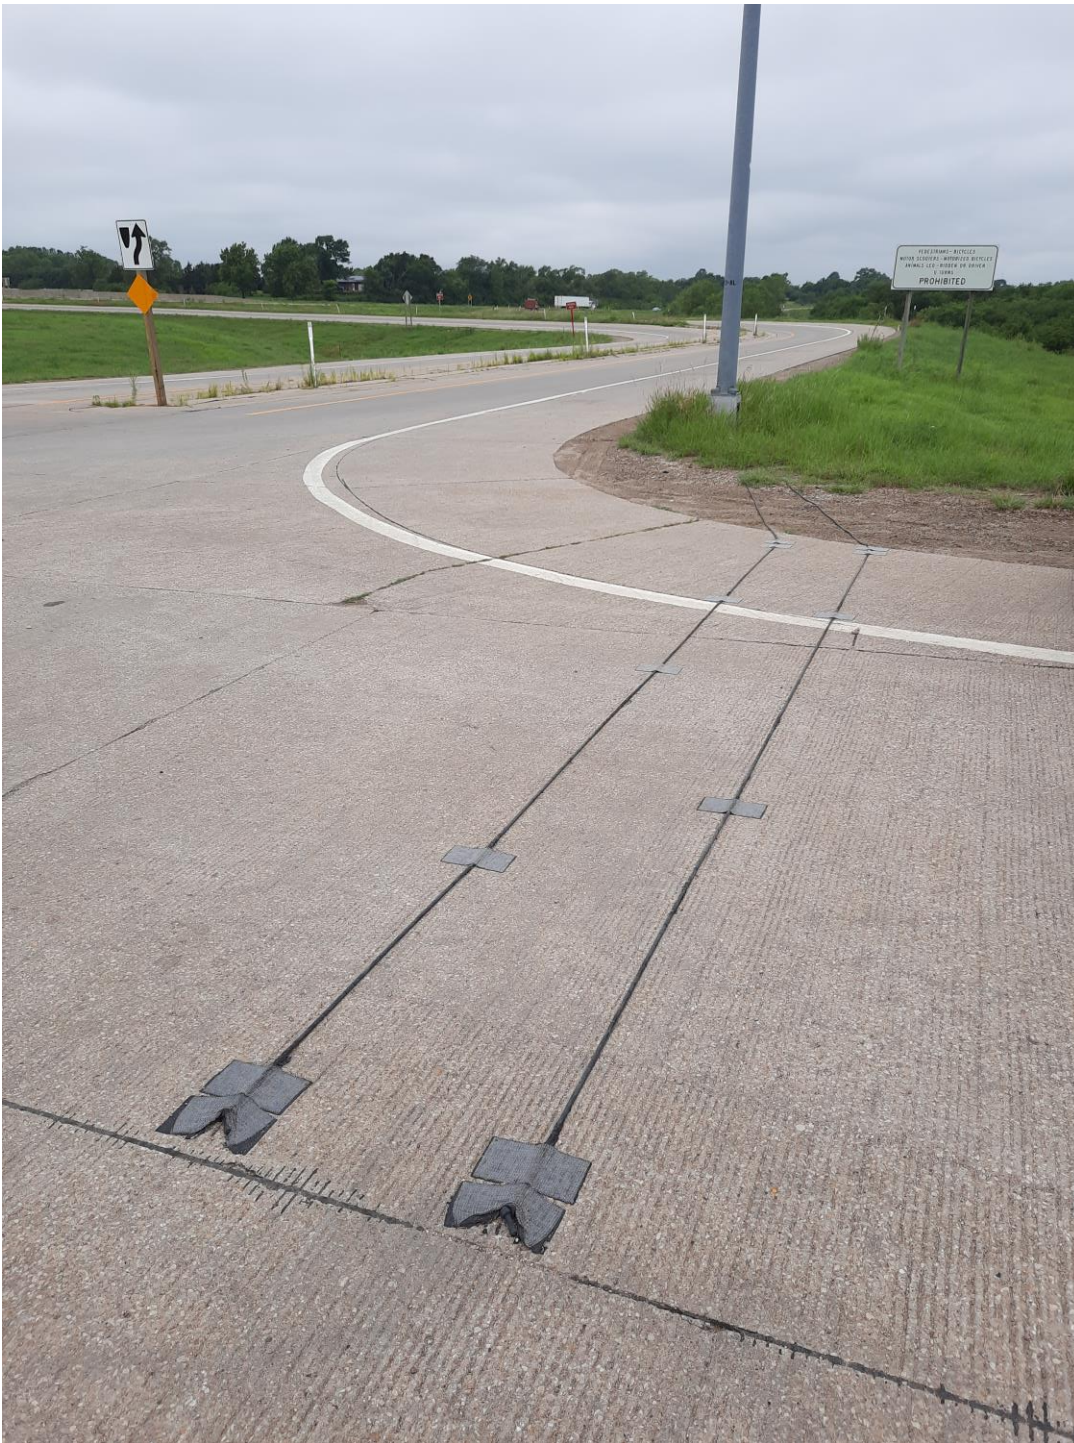
**Figure C. 41: Counter 4 Location on Southbound Auburn Rd**

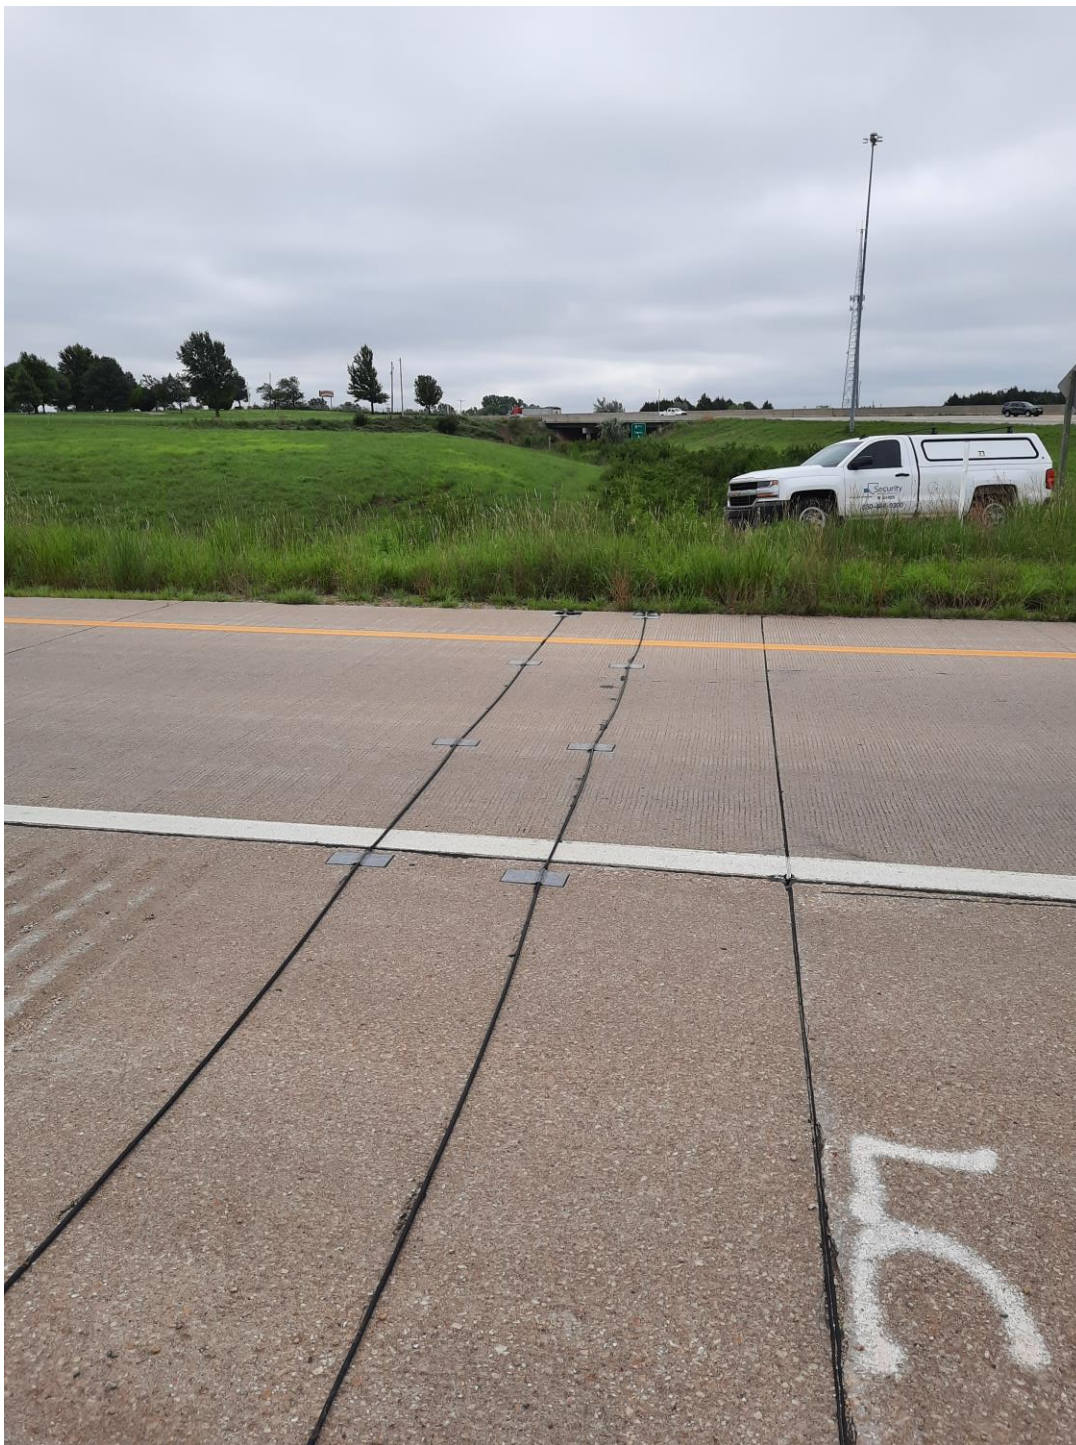
**Figure C. 42: Counter 5 Location on I-70 Entrance Ramp**

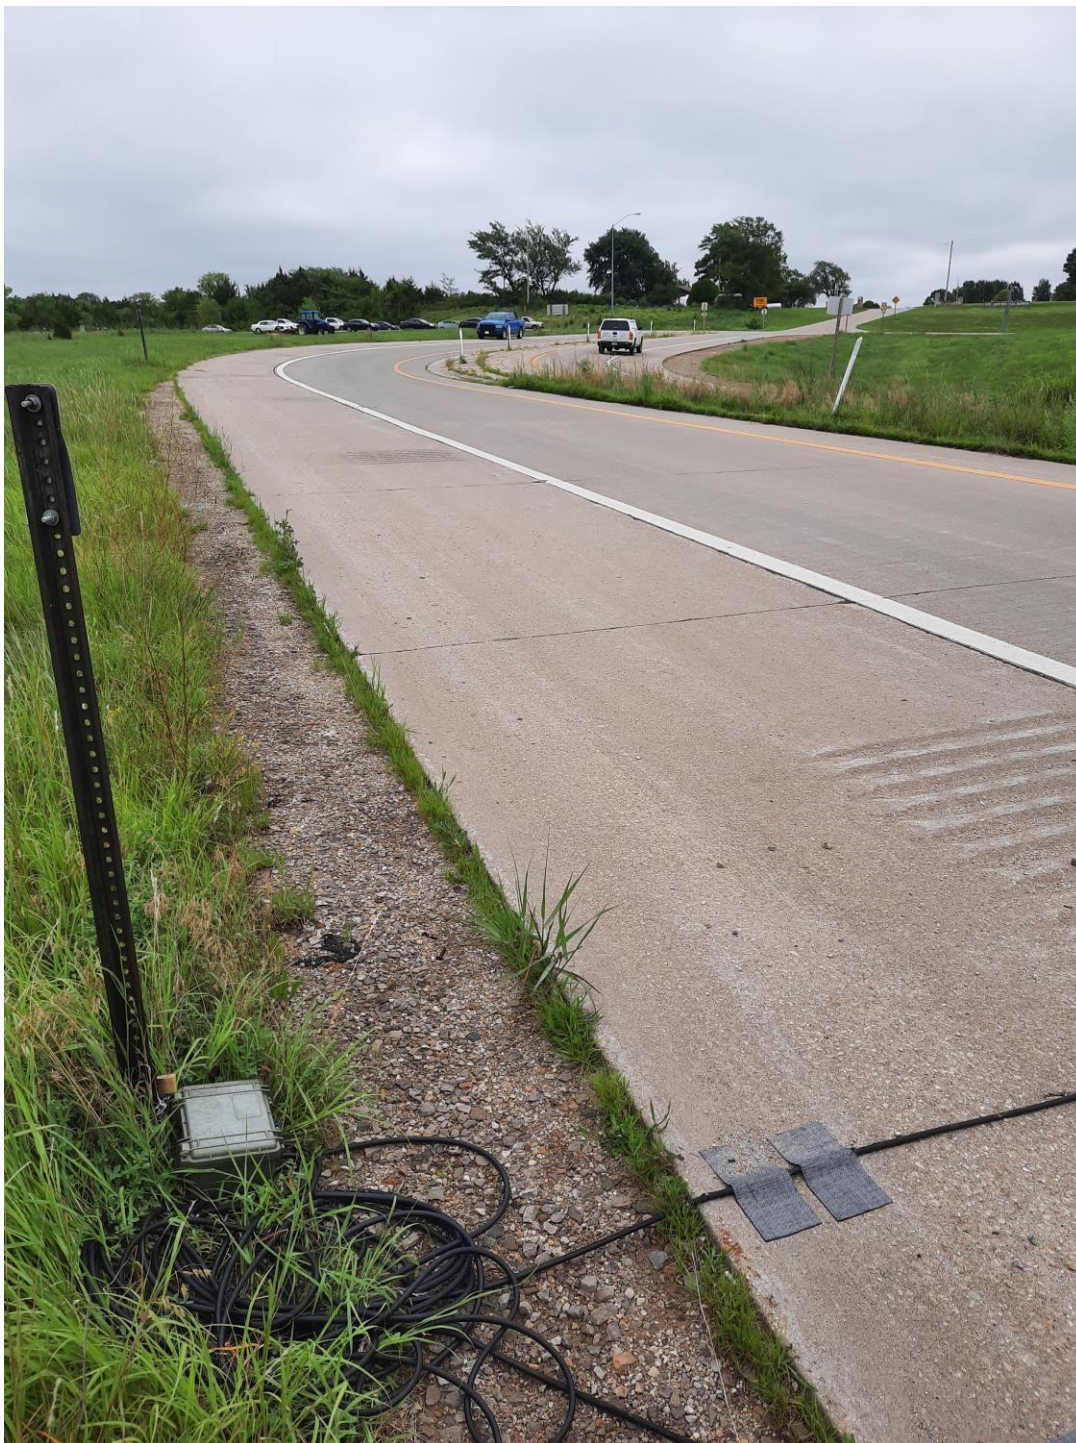
**Figure C. 43: Counter 5 Location on I-70 Entrance Ramp**
