STREAMBANK REVEGETMENT

MF-2294

September 1997

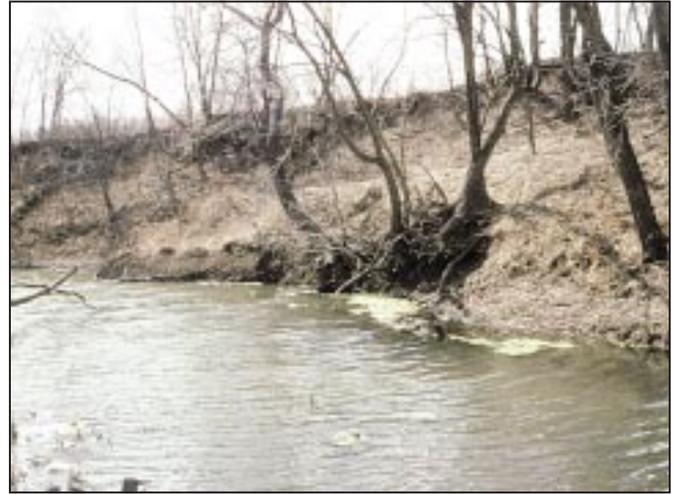
Tree revetments are constructed by anchoring finely branched trees, like eastern red cedar at the bottom of an unstable streambank. Installation starts at the downstream end of the eroded bank—at a point where the bank is stable. Each tree is placed into the stream with the cut end pointing upstream. Trees are overlapped approximately one-third and are anchored twice using a Duck-bill Anchor. Construction continues until the entire eroded surface is covered and the tree revetment is secured at a stable point upstream.

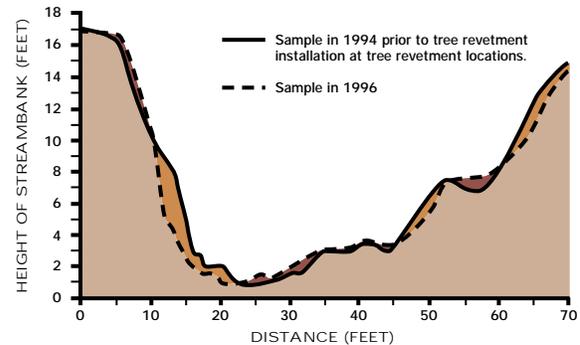
KINGS CREEK

- The control sites all had well-developed riparian corridors, as shown in the photo above. There was little change in the channel cross-section at the controls sites from 1994 to 1996, as shown by the representative cross-section in the graph.

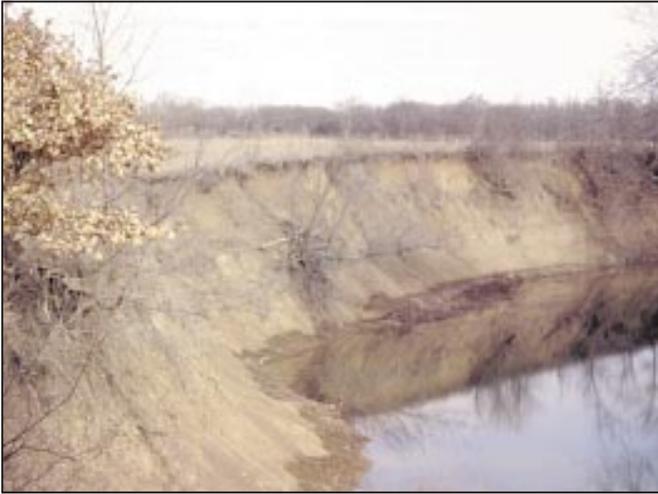
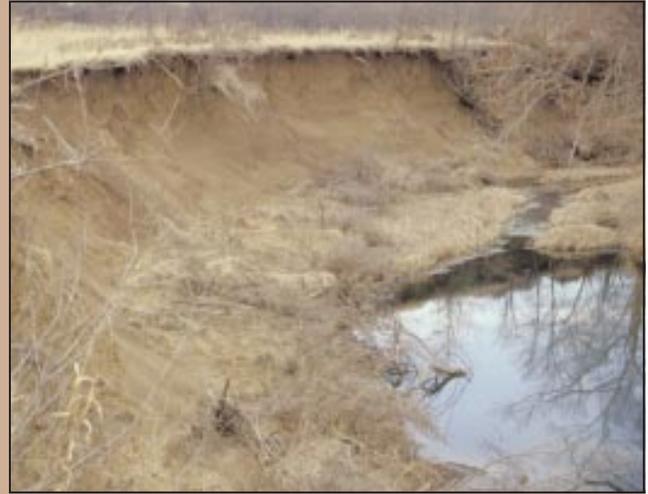
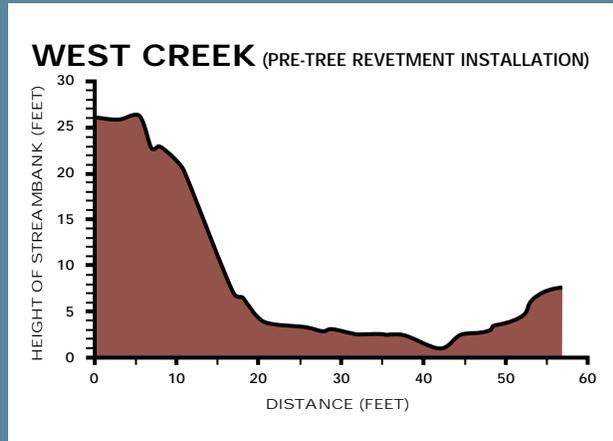
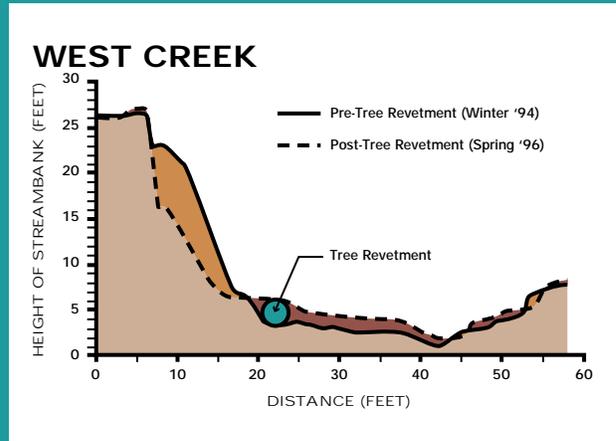
■ The tree revetment sites lacked a riparian corridor and had accelerated erosion problems, as shown in the photo above. The corresponding graph shows the eroding outside bend at 26 feet in height.

■ After tree revetment installation, banks became more gradual and the main channel of the stream was moved away from the eroding bank, protecting the streambank from excessive erosion. The corresponding graph illustrates how the slope of the eroding streambank decreased, and how silt increased within the tree revetment.

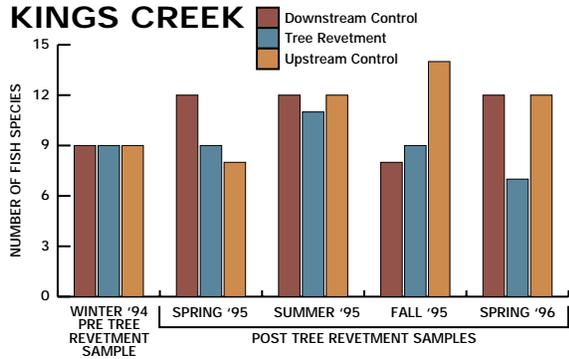
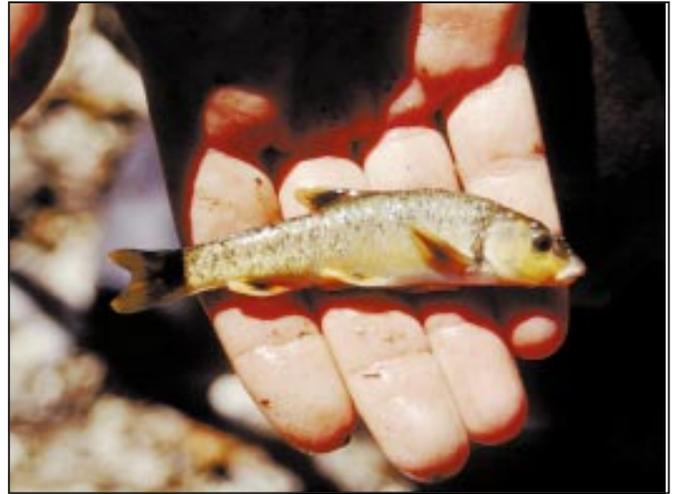
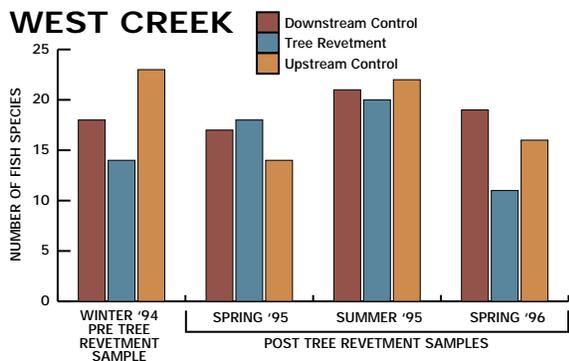
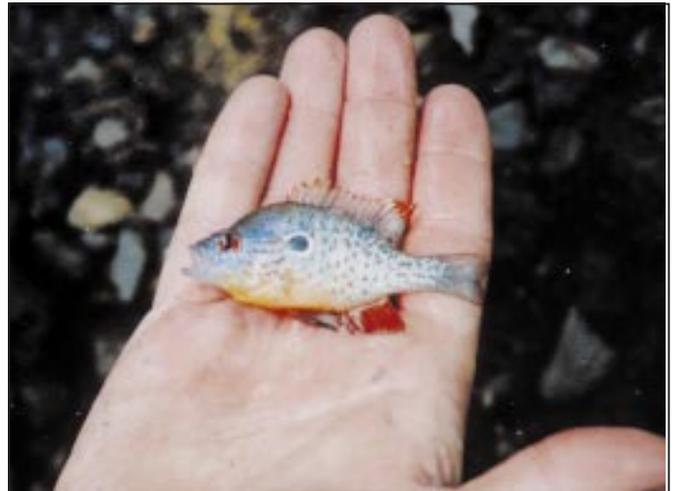
■ The number of fish species present at Kings Creek and West Creek was not related to the establishment of the tree revetments. This is evident by the lack of a distinct pattern in number of fish species present among the controls and tree revetment location.

- Central stoneroller (top photo) were the most abundant fish present in Kings Creek. Central stonerollers are common in streams through eastern Kansas. Central stonerollers feed primarily on algae and micro-organisms associated with the streambottom. Central stonerollers only get 6 to 8 inches long.
- Orangespotted sunfish were the most abundant fish present in West Creek. Orangespotted sunfish are in the same family of fish as bluegill and crappie, and usually feed on small aquatic insects and other fish. Orangespotted sunfish do not grow much larger than 6 inches.

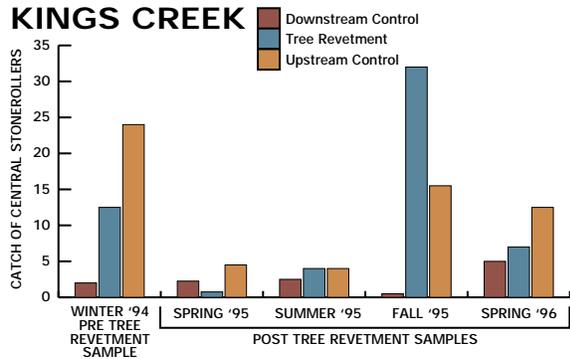
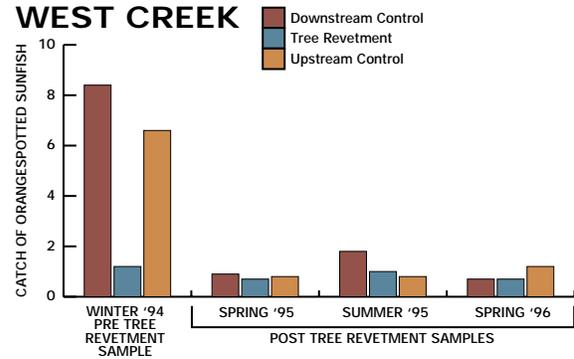
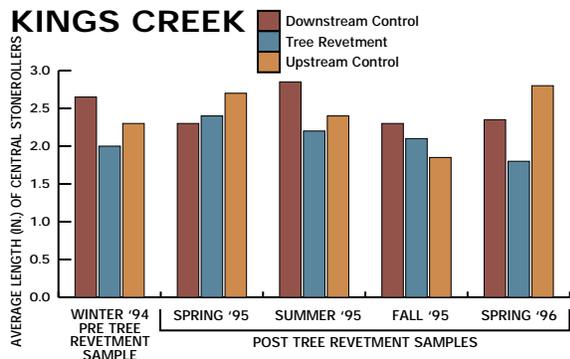
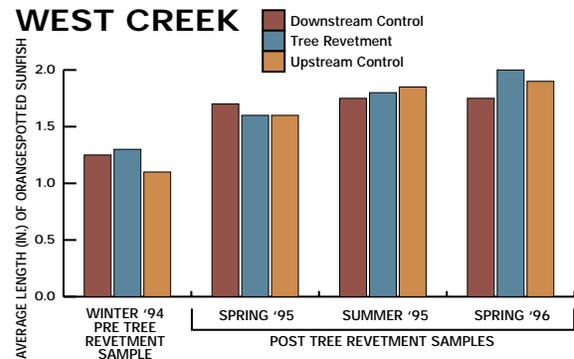
■ Catch of central stoneroller declined slightly after installation of the tree revetment at the tree revetment and upstream control locations. Thus, it is likely that catch of central stonerollers was influenced by a factor other than the tree revetment. Average length of central stonerollers remained similar at all locations before and after installation of the tree revetment.

■ Catch of orangespotted sunfish declined at all locations after installation of the tree revetment. Similar to catch of central stonerollers in Kings Creek, catch of orangespotted sunfish was not influenced by the tree revetment. Average length of orangespotted sunfish remained similar at all locations before and after installation of the tree revetment.

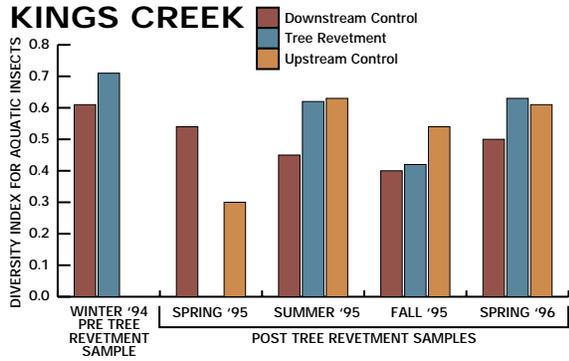
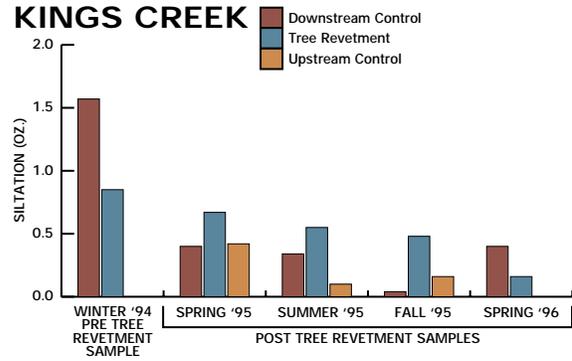
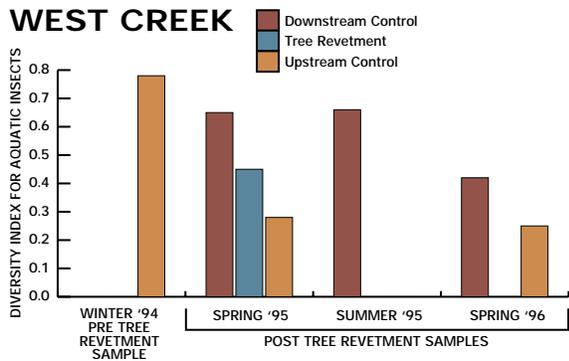
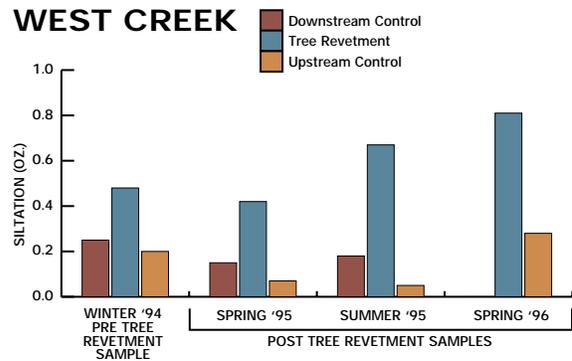
■ Diversity of aquatic insects was variable in Kings Creek and West Creek, but was not related to the tree revetment. Overall, the tree revetments had no effect on the diversity of aquatic insects present.

■ The amount of siltation within Kings Creek (left) was generally lower at all locations after installation of the tree revetment. Conversely, siltation increased in West Creek at the tree revetment location after installation. This is likely caused by the tree revetments trapping sediment. Sediment trapping did not occur on Kings Creek because the tree revetment was slightly above the water level during normal flow.
